**Re: WPA Building Existing Conditions Evaluation
N 141 Street & Oldfield Street
Waverly, NE**

Per your request, I have performed an observation of the reference properties to review the building's integrity for your determination of viable future uses. This Existing Conditions Evaluation was prepared based on a site visit observations made at the WPA Building on February 5, 2026 and February 18, 2026.

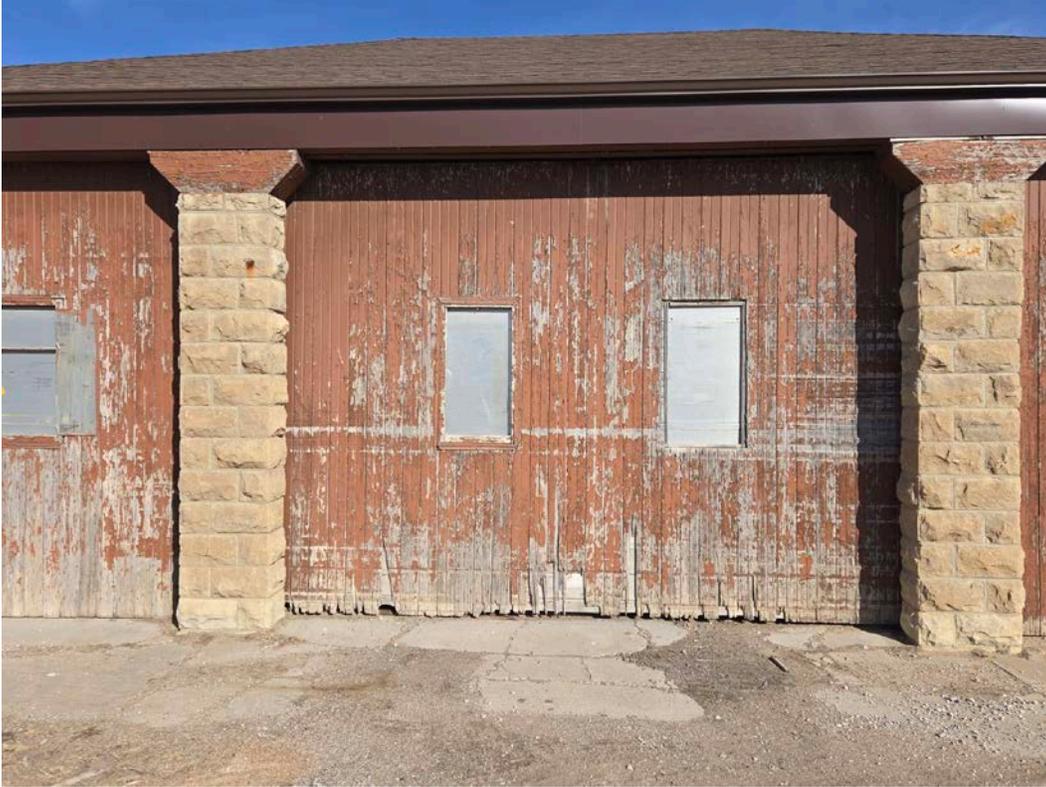
- ❖ **Condition: Main Building – Very poor. No glass in windows that are covered with plywood and road signs. No reliable seals. Needs painted and repaired.. Replacement recommended.**

6.13 WPA Building typical south sliding door looking north.

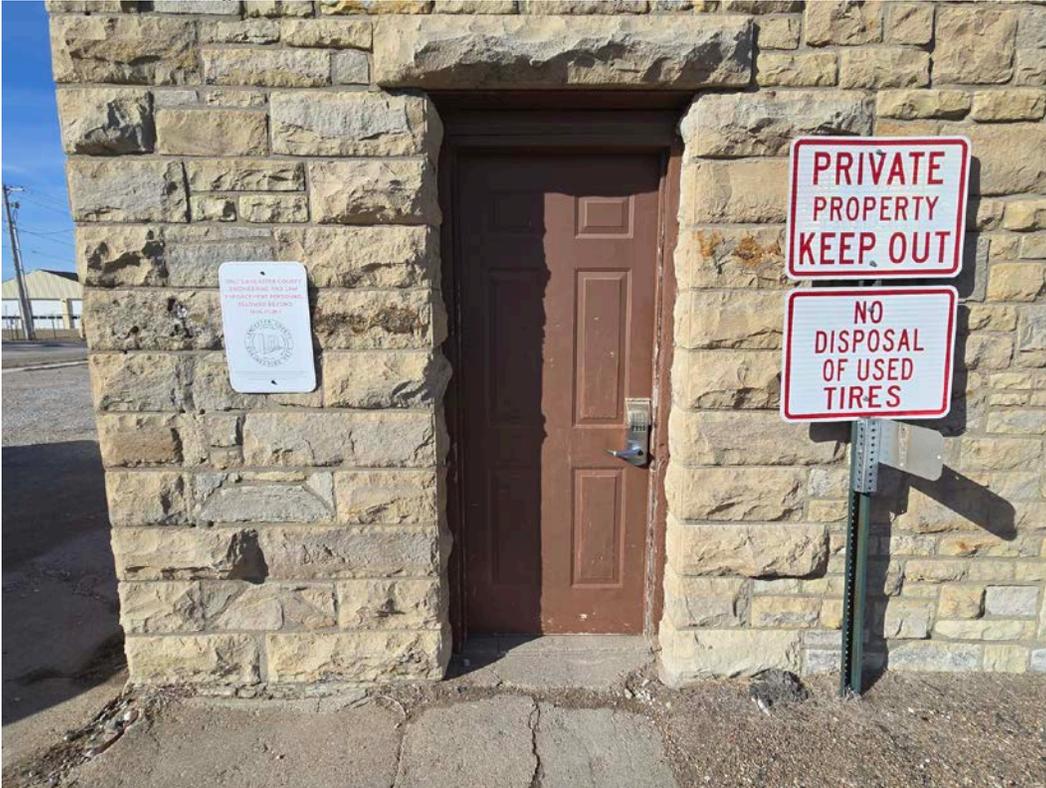
- ❖ **Condition: - Main Building - Very poor. No glass, frame rotting. Needs painted. Replacement recommended.**
 - ◆ Access Doors: Main Building - 3 at south @ 14'-0" wide x 10'-8" tall sliding wood with 2 - 1'-7" wide x 3' tall windows / Addition - None.

6.14 WPA Building east elevation entrance door looking west.

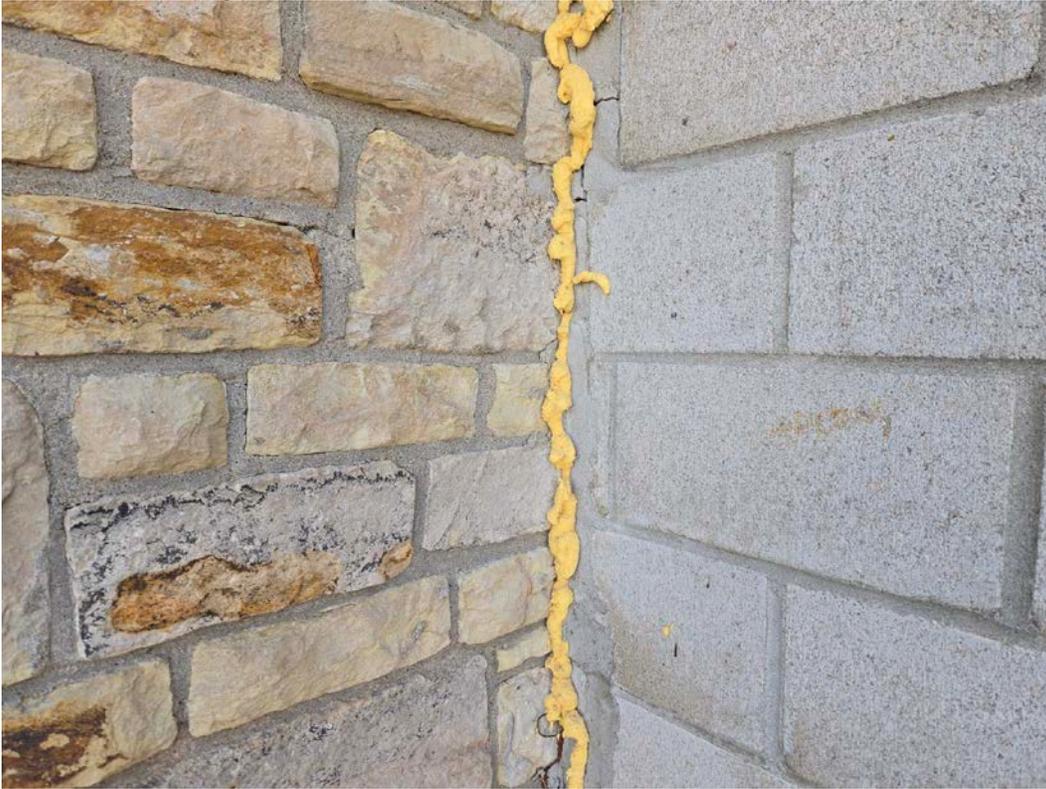
- ❖ **Condition: Addition - Good. Some minor cracking at base at the northeast corner and connections to main building has expanding foam fill.**
 - ◆ Floor: Main Building - Concrete Slab thick unknown / Addition - Concrete Slab thick unknown

6.15 WPA Building north elevation inside corner to Addition foamed joint looking southwest.

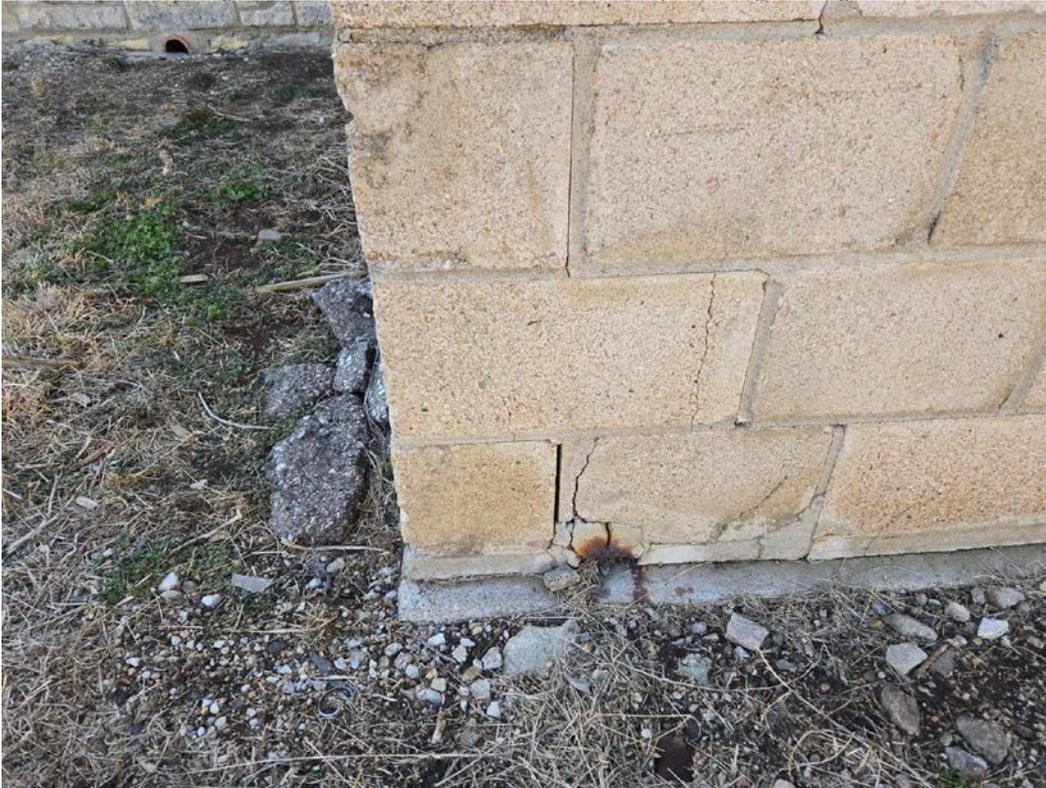
6.16 WPA Building north Addition northeast corner masonry cracking looking south.

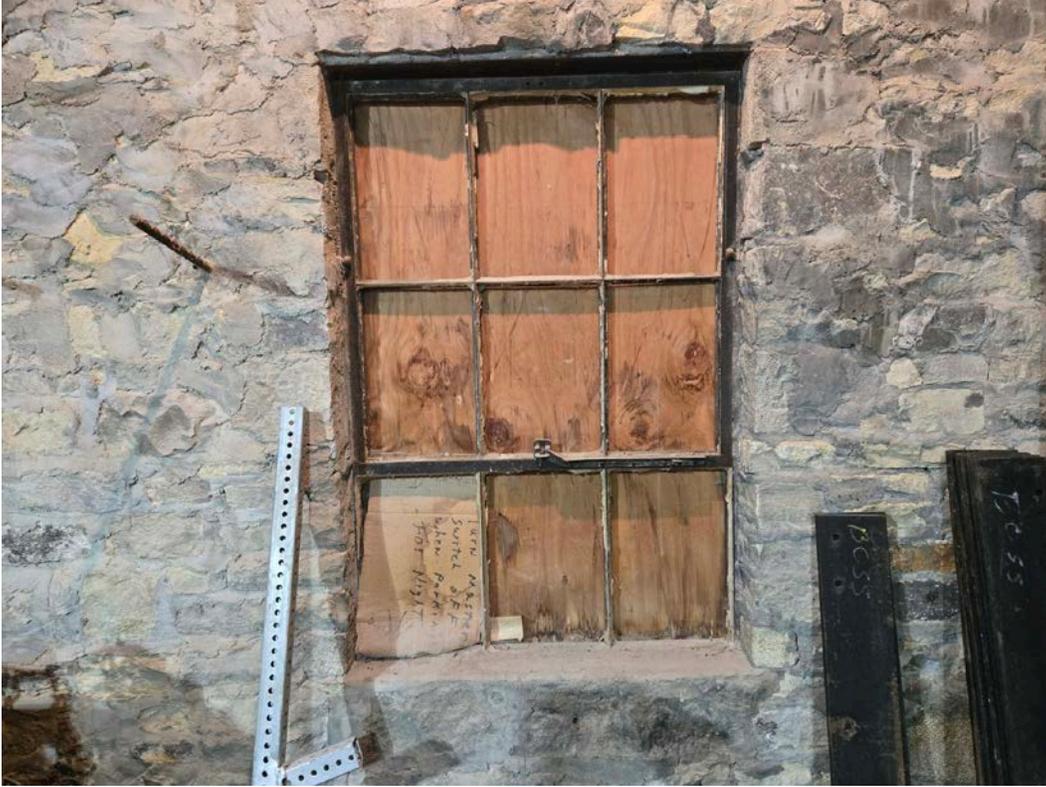
- ❖ **Condition - Main Building – Very poor. No glass, covered with plywood. Replacement recommended.**
 - ◆ Man Doors: Main Building - 1 at east @ 2'-8" wide x 6'-8" tall metal clad with wood frame / Addition - None.

6.17 WPA Building west elevation window looking east.

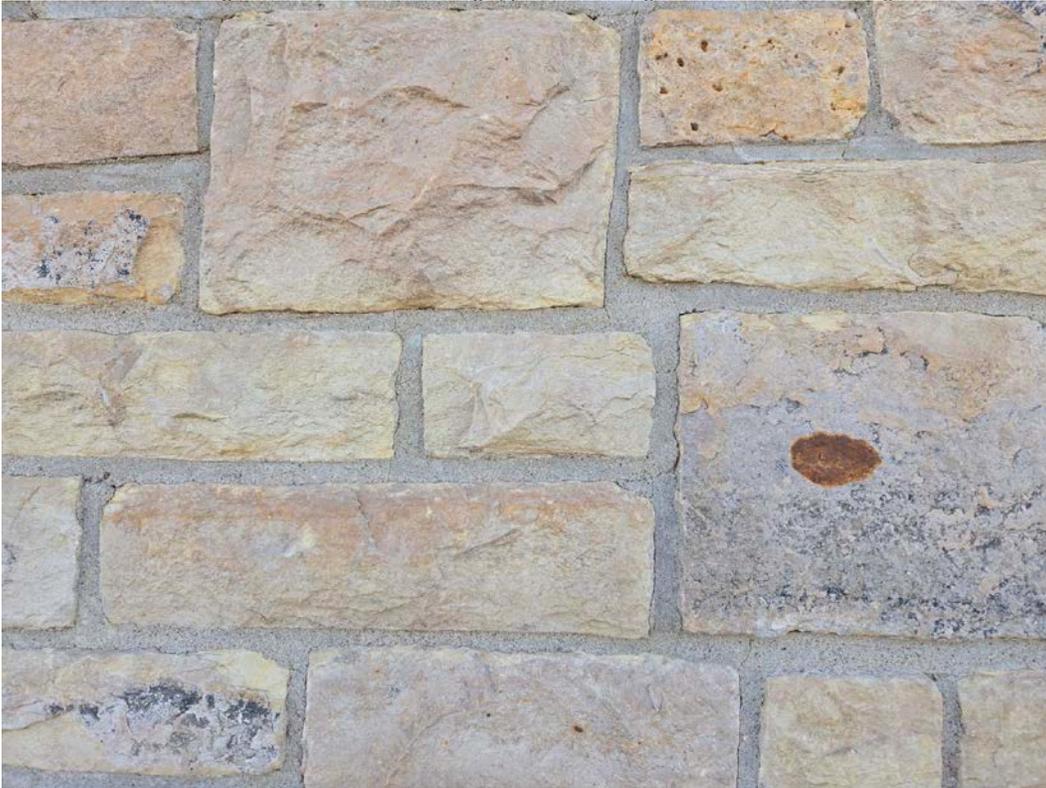
- ❖ **Condition: Main Building - Good. Some shrinkage cracking/weathering observed around limestone. Opening cut through north wall into the addition with steel supporting beam and column. Steel rusted but appears in good condition.**

6.18 WPA Building west elevation showing typical cracking around stones looking east.

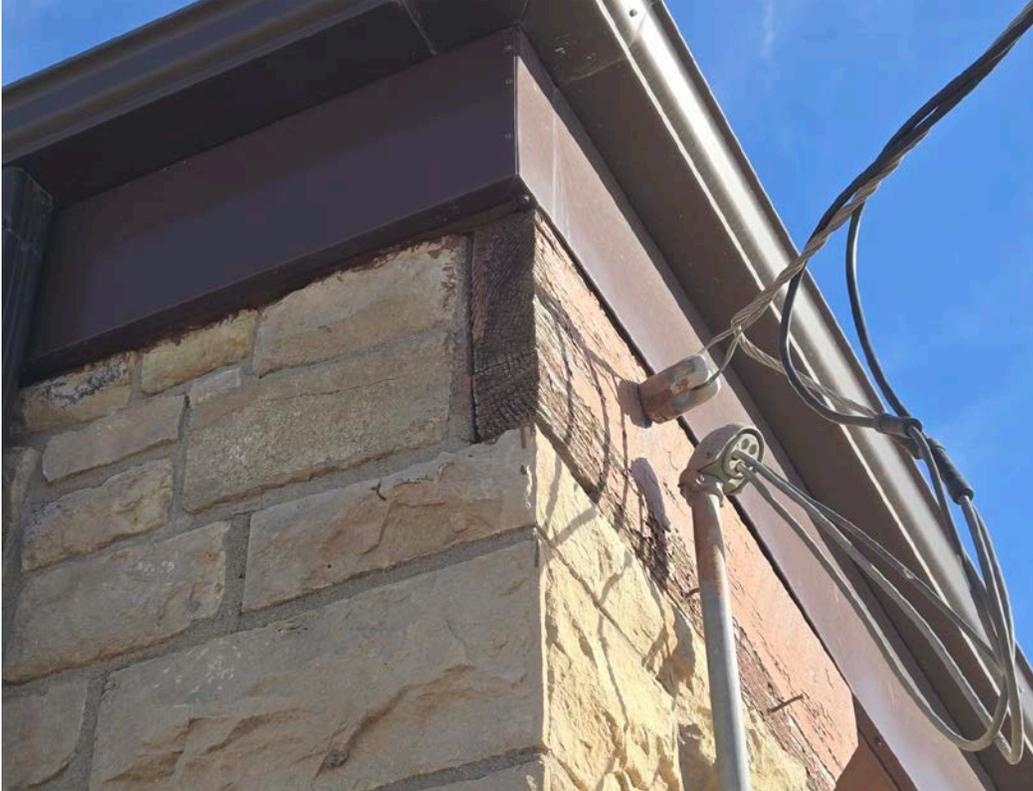
- ❖ **Condition: Main Building – Fair. Bearing at 11'-7" +/- AFF with some sagging of the bottom chord. No members appear compromised but would not be compliant with current building codes. Reinforcement recommend. Fascia, gutters and downspouts in excellent condition. Pier caps at south elevation made of wood which have weathered and possibly rotted which may require partial replacement**

6.19 WPA Building southwest corner weathered and possibly rotted wood block looking northeast.

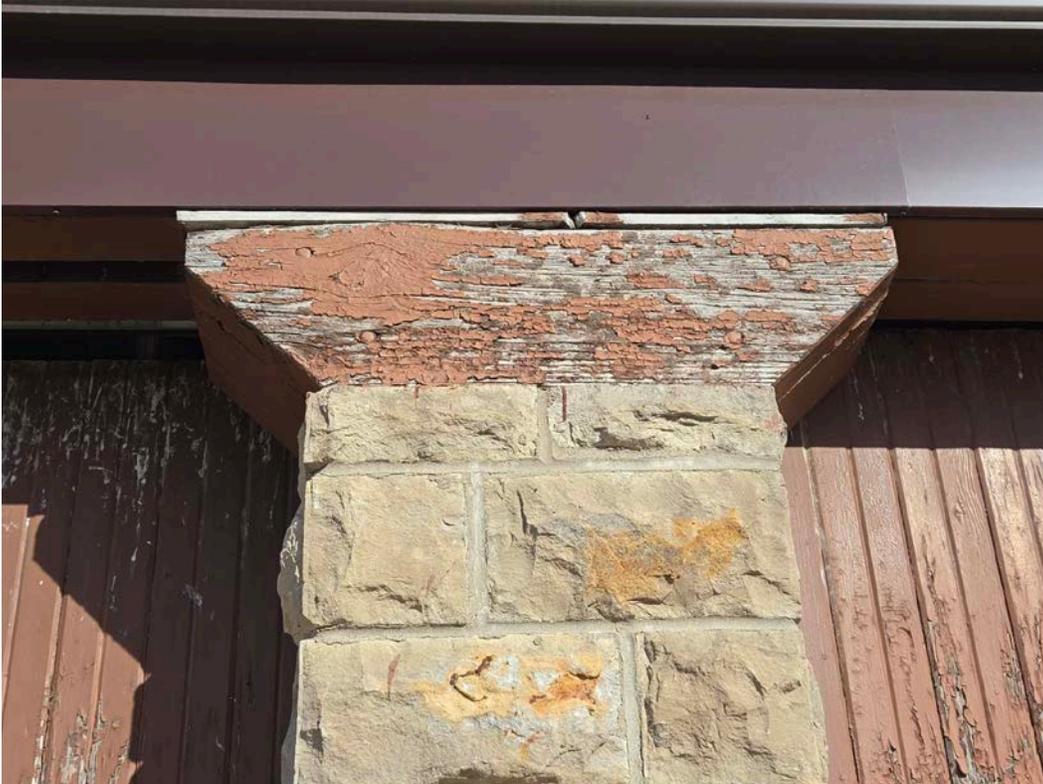
6.20 WPA Building south pier weathered and possibly rotted wood block looking northeast.

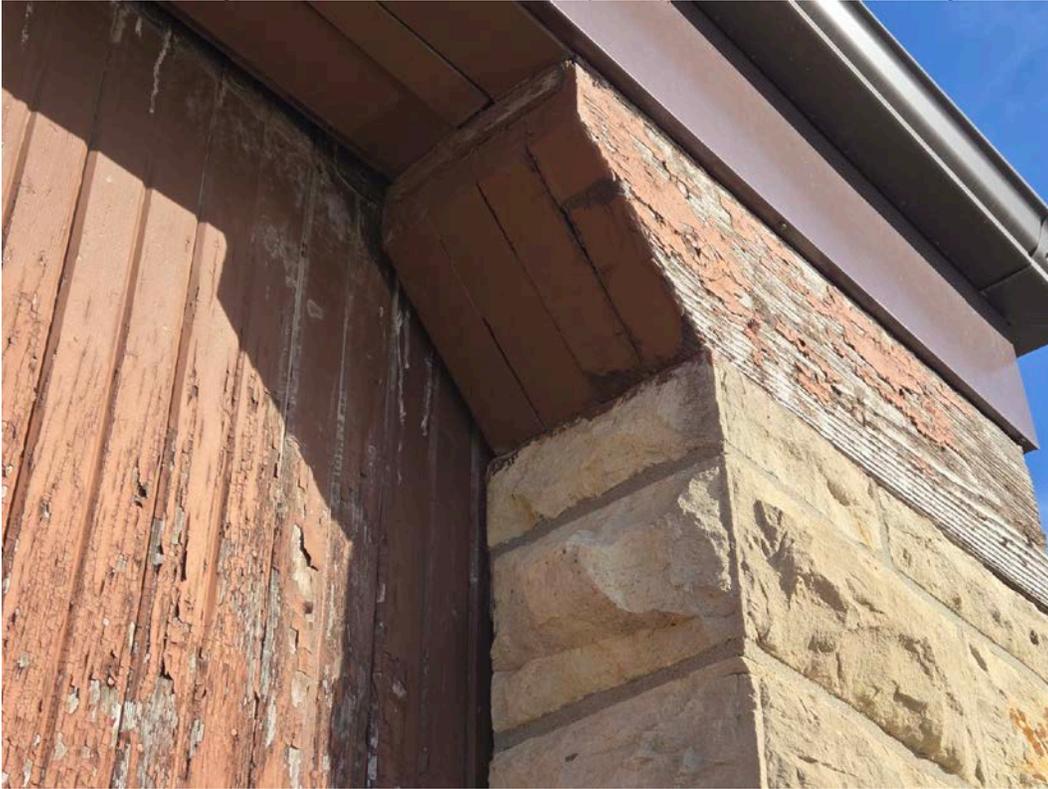
6.21 WPA Building southeast corner weathered and possibly rotted wood block looking northeast.

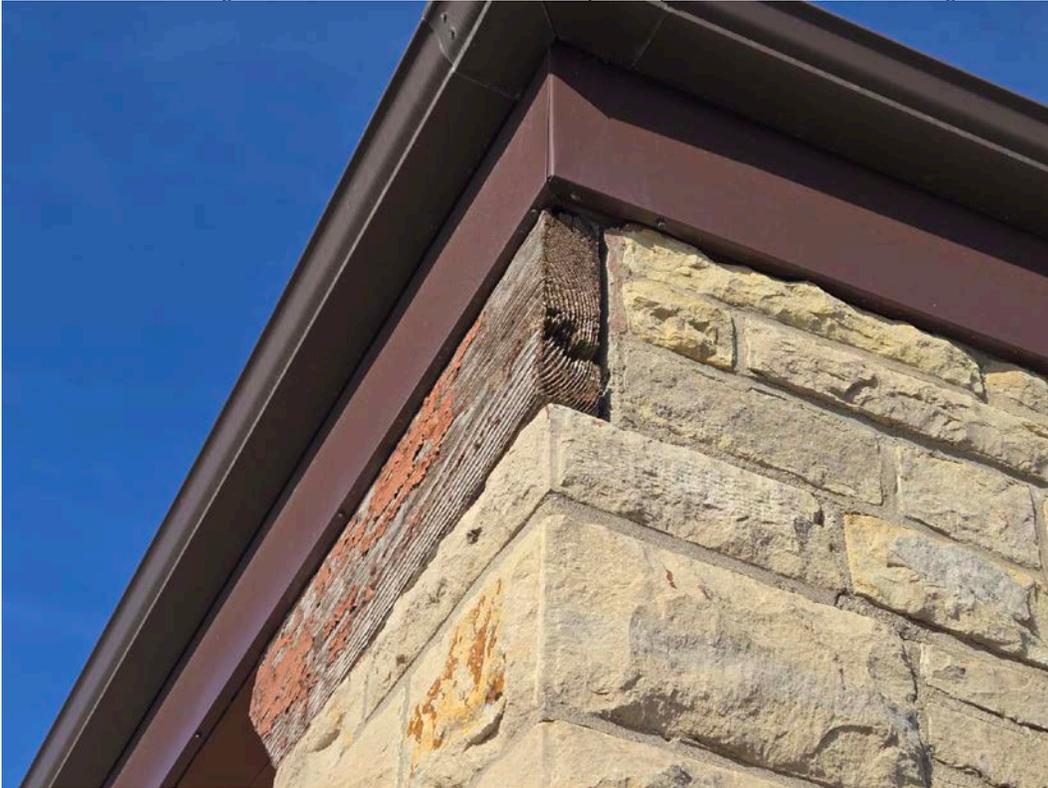
6.22 WPA Building southeast corner weathered and possibly rotted wood block looking northwest.

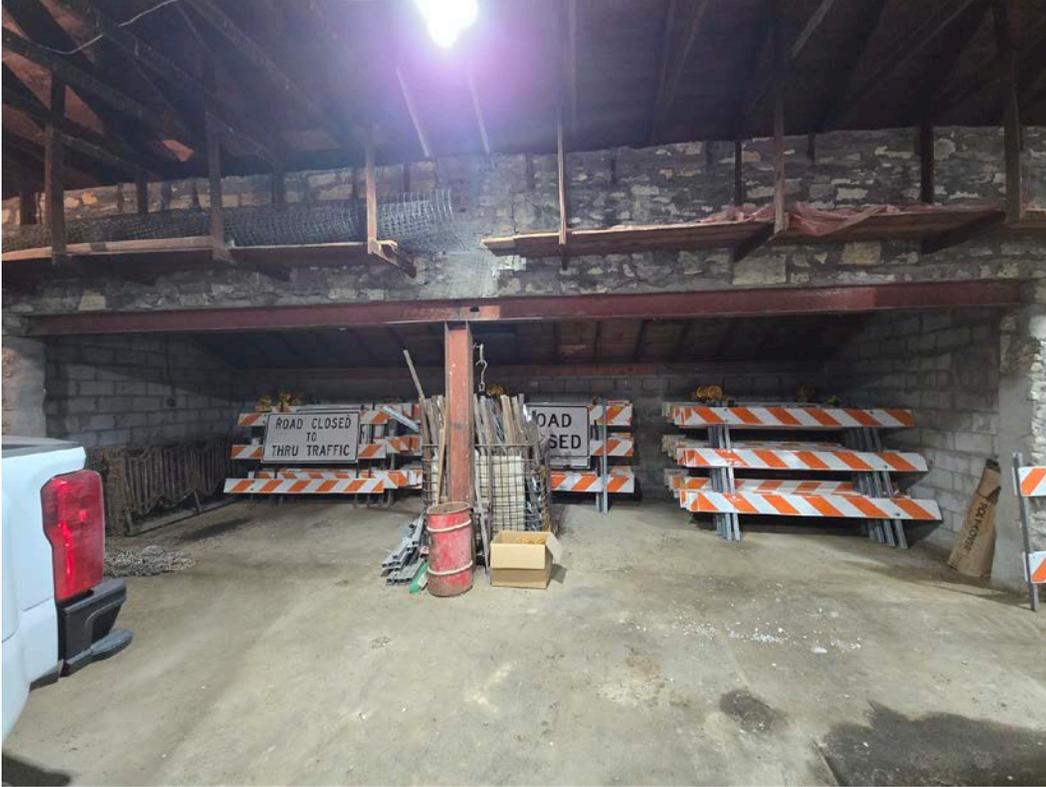
6.27 WPA Building interior looking north with opening into the addition.

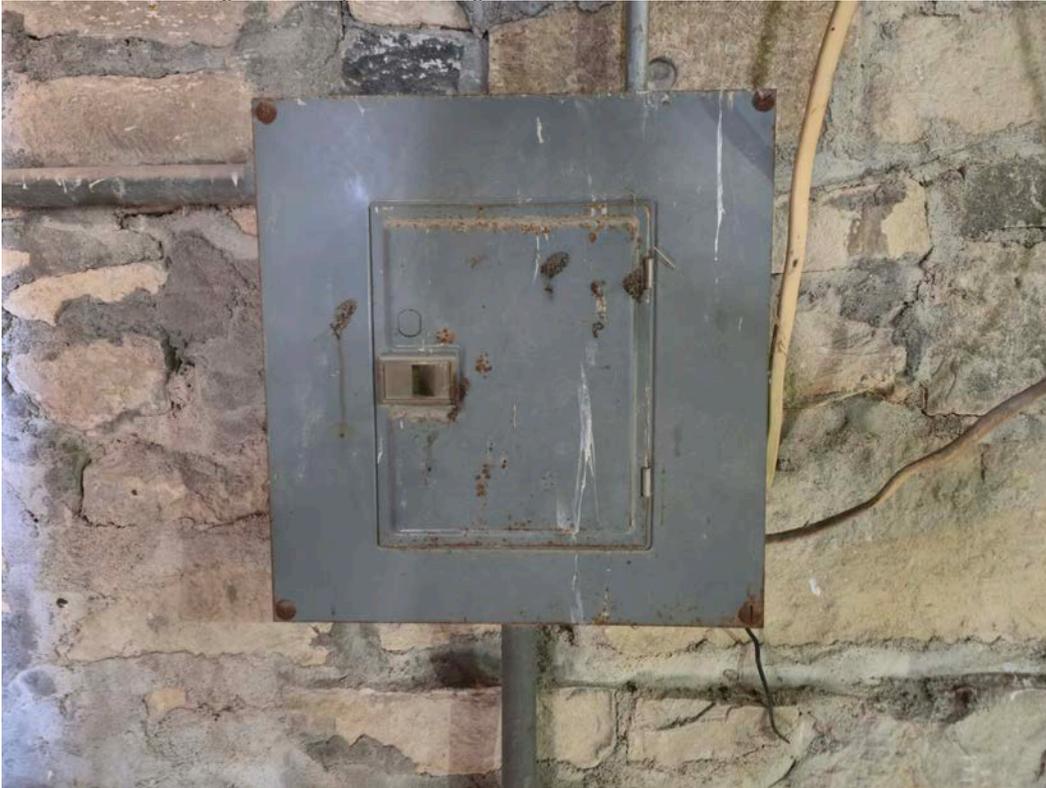
- ◆ HVAC: Main Building - None / Addition - None.
 - ◆ Electrical: Main Building - 100 Amp power panel with capacity of 12 breakers. 7 breakers utilized in 9 of the slots. 6 serving 4 light fixtures and approximately 4 receptacles in the building and one serving the Granular Material Storage Building. Light fixtures producing minimal light. / Addition - None.

- ❖ **Condition: Main Building – Fair. Replacement recommended if more electrical devices are added.**
 - ◆ Plumbing: Main Building: None / Addition: None.

6.28 WPA Building electrical panel looking west.
