### **Alma Public Schools**

# Alma Public Schools Facilities Assessment

April 11, 2022

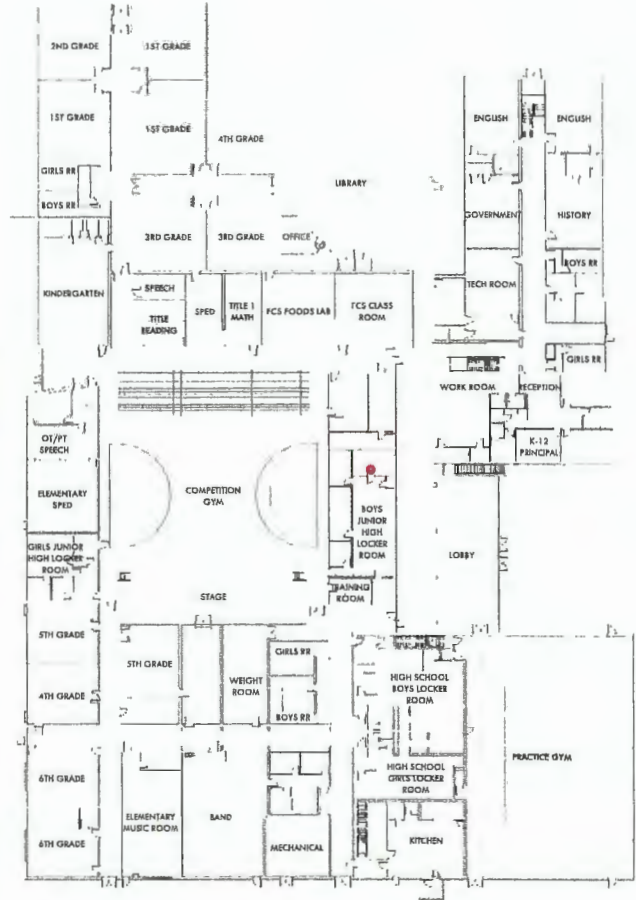
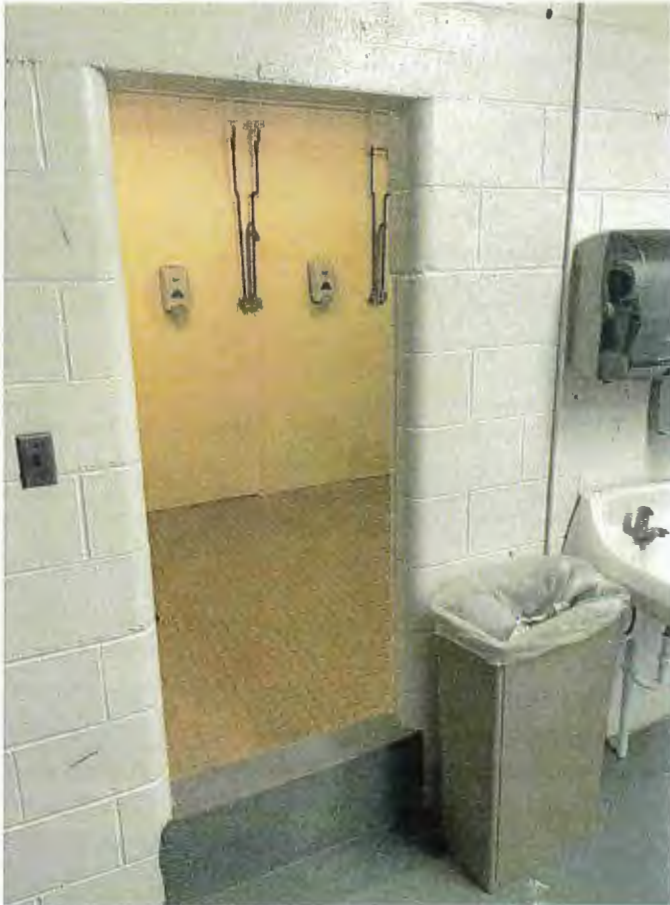
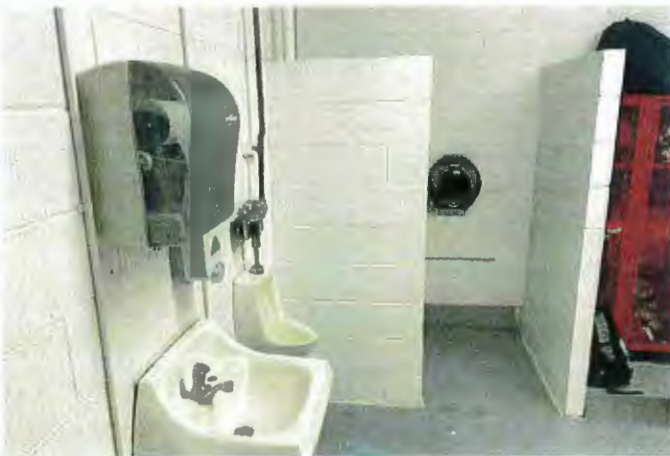
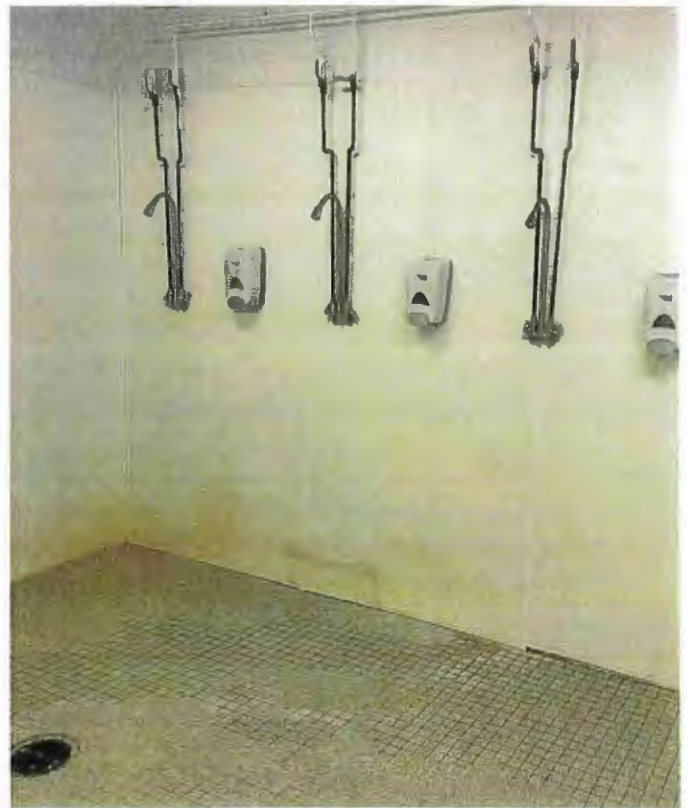
The boys junior high locker room is not ADA accessible.

Renovate junior high locker room to meet ADA guidelines.

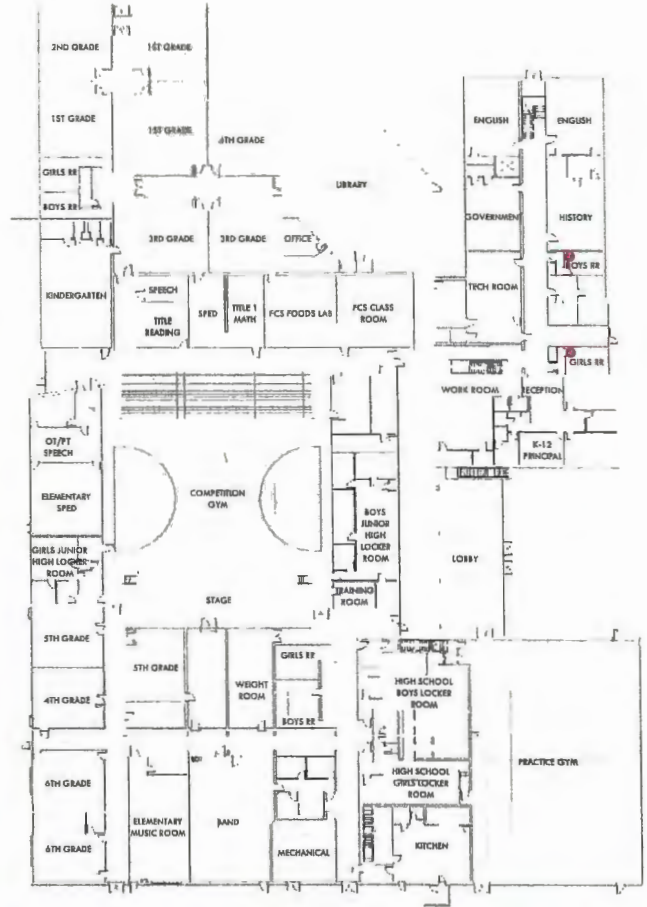
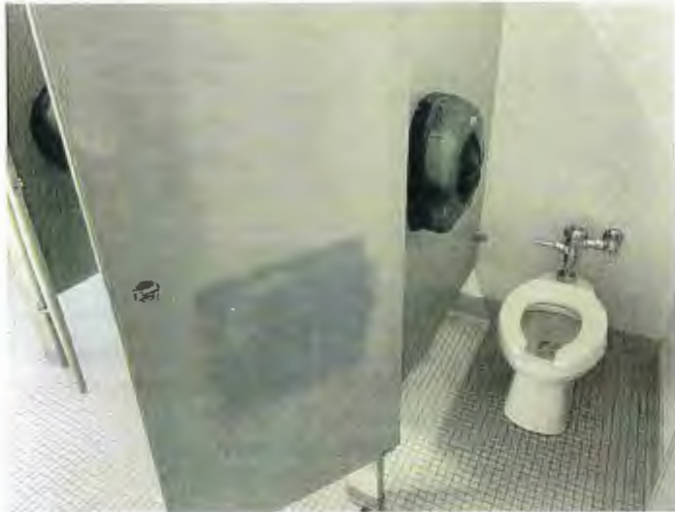
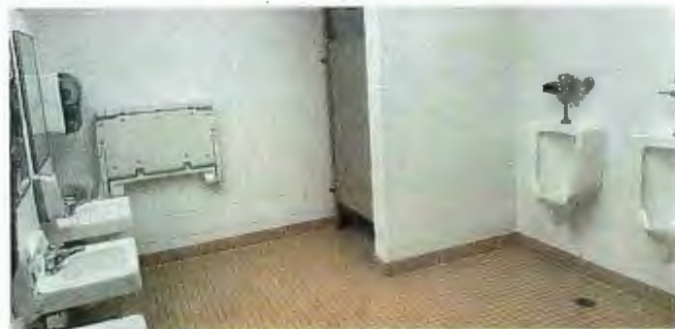
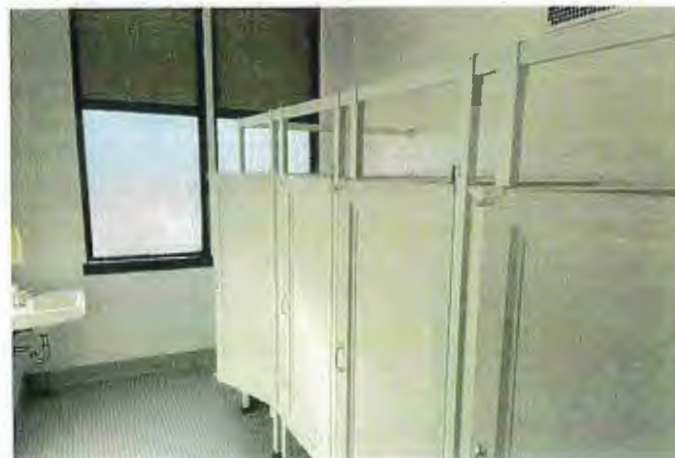
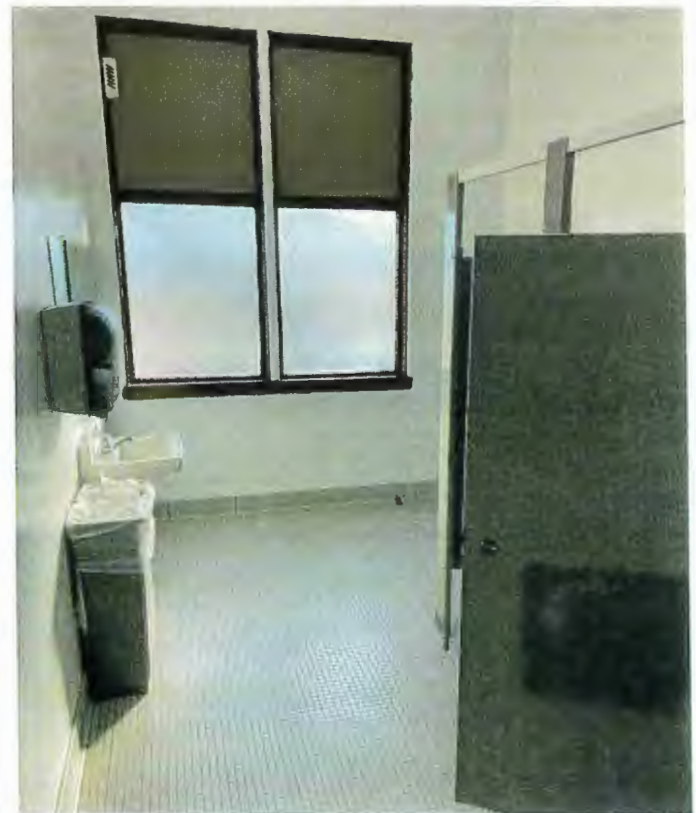
The girls and boys restrooms are not ADA accessible.

Renovate the girls and boys restrooms to meet ADA guidelines.

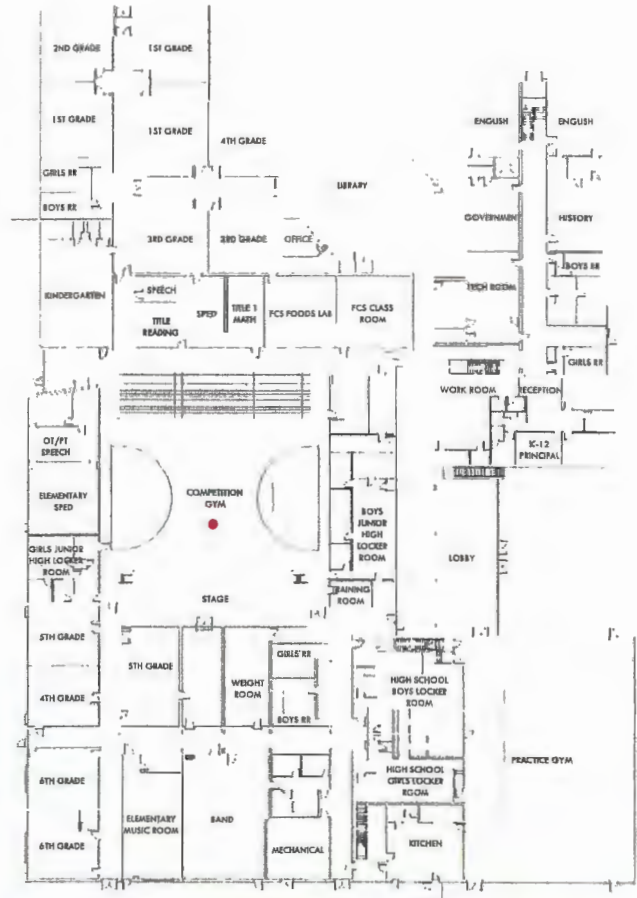
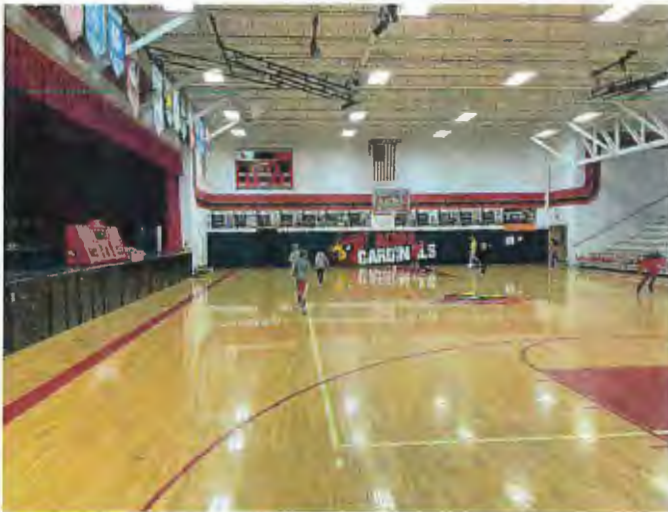
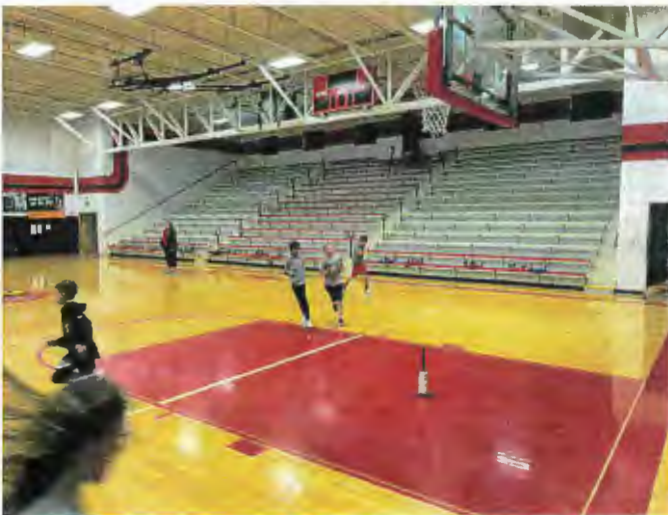
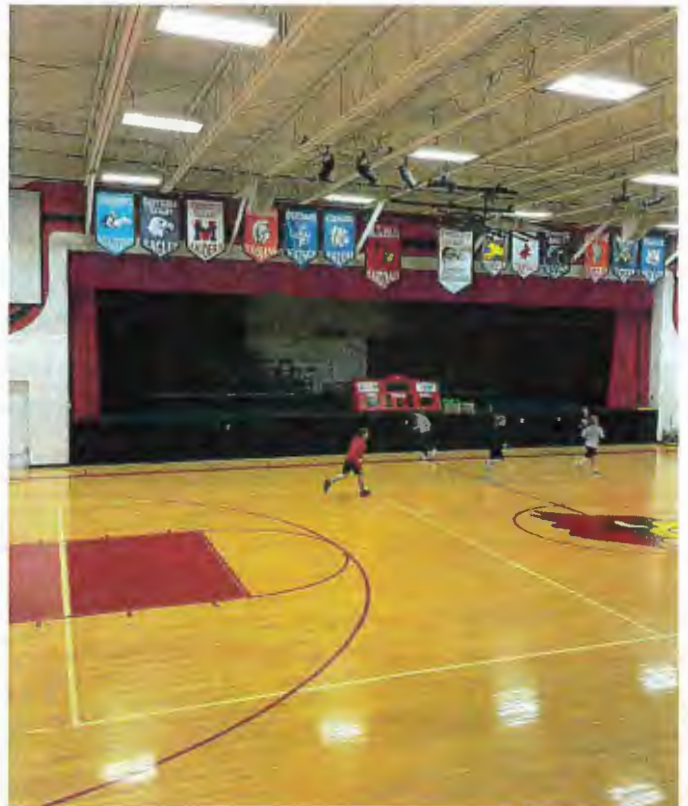
At the Main Competition Gym there are a number of deficiencies including:

- No wheelchair seating areas.
- The clearances around the main basketball court do not meet current NFHS and NSAA standards/guidelines.
- The current seating capacity is not in line with a number of peer institutions and a lack of seating capacity is a limiting factor for hosting postseason NSAA tournaments.

While this is a costly solution, the only practical way to resolve most, if not all, of the noted deficiencies is to construct a new gymnasium.

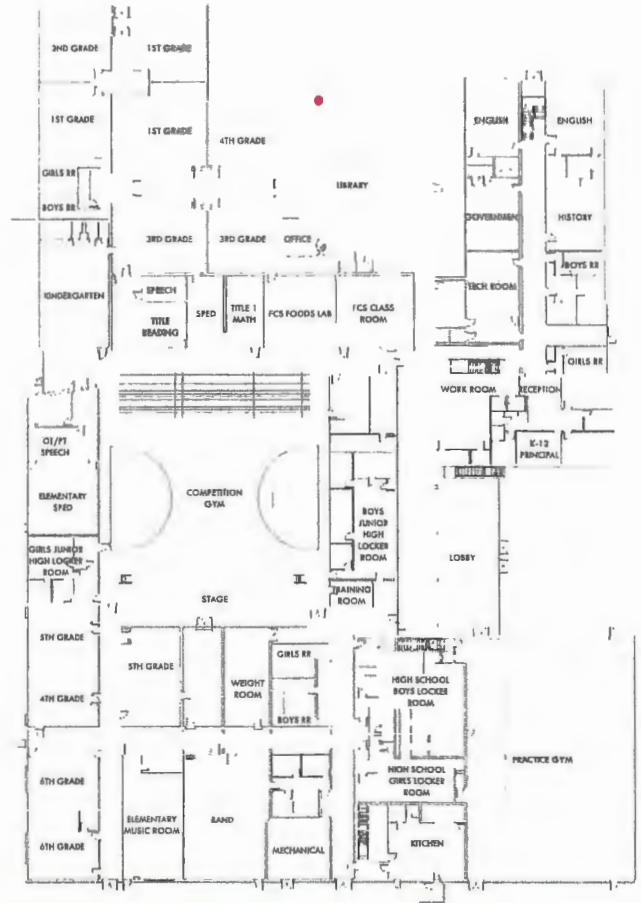
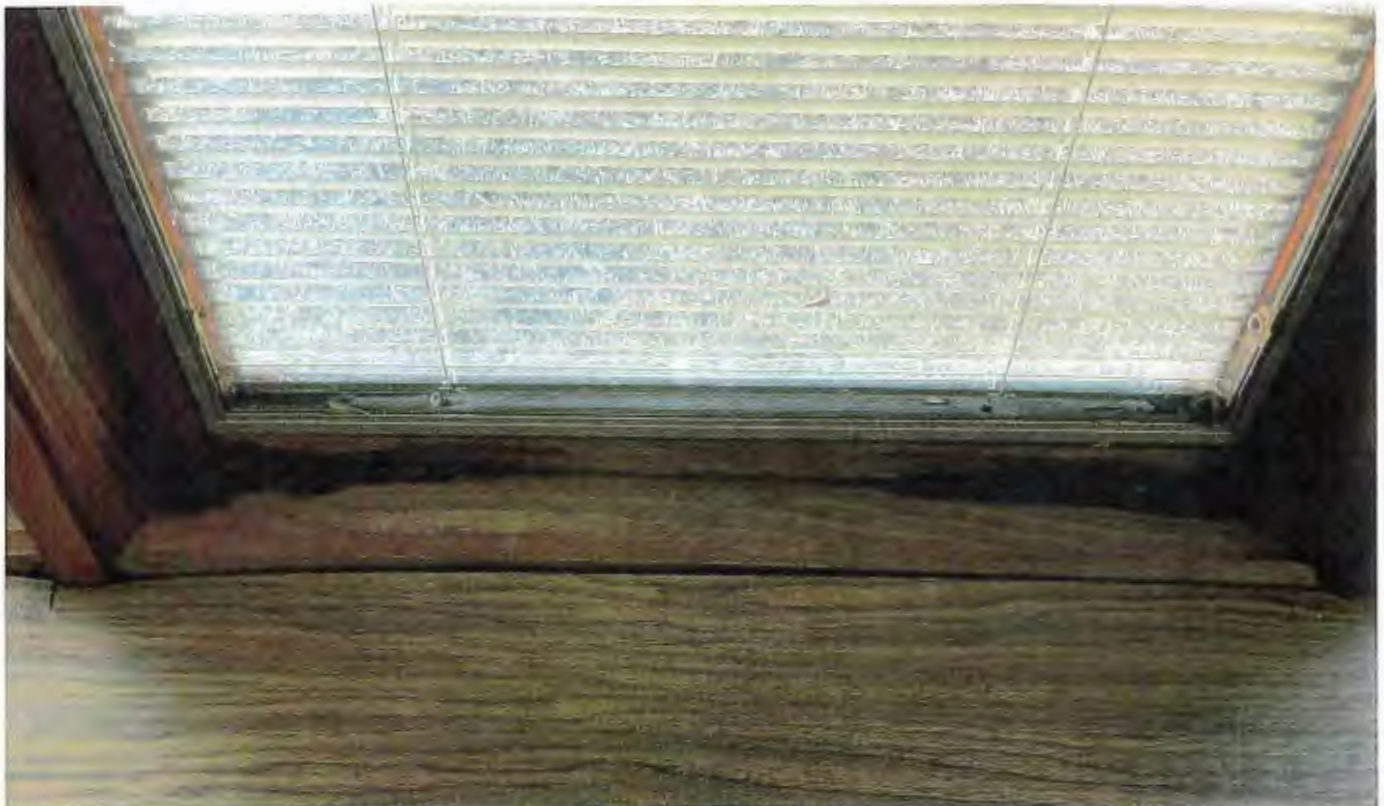
In the library, (and other places) the wood windows are rotting/deteriorating.

Replace all wood windows.

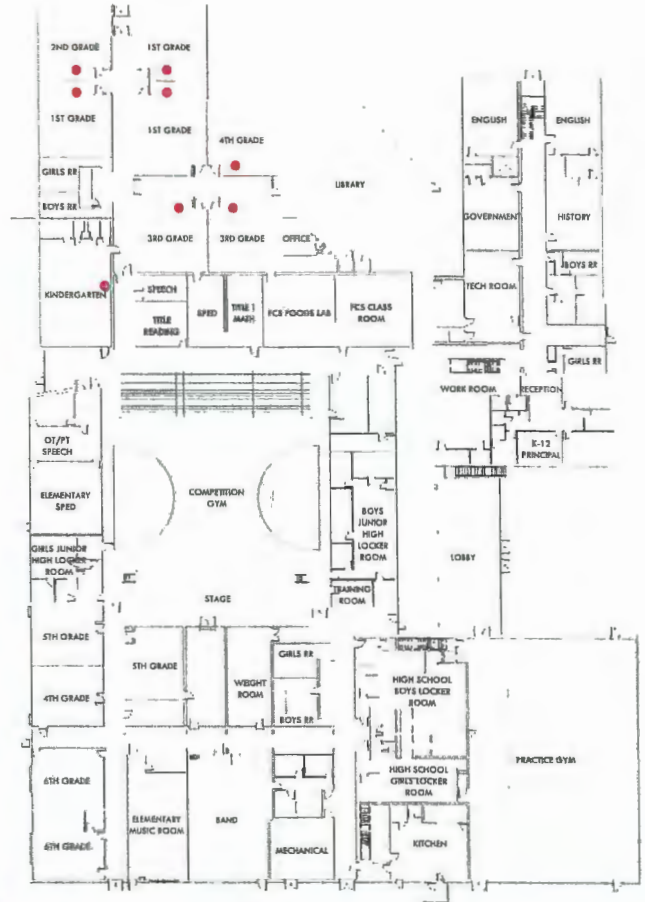
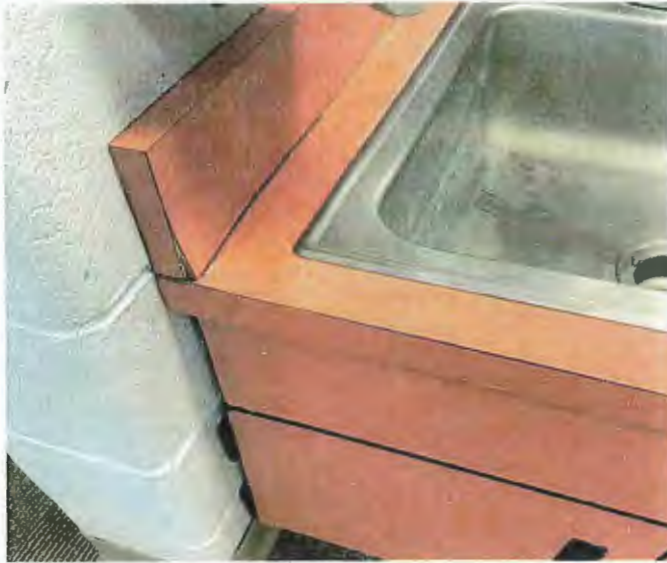
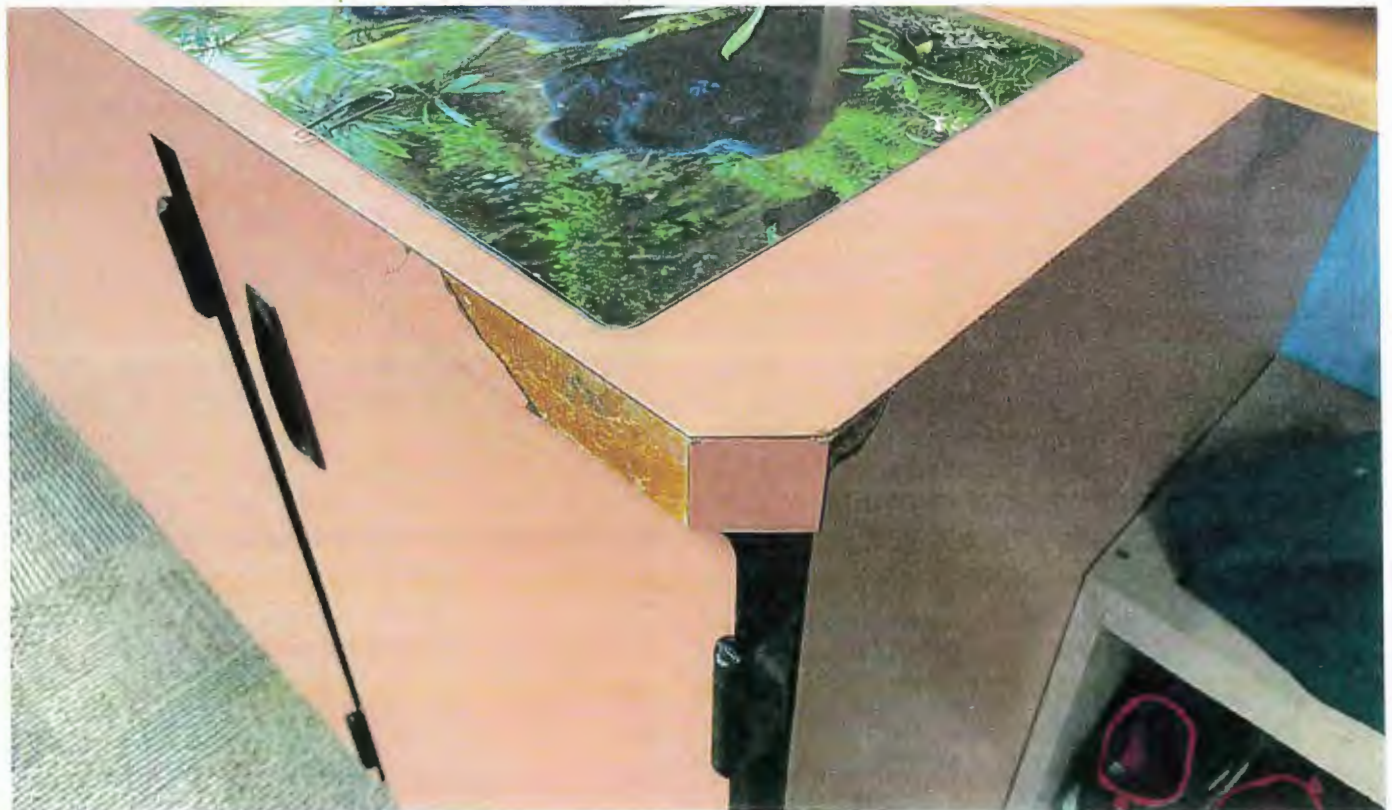
In the classrooms, the laminate is separating from the counter top. In general, many of the counter tops and some of the cabinets are worn and should be scheduled for replacement.

Replace counters. Consider replacing all original counter tops.

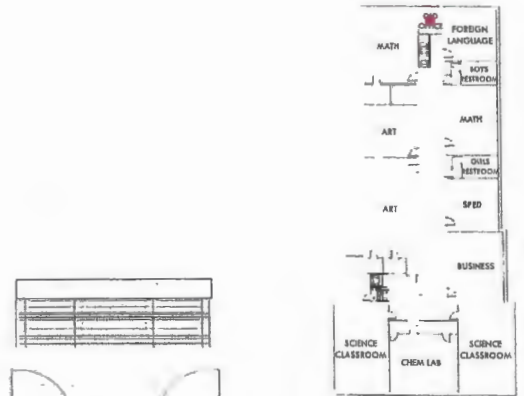
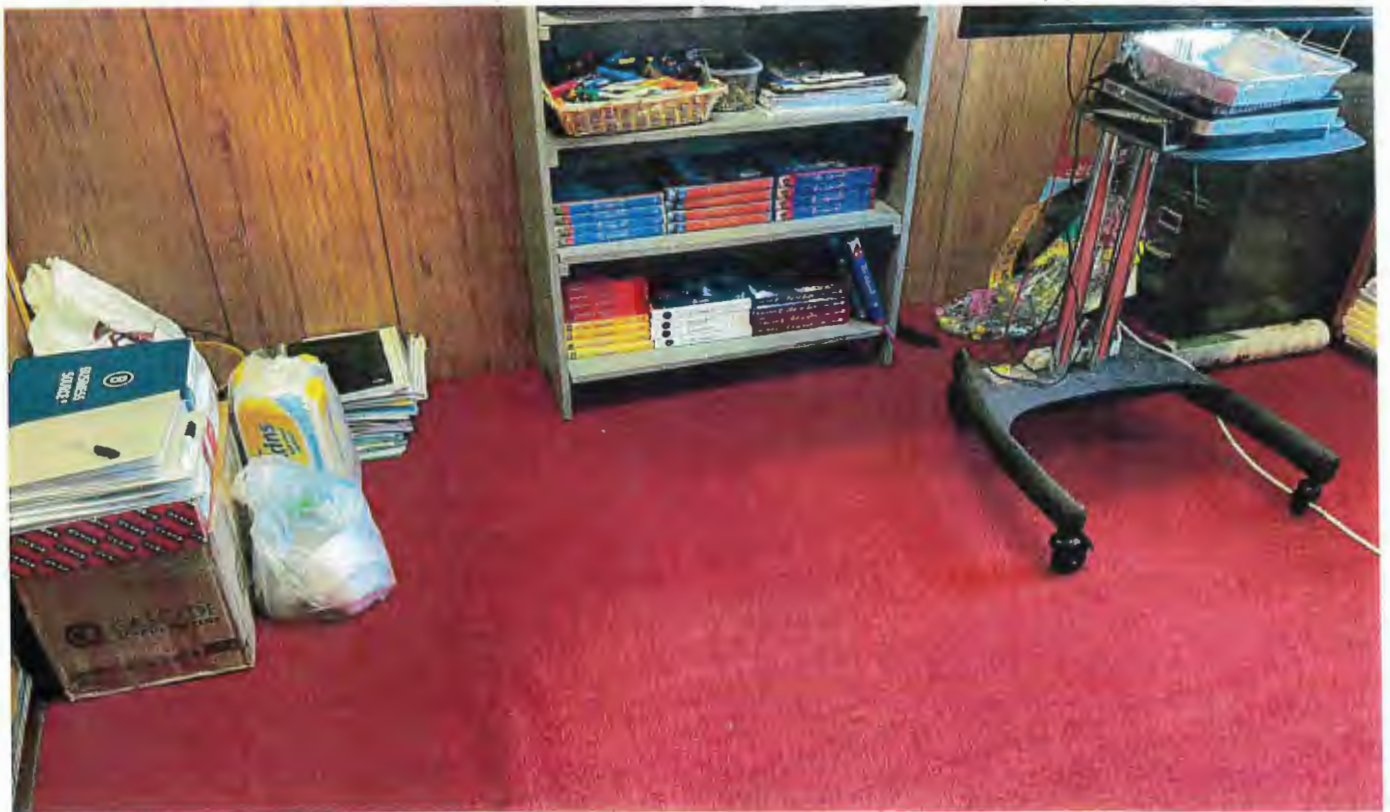
Office/resource room has outdated/worn finishes and wall paneling.

Replace carpet and wall paneling.

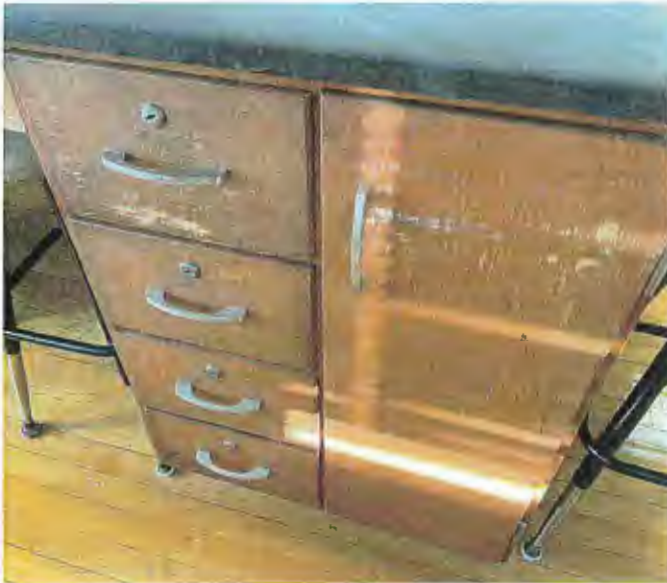
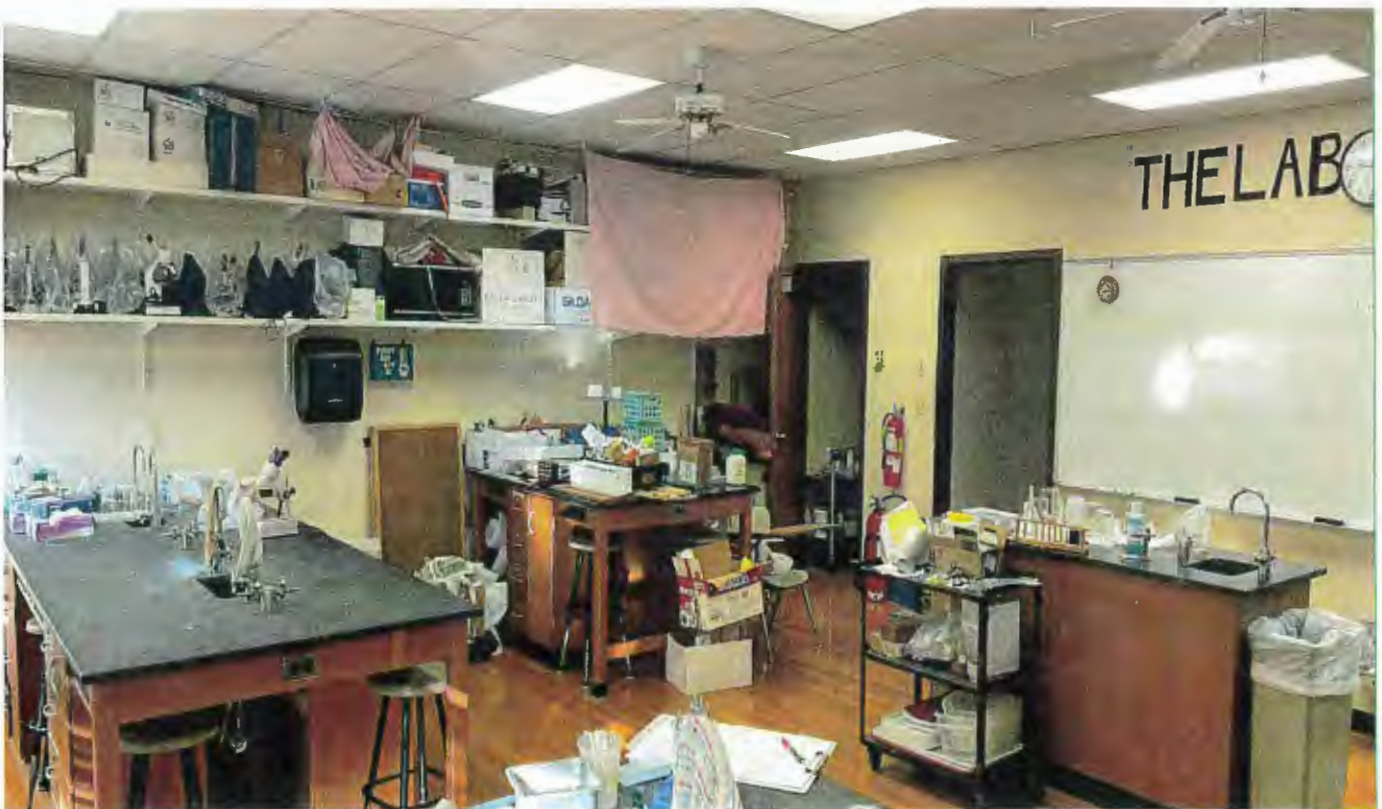
In the science room, the cabinets are worn and some are deteriorated. In addition, the lab lacks current/modern ventilation equipment.

Refinish and/or replace cabinet and install modern fume extraction equipment.

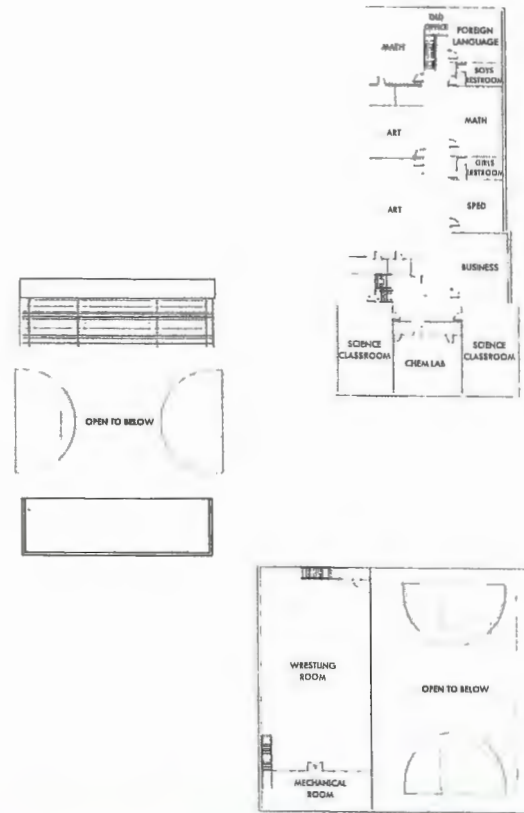
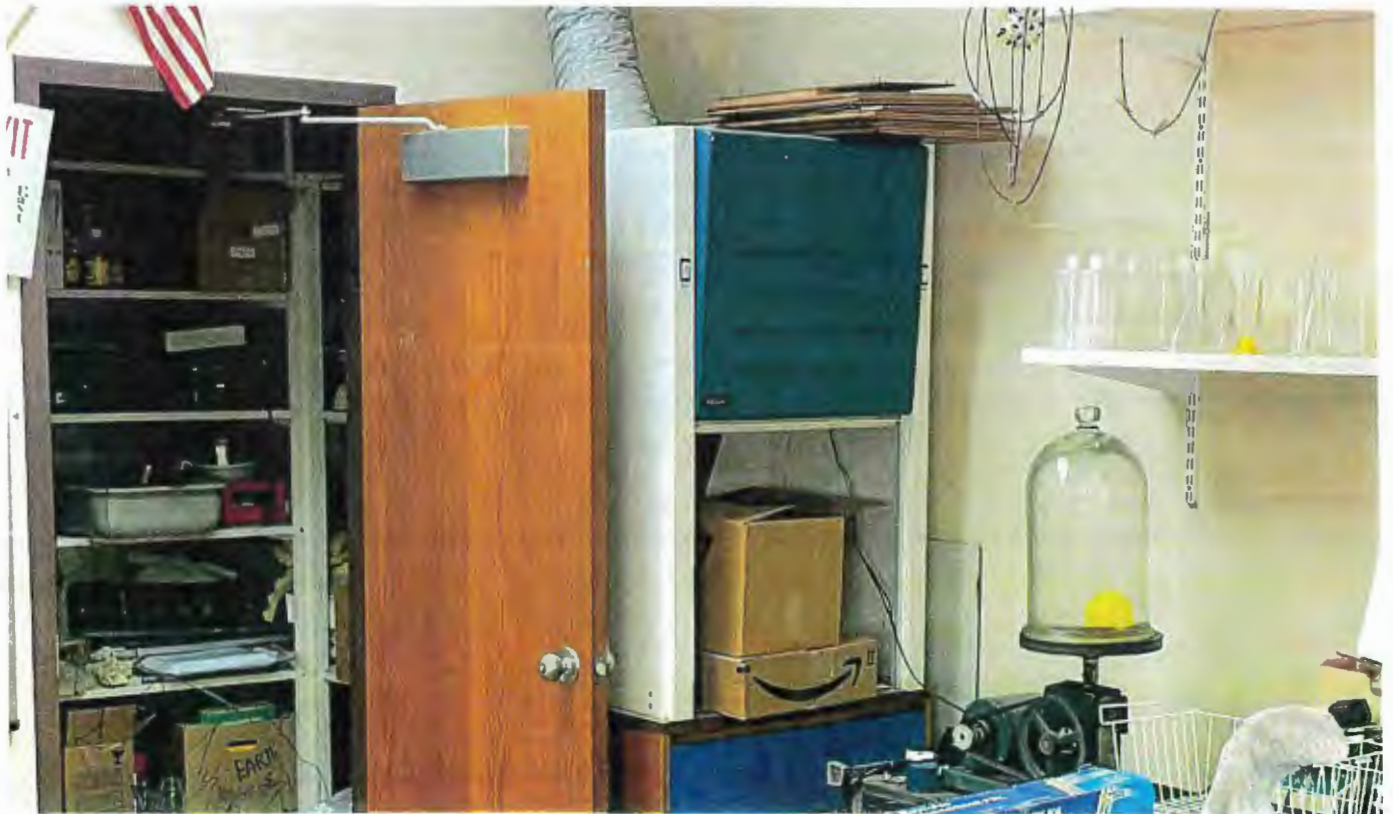
In the science room, the fume hood is inaccessible and there is no emergency eye wash station/safety station.

Make fume hood accessible and add an eye wash station and safety station where required.

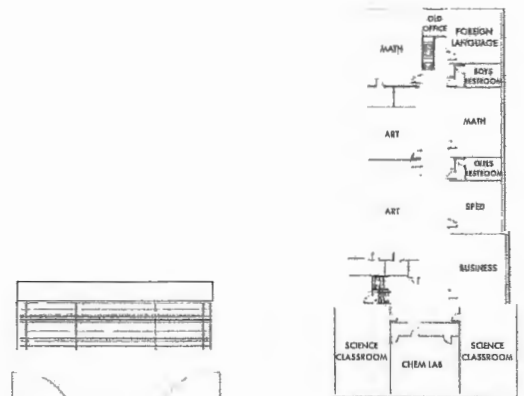
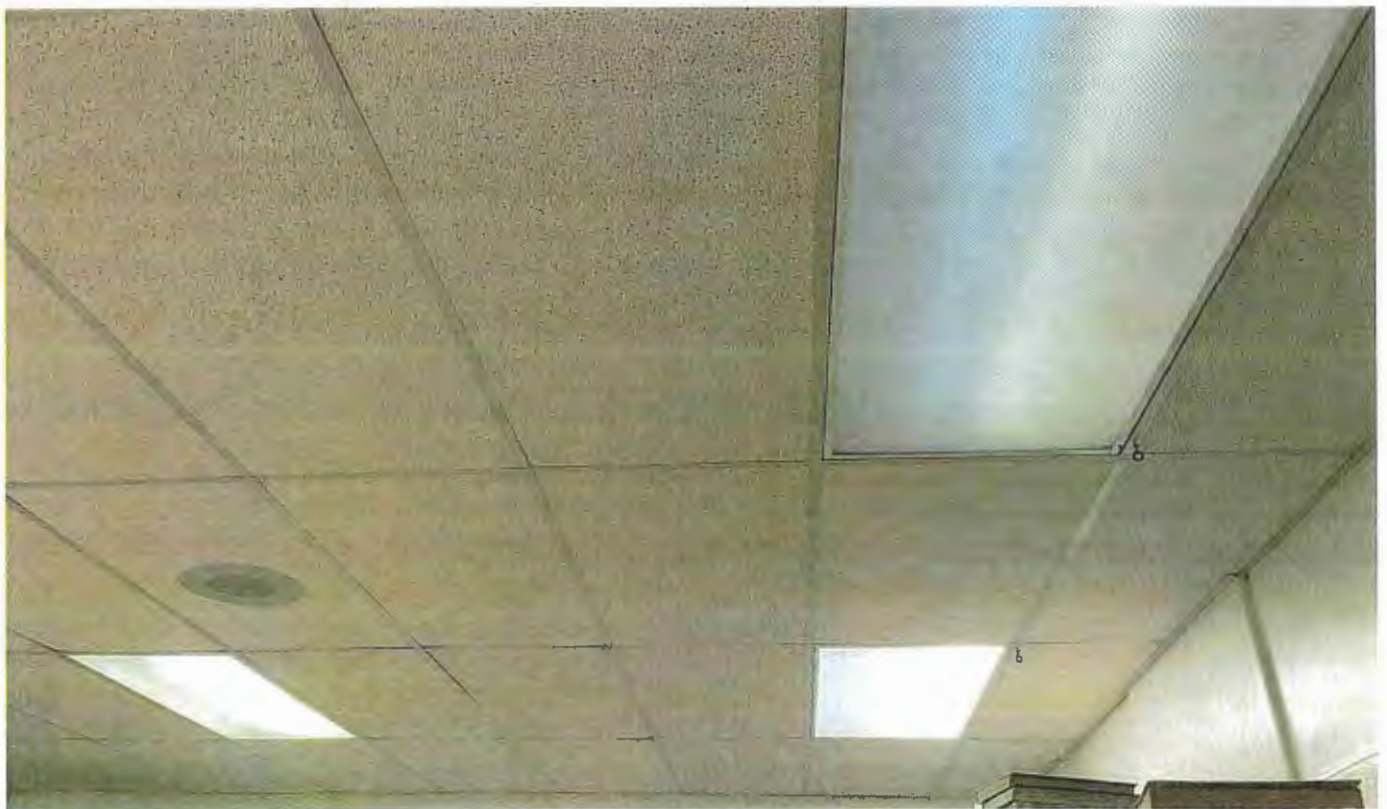
The second floor has outdated/failing florescent lighting technology.

Replace all non LED lighting throughout the campus with LED lighting.

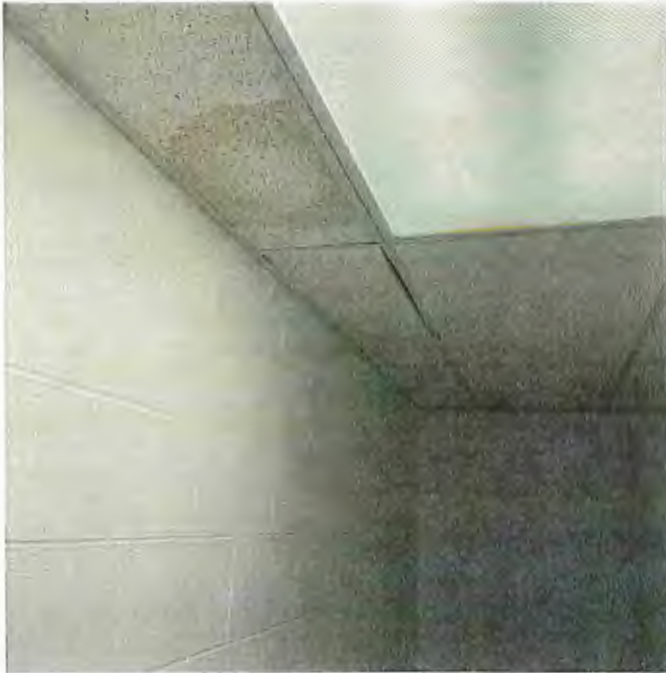
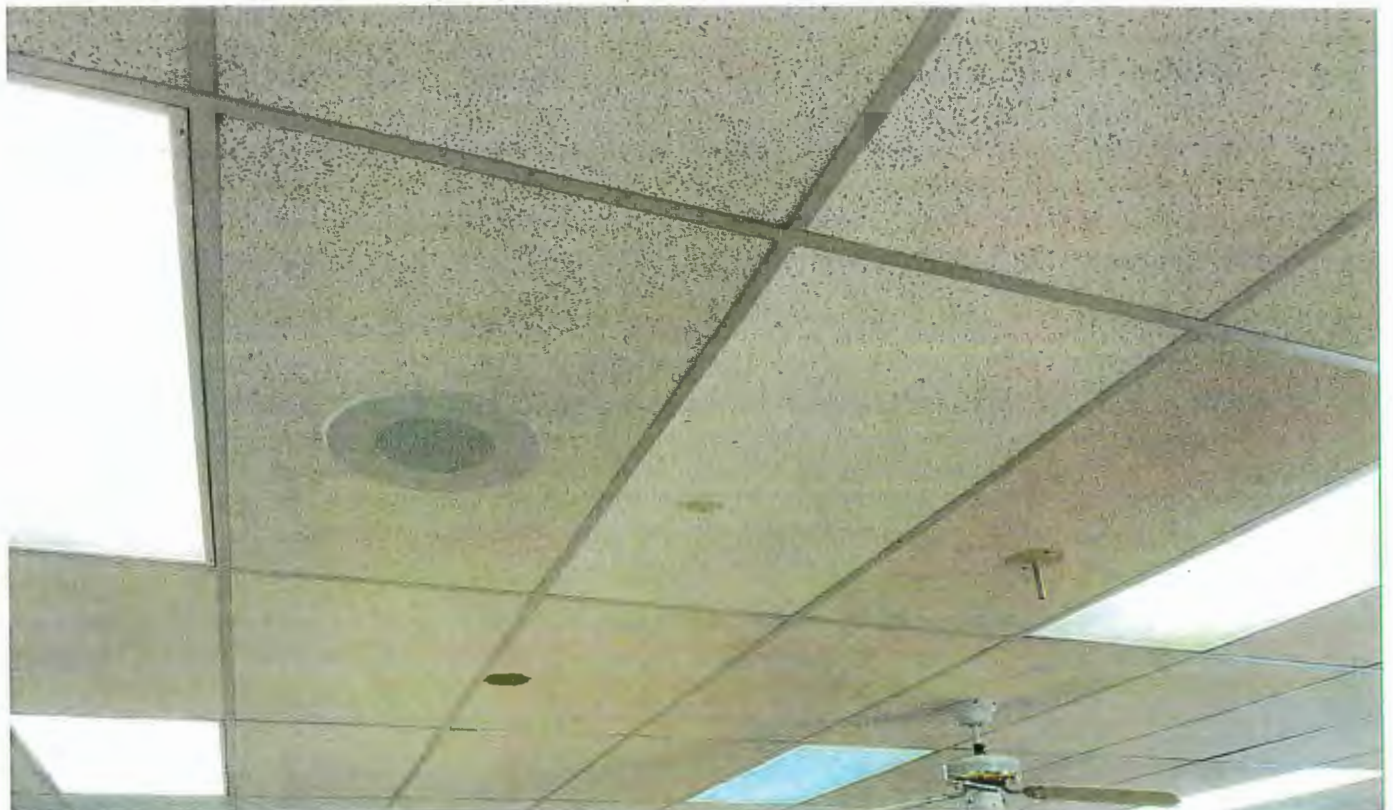
The second floor ceiling has water damage.

Replace ceiling tiles. If there are no roof leaks and/or mechanical issues.

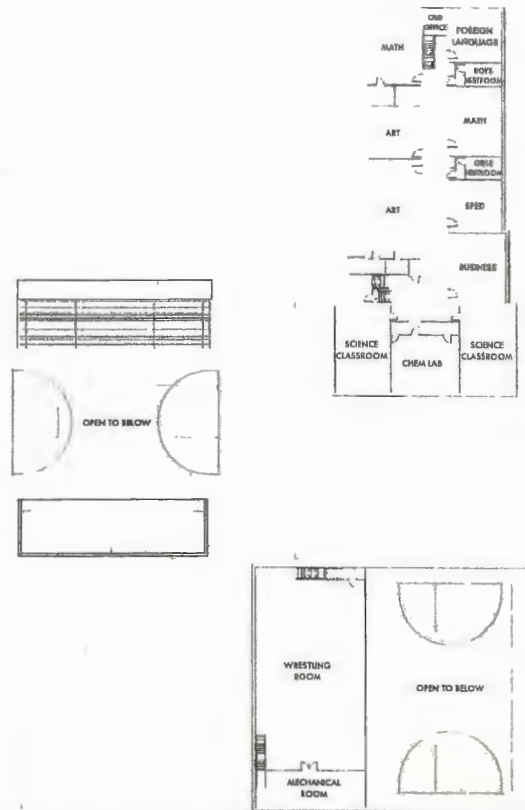
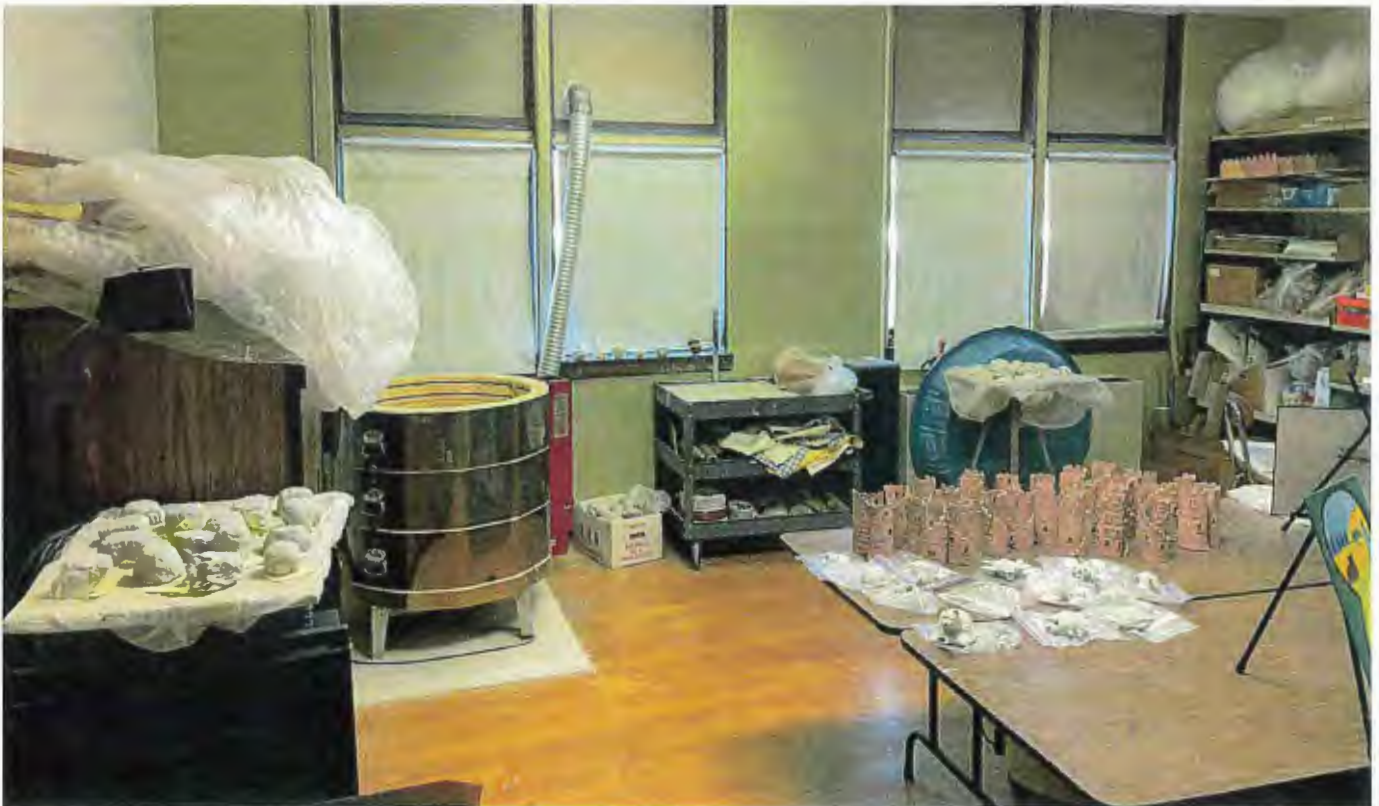
In the art room, the kiln is out in the open.

Also the lighting is poor.

Create a fire, rated kiln room.

Install new LED lighting in room.

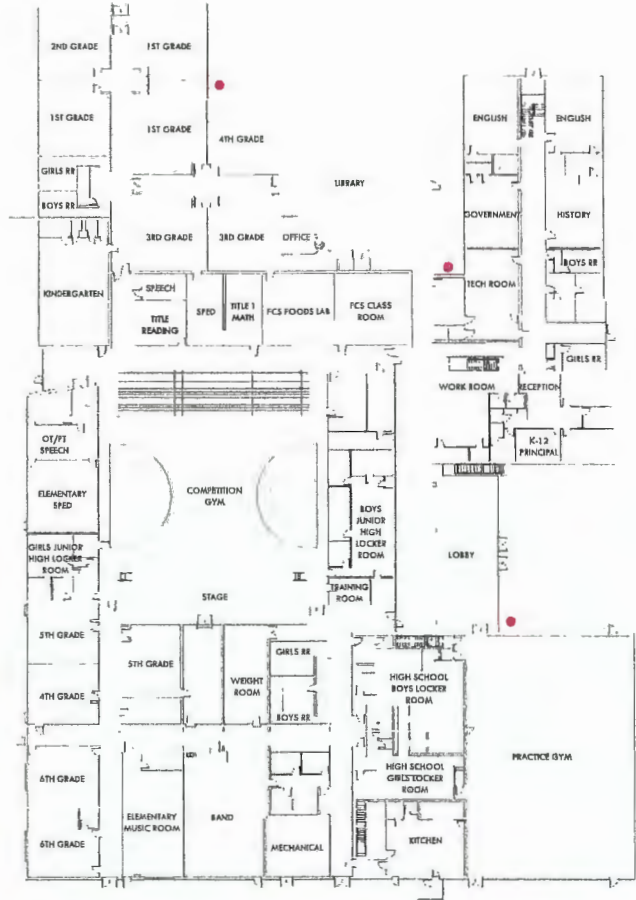
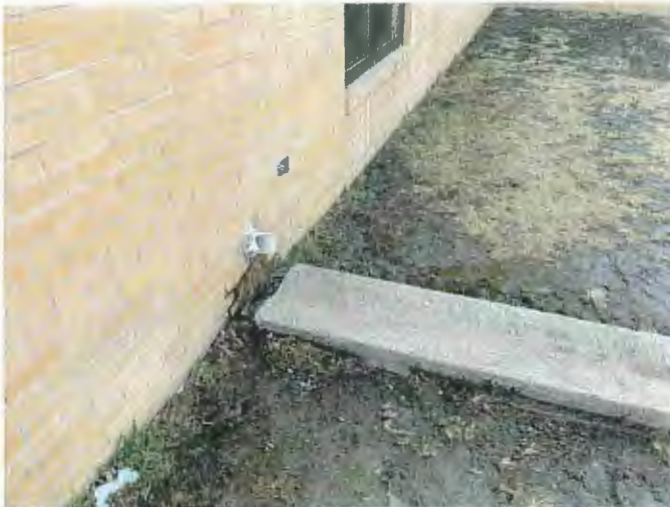
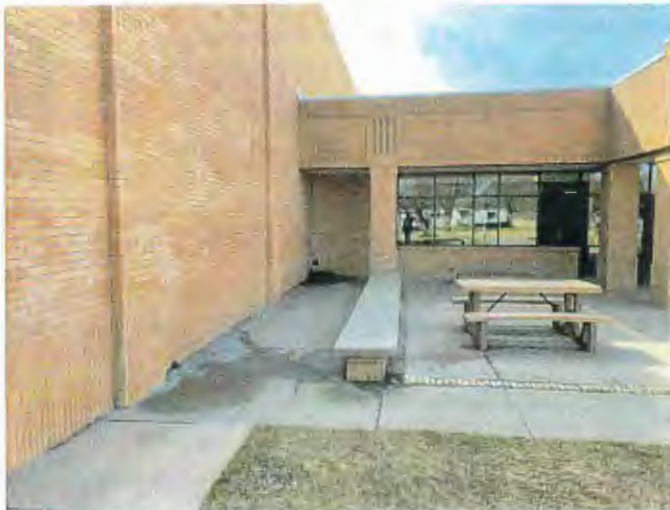
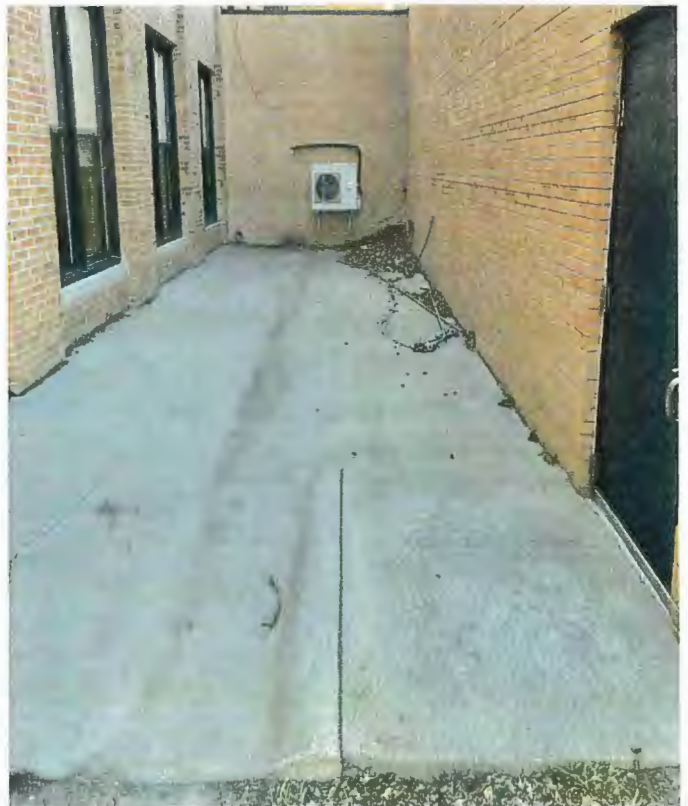
The area between the high school and the library does not drain effectively.

Look into installing storm sewer/drain tile around building and connect downspouts to the drain tile to convey storm water away from the building and to prevent ice buildup.

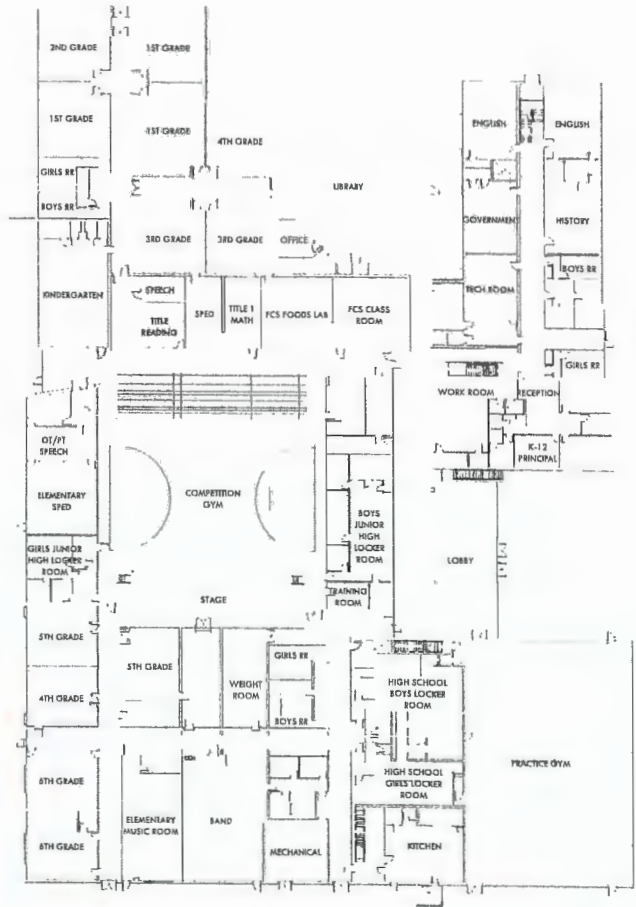
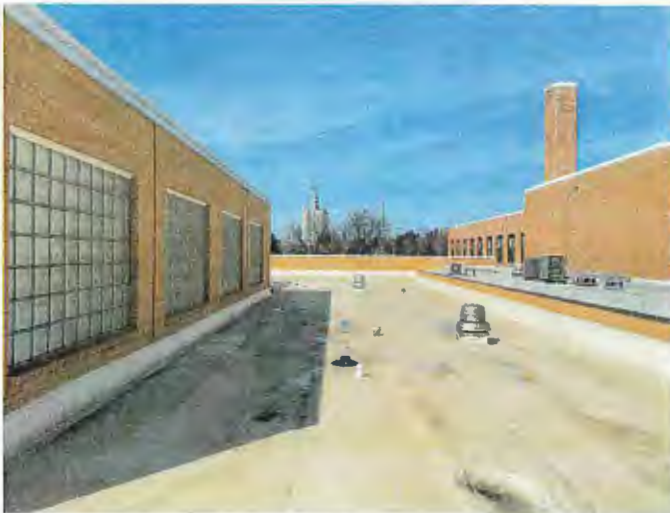
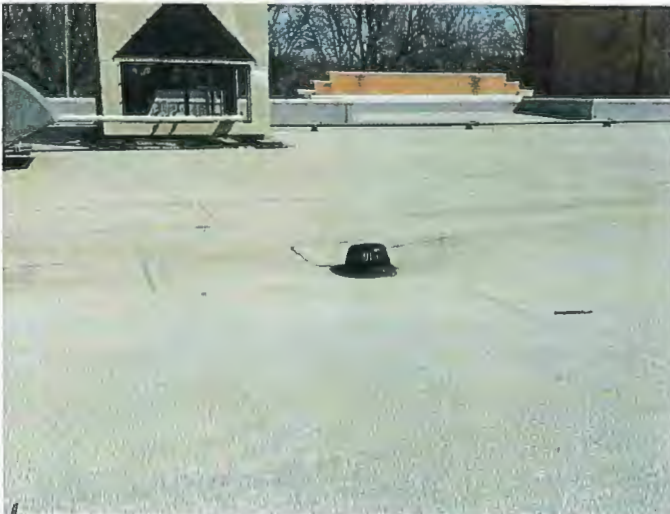
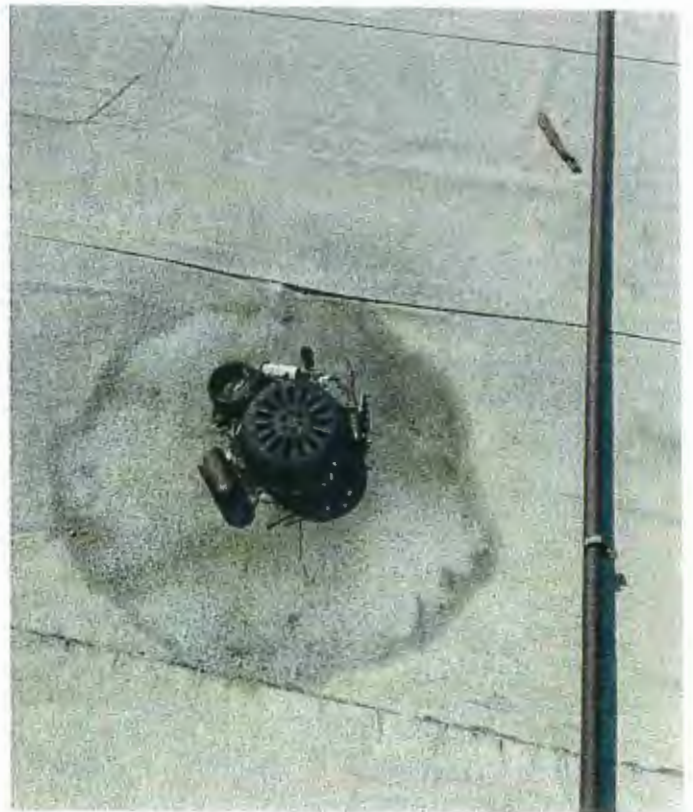
A number of primary roof drains are plugged with debris.

Remove debris from drains.
