### **Alma Public Schools**

# Alma Public Schools Facilities Assessment

April 11, 2022

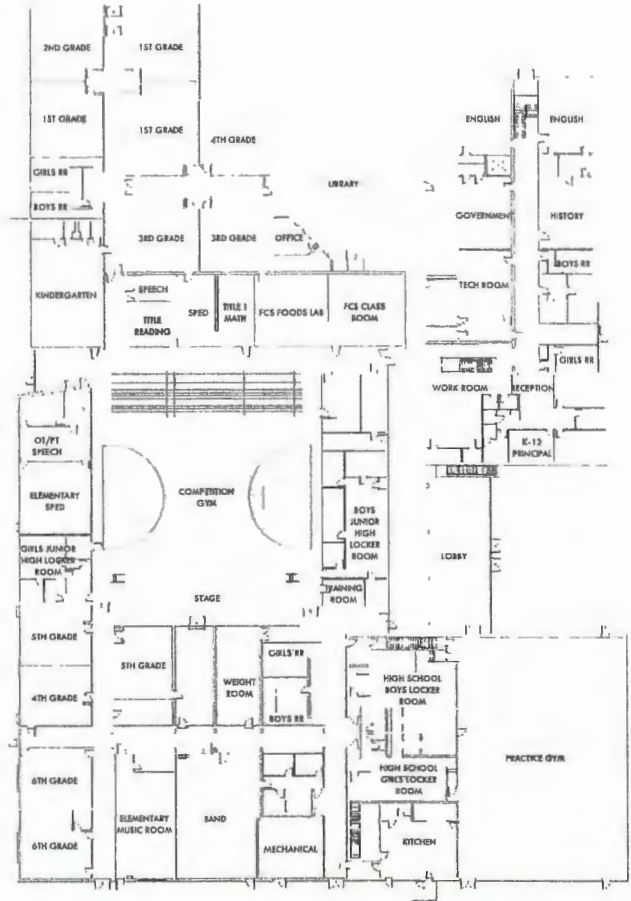
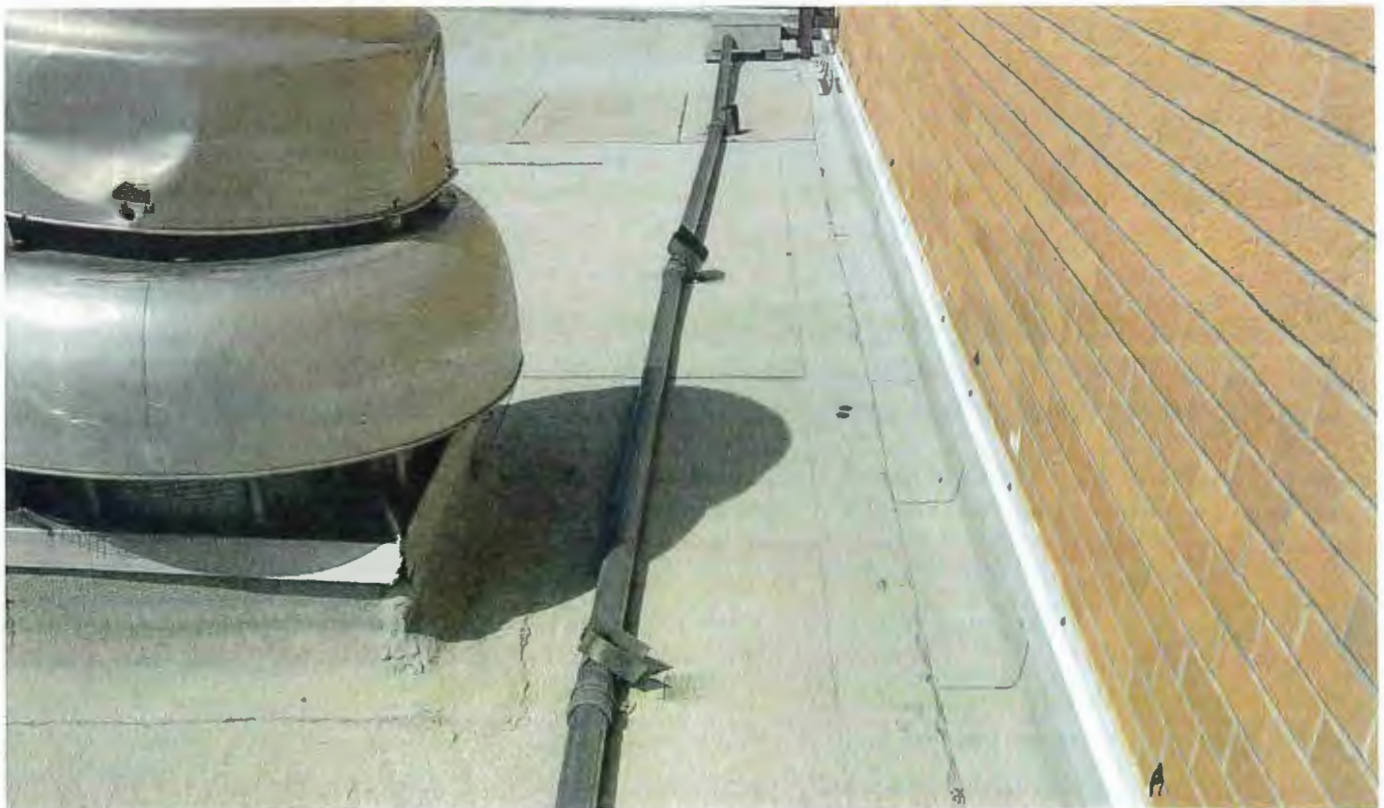
Gas piping on roof is not properly supported.

This does not look like gas pipe  
It is Electrical conduit

Repair supports for gas piping.

Definitely needs to be checked to be sure conduit  
is still sealed and water will not enter  
we will take look at it when we do the Mechanical  
Electrical Upgrades the District just contracted with  
Rasmussen Mechanical  
Ron Paul

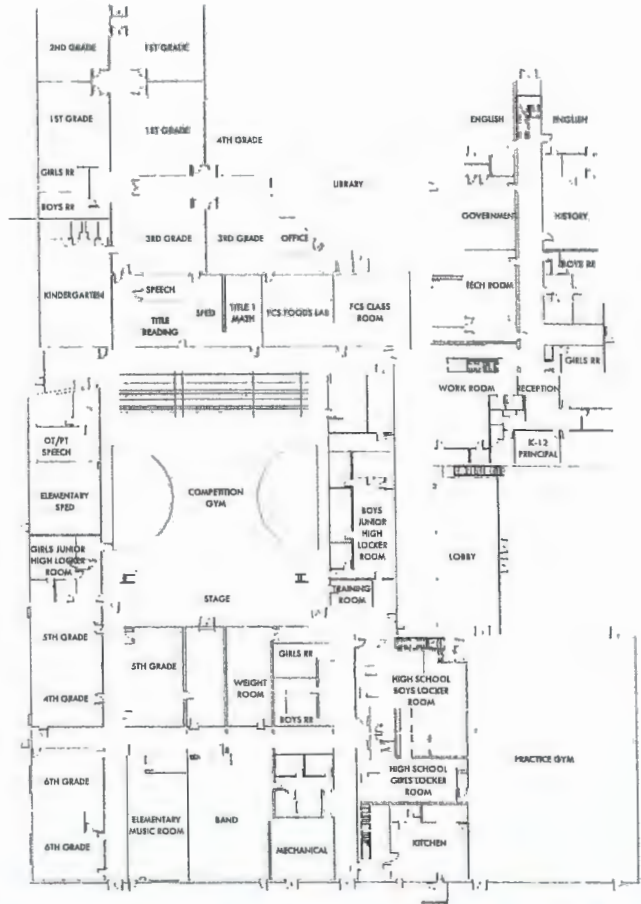
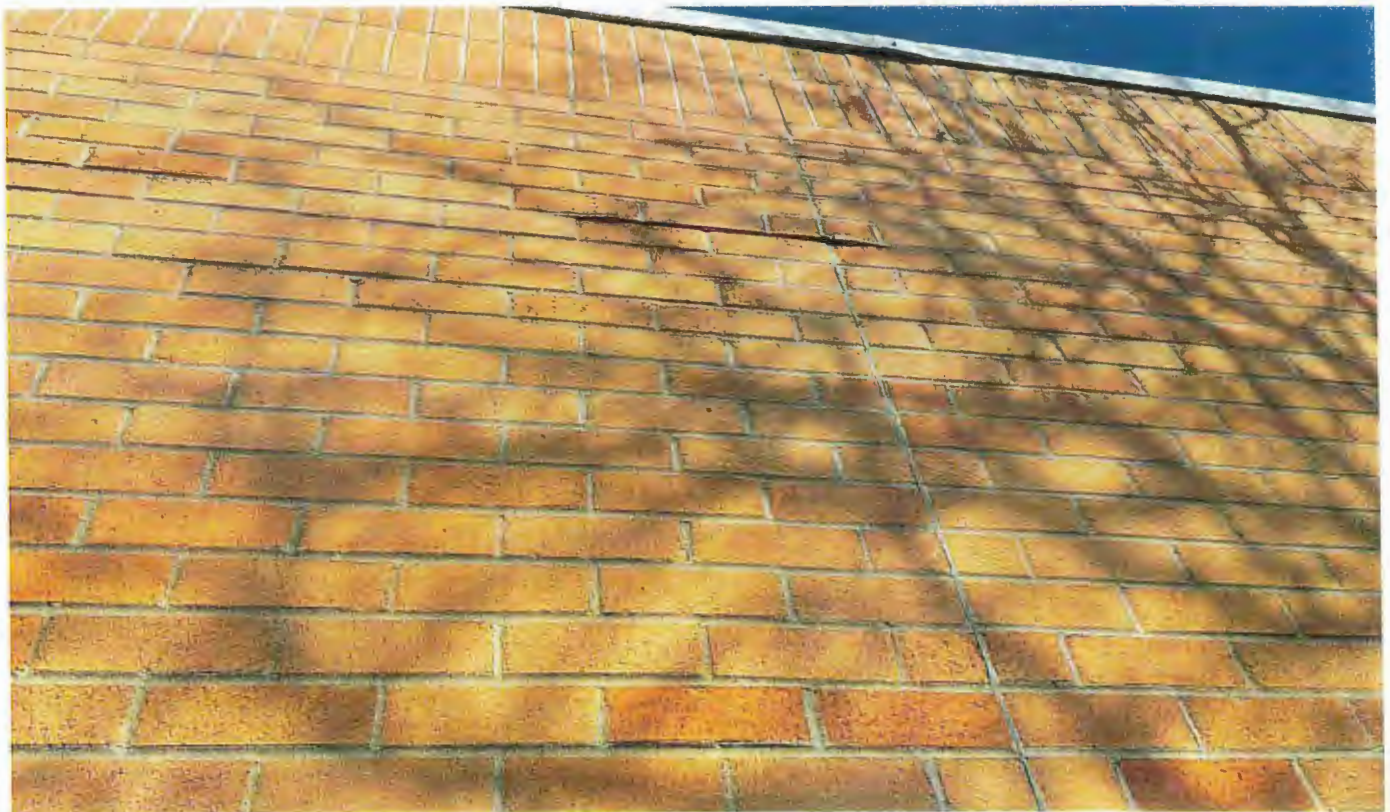
At control joint there is missing sealant.

At control joint, replace/install sealant.

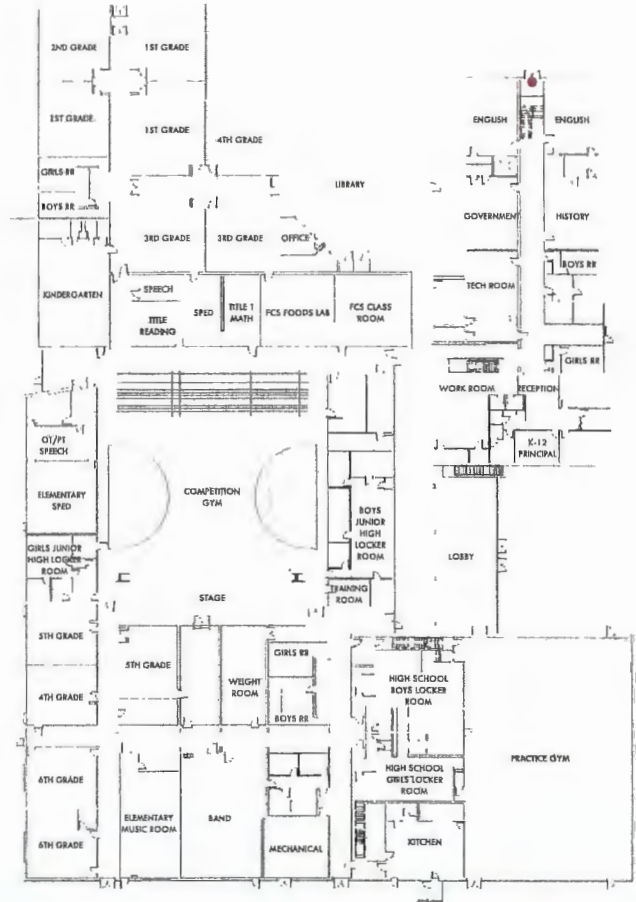
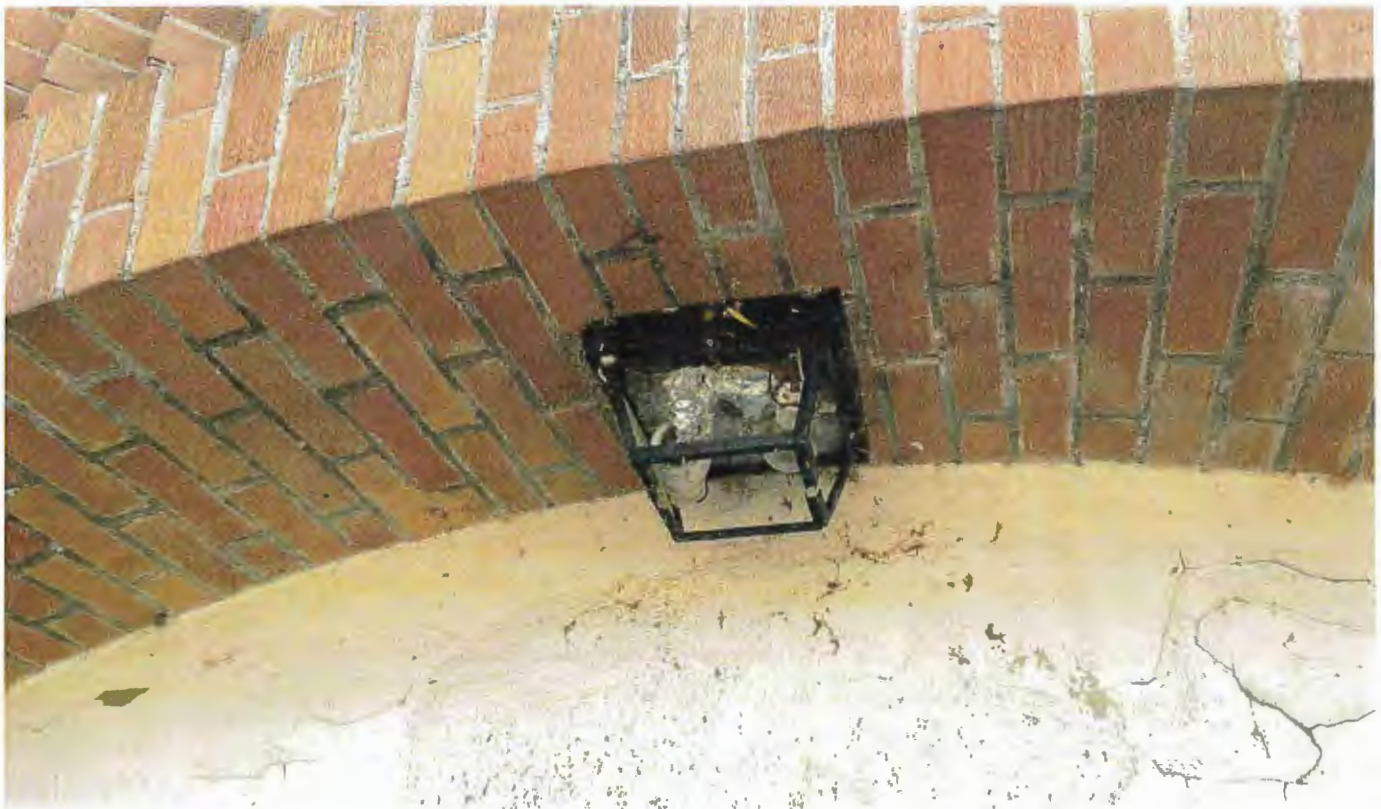
Light fixture damaged/not functioning.

Replace light fixture with new LED light fixture.
