Board of Education Study Session

School District of Seward

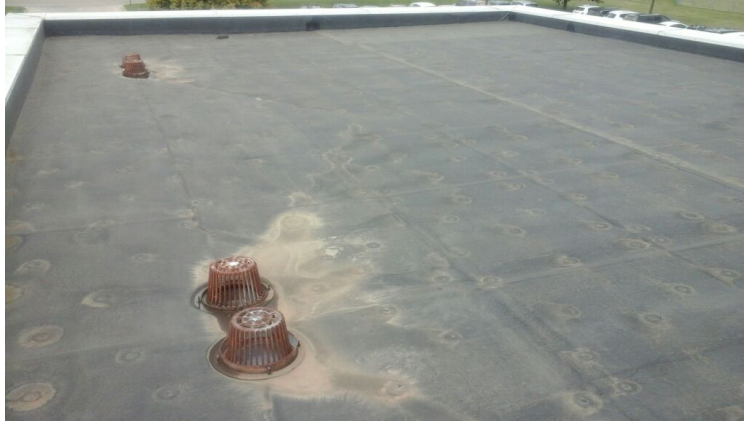
Photo showing overview of Area 01 Roof.

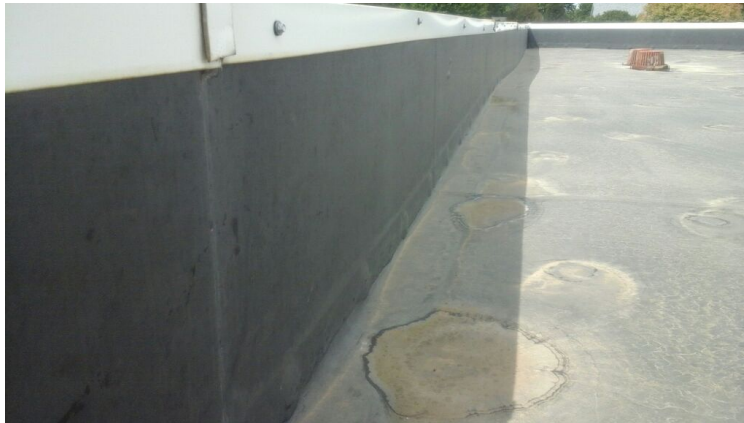
Photo showing condition of the perimeter flashings.

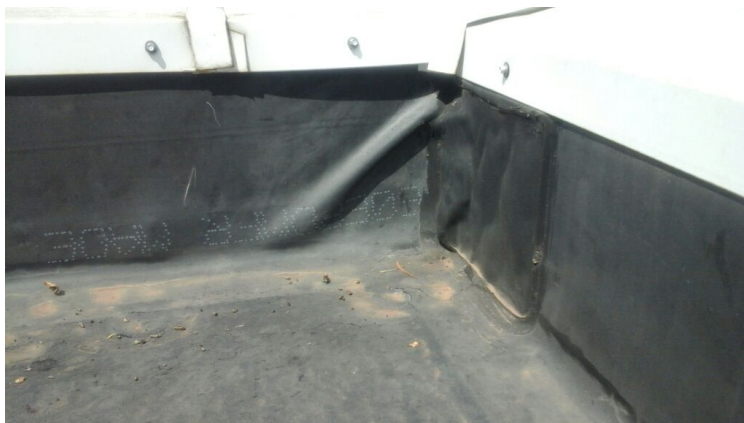
Photo showing condition of the perimeter flashings in the corner.

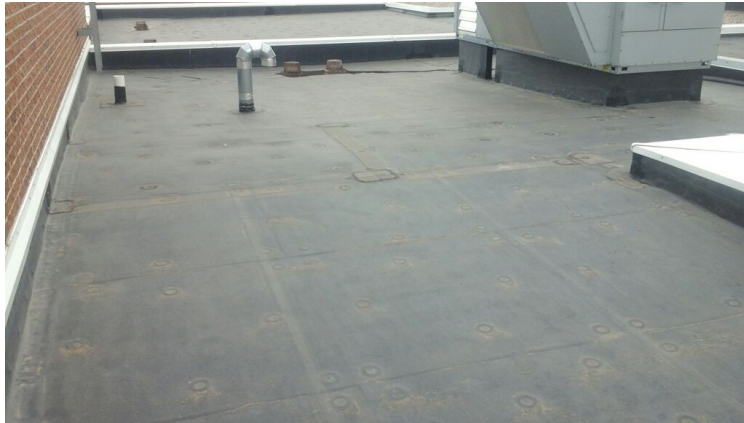
Photo showing overview of Area 02 Roof.

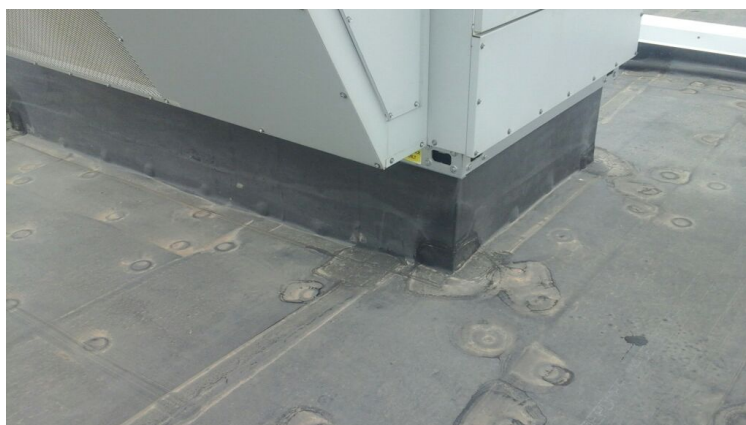
Photo showing condition of projection flashings.

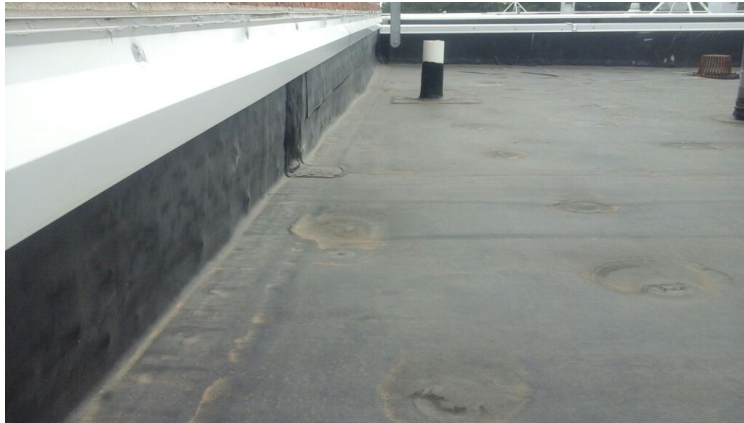
Photo showing condition of the perimeter flashings.

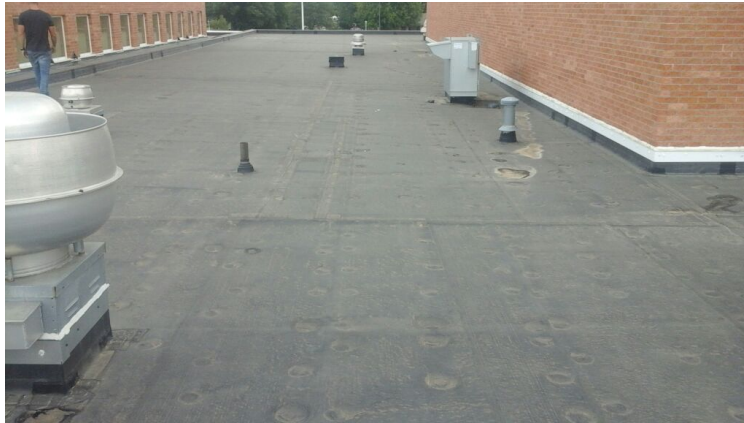
Photo showing overview of Area 03 Roof.

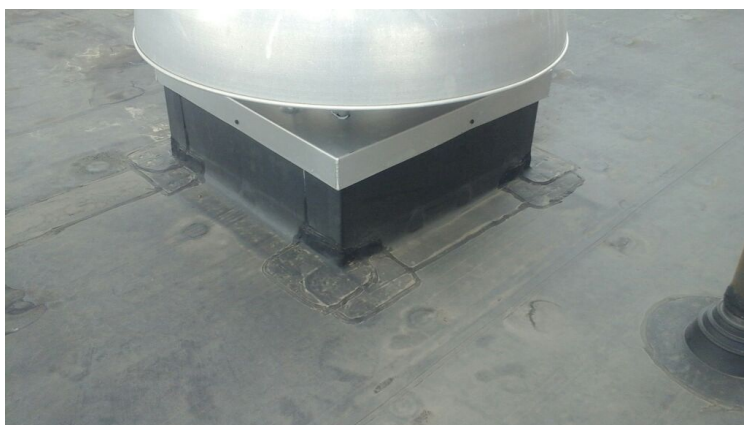
Photo showing condition of projection flashings.

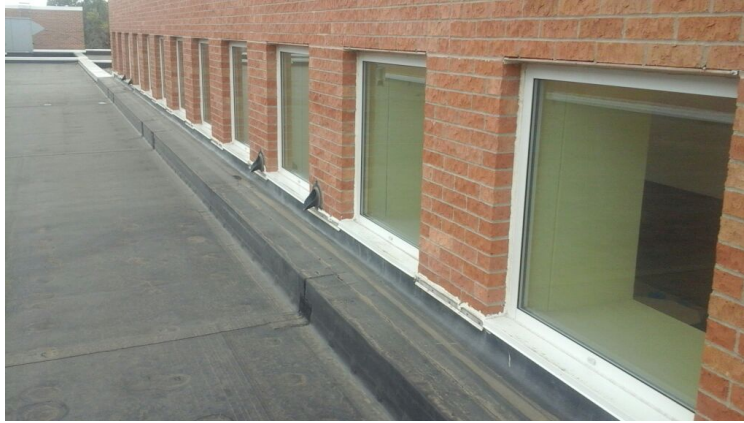
Photo showing condition of the perimeter flashings along window wall.

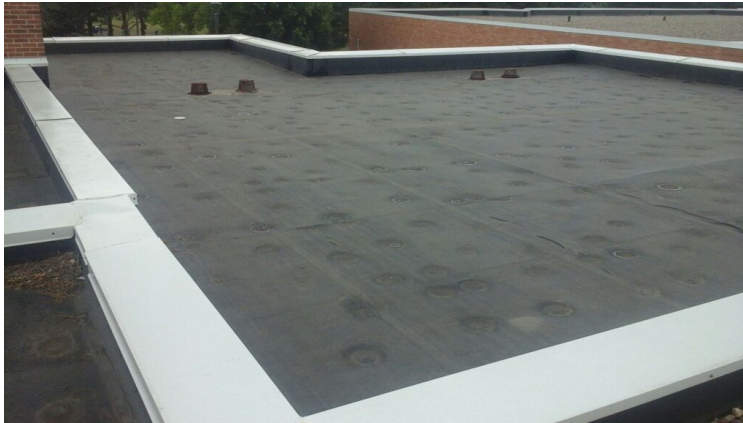
Photo showing overview of Area 04 Roof.

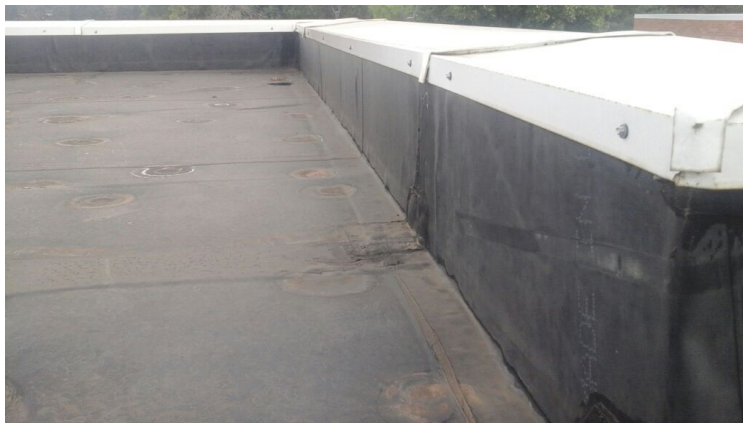
Photo showing condition of the perimeter flashings.

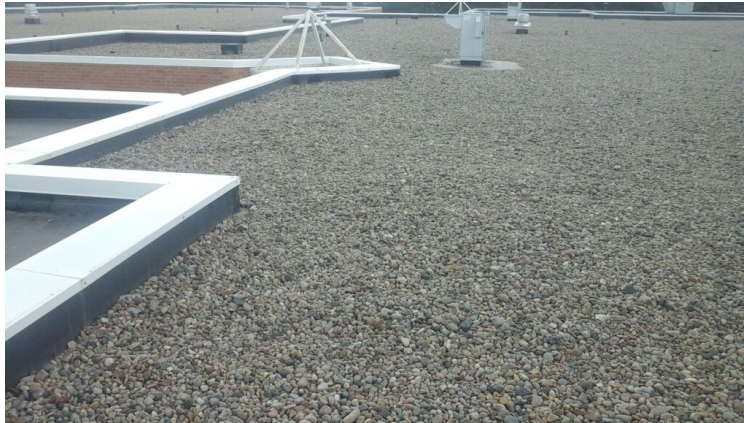
Photo showing overview of Area 05 Roof.

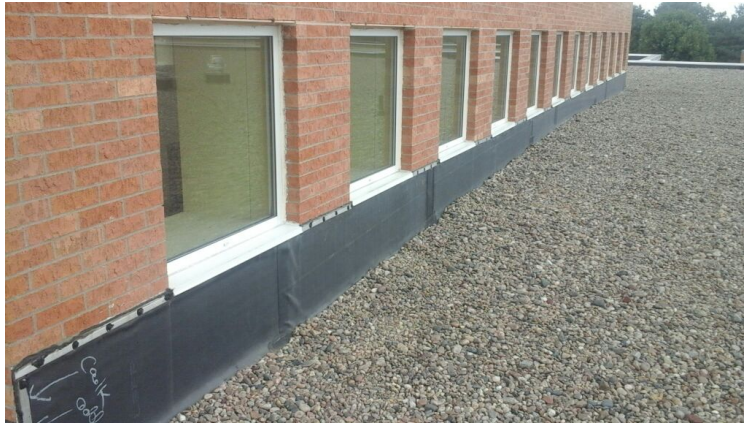
Photo showing condition of the perimeter flashings along the window wall.

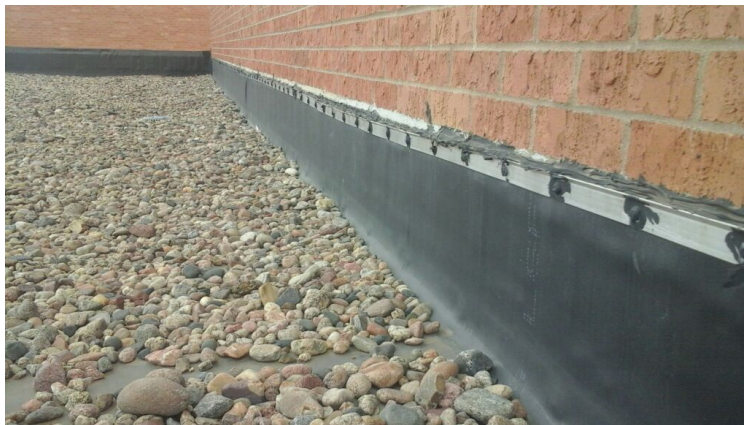
Photo showing condition of the perimeter flashings along the brick wall.

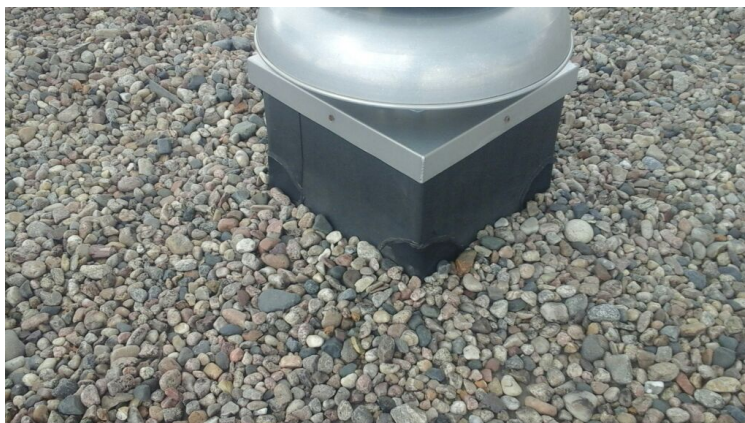
Photo showing condition of projection flashings.

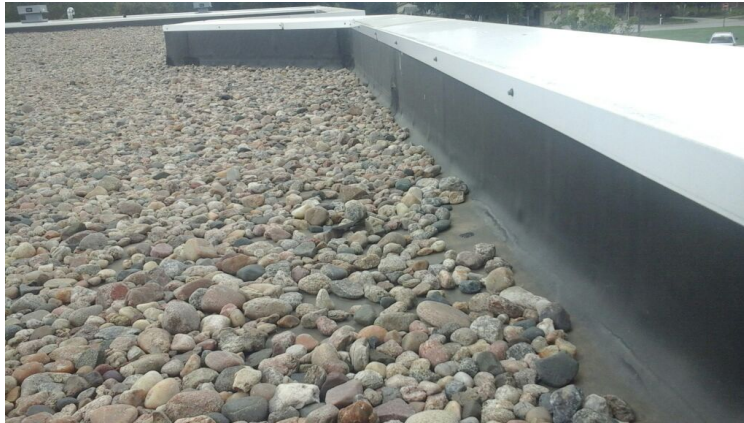
Photo showing condition of the perimeter flashings.

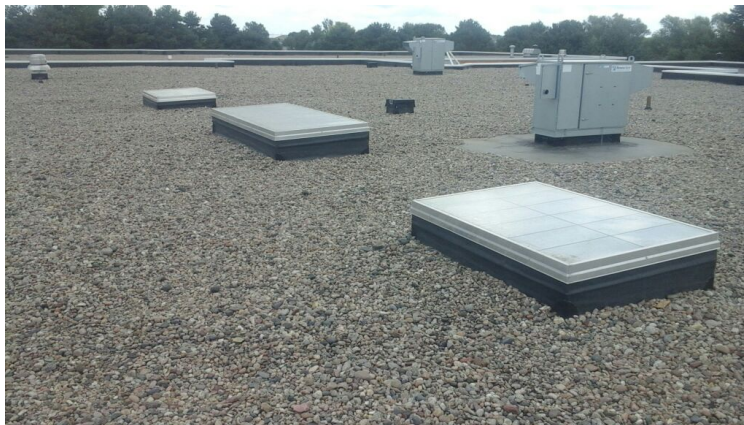
Photo showing condition of the skylights.

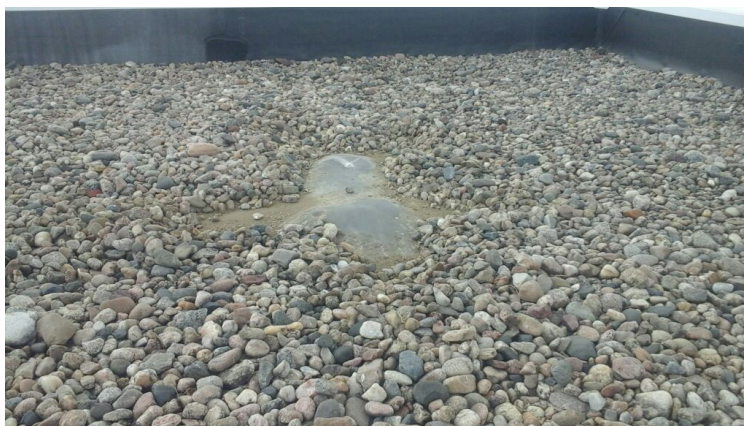
Photo showing additional area where isolation is extruding against the field membrane.

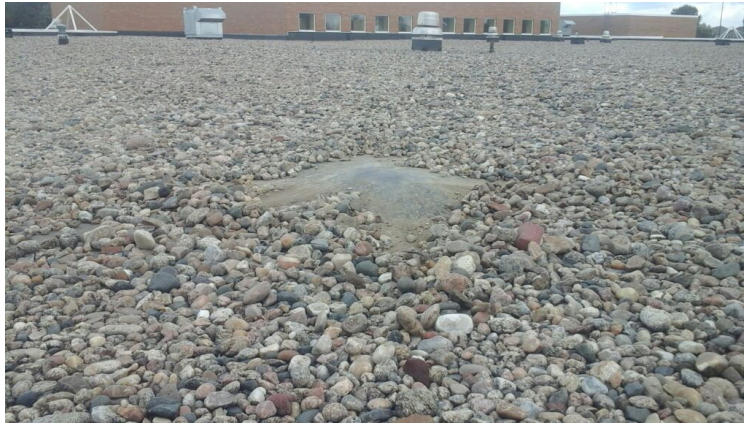
Photo showing area where insulation is pushing up on membrane.

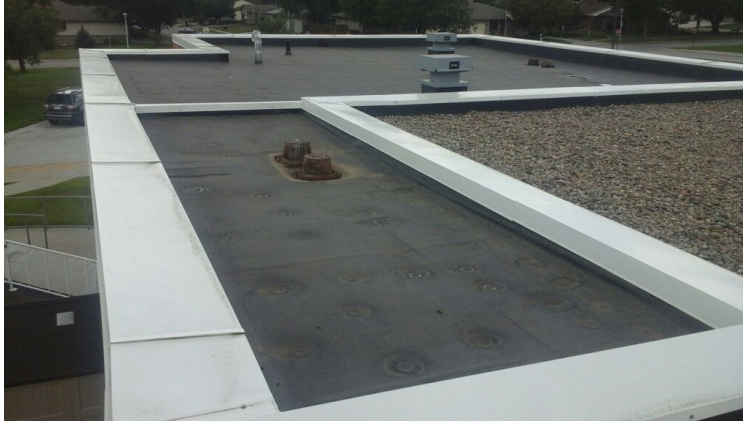
Photo showing overview of Area 06 Roof.

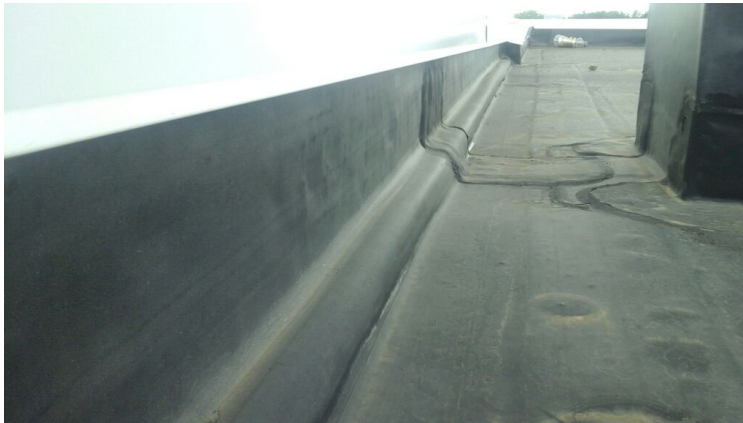
Photo showing condition of the perimeter flashings.

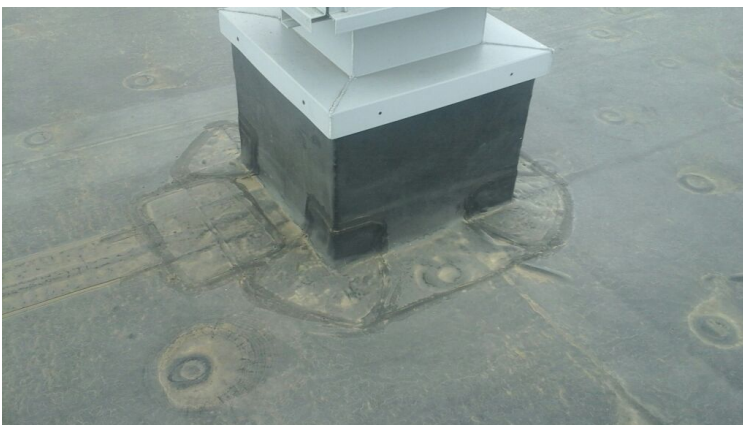
Photo showing condition of projection flashings.

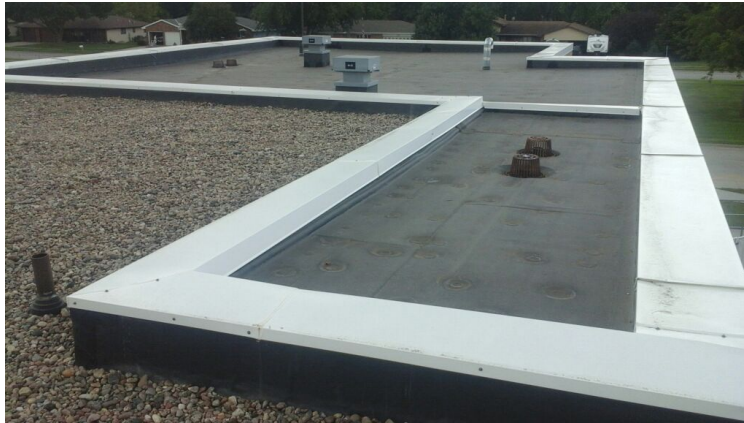
Photo showing overview of Area 07 Roof.

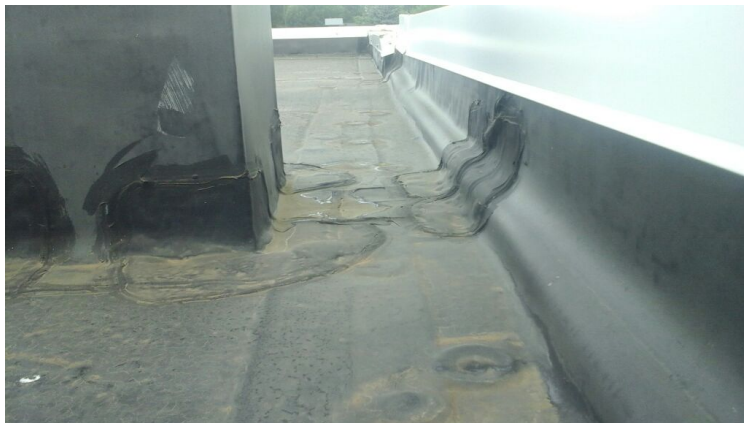
Photo showing condition of the perimeter flashings.

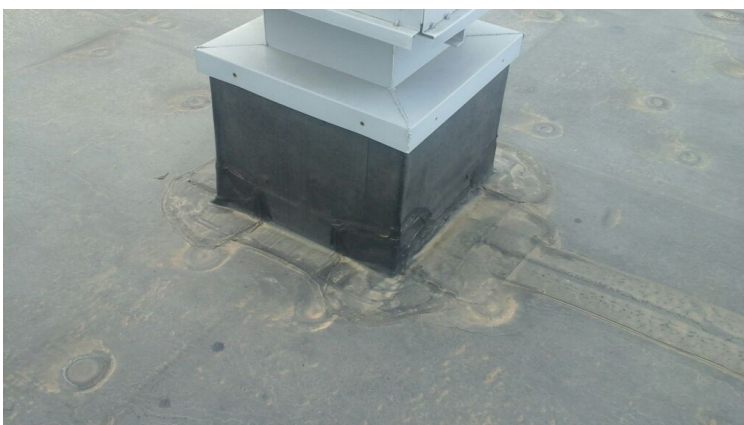
Photo showing condition of projection flashings.

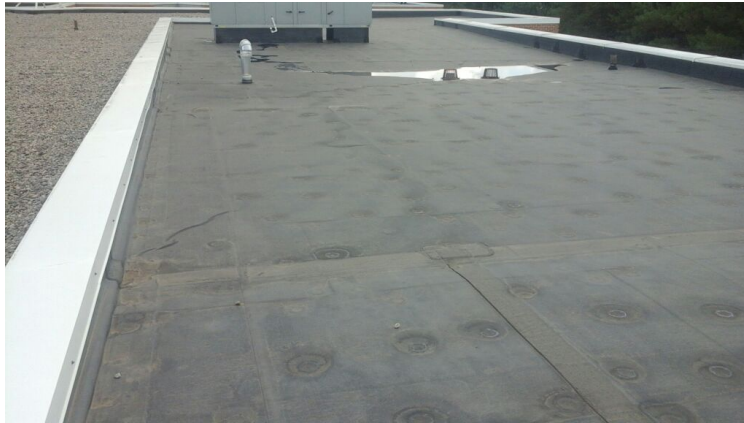
Photo showing overview of Area 08 Roof.

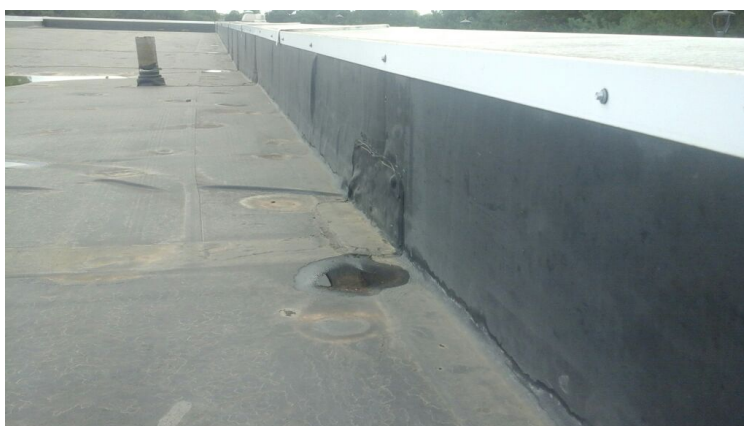
Photo showing condition of the perimeter flashings.

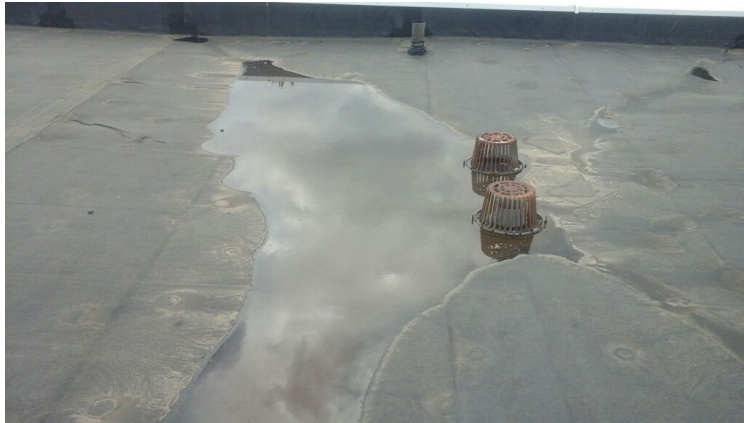
Photo showing ponding water due to lack of sump.

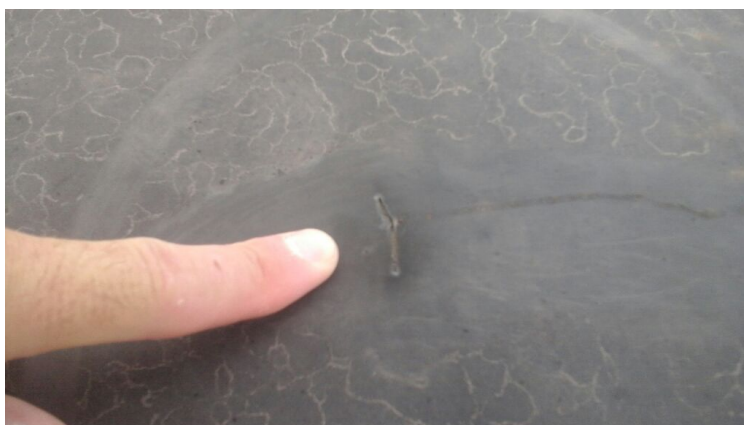
Photo showing a hole in the field membrane.

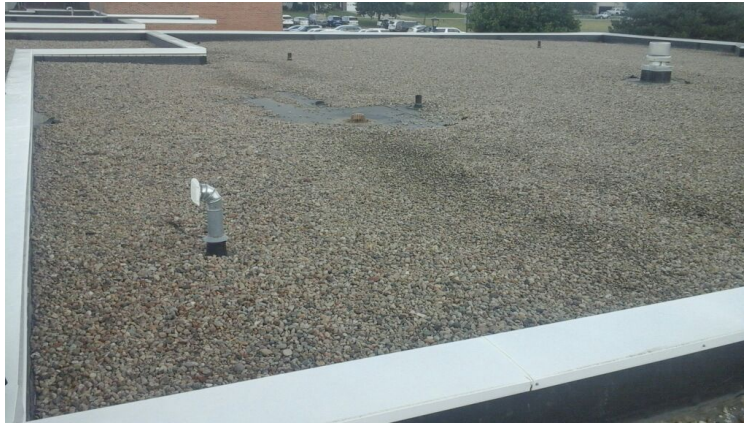
Photo showing overview of Area 09 Roof.

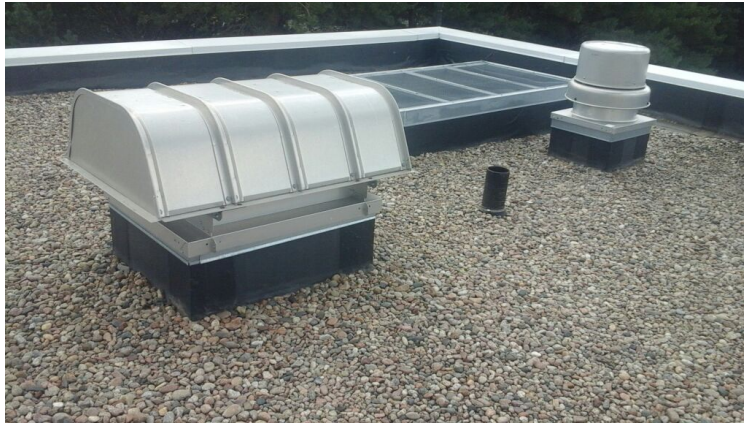
Photo showing condition of projection flashings.

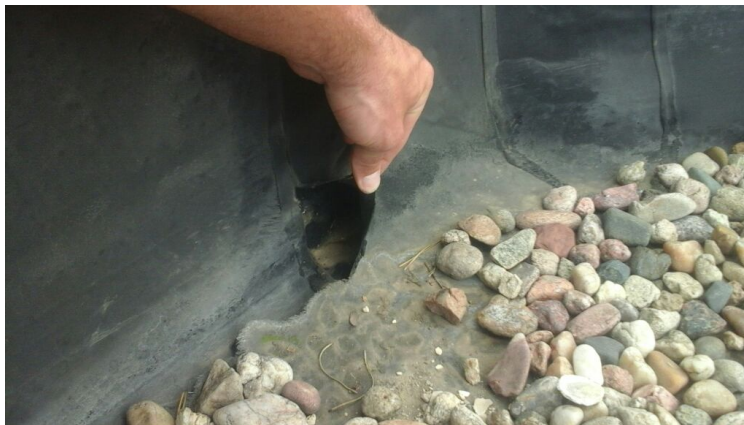
Photo showing patch pulling loose on perimeter flashings.

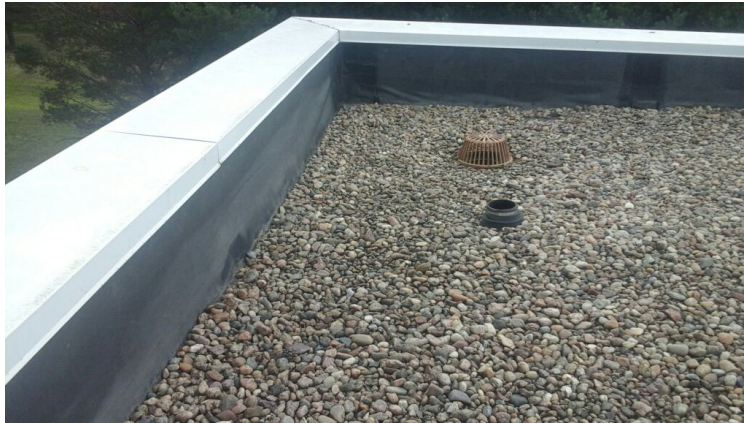
Photo showing tenting occurring corners.

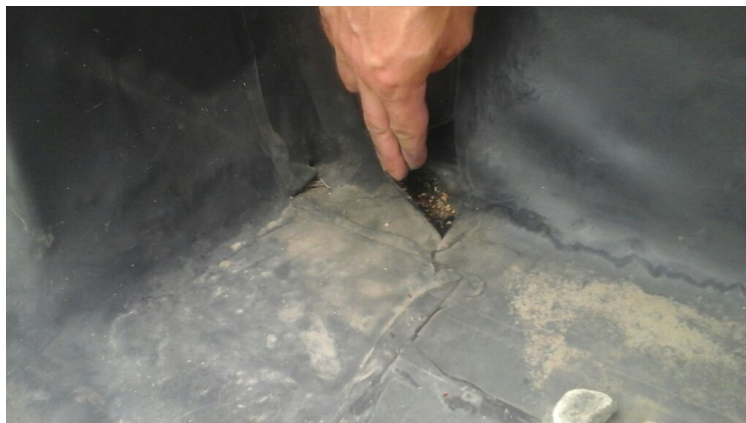
Photo showing a patch pulling loose along the perimeter flashings.

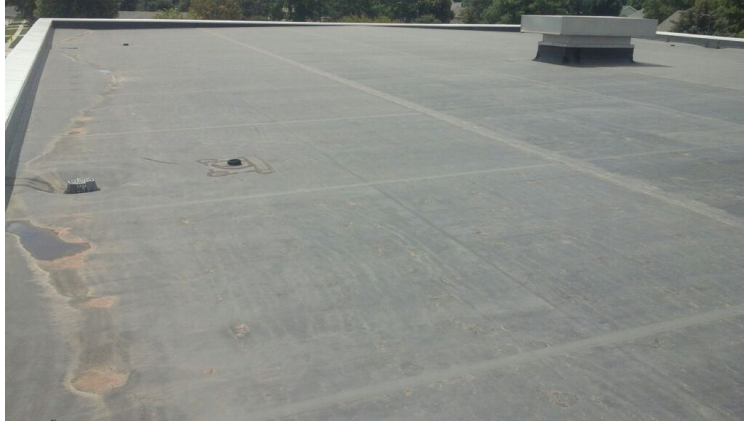
Photo showing overview of Area 10 Roof.

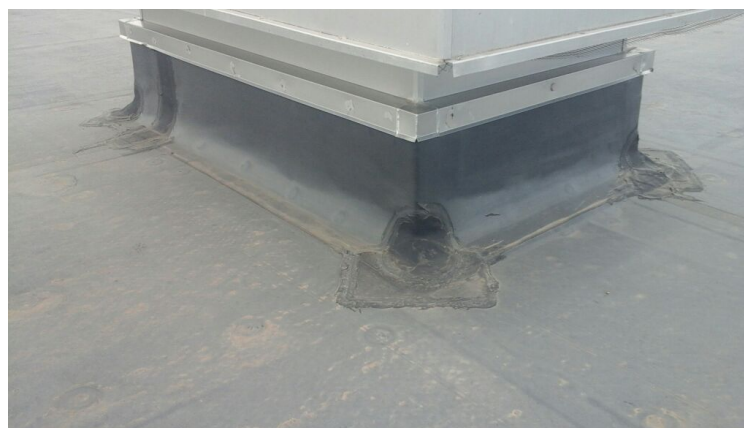
Photo showing condition of projection flashings.

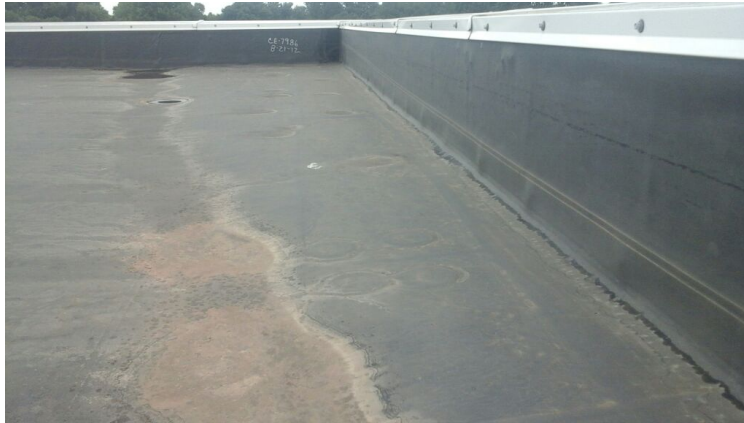
Photo showing condition of the perimeter flashings.

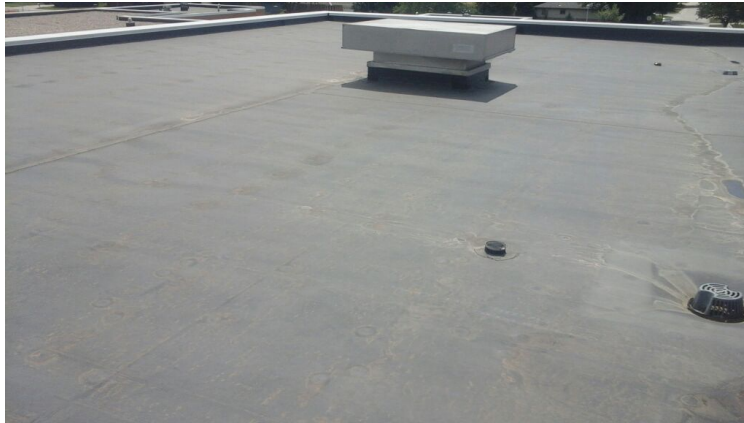
Photo showing overview of Area 11.

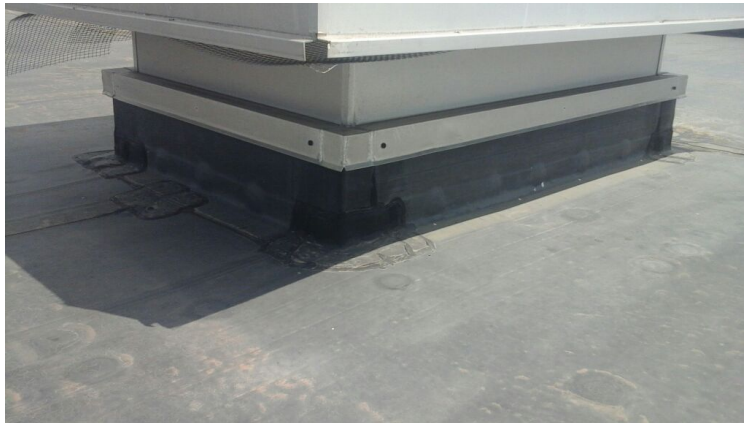
Photo showing condition of projection flashings.

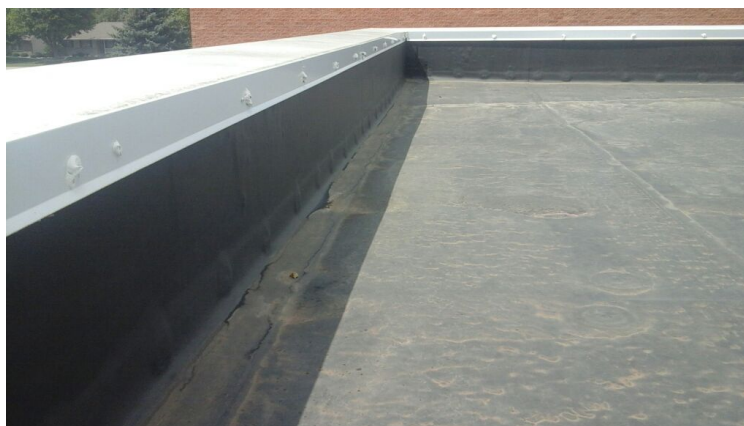
Photo showing condition of the perimeter flashings.

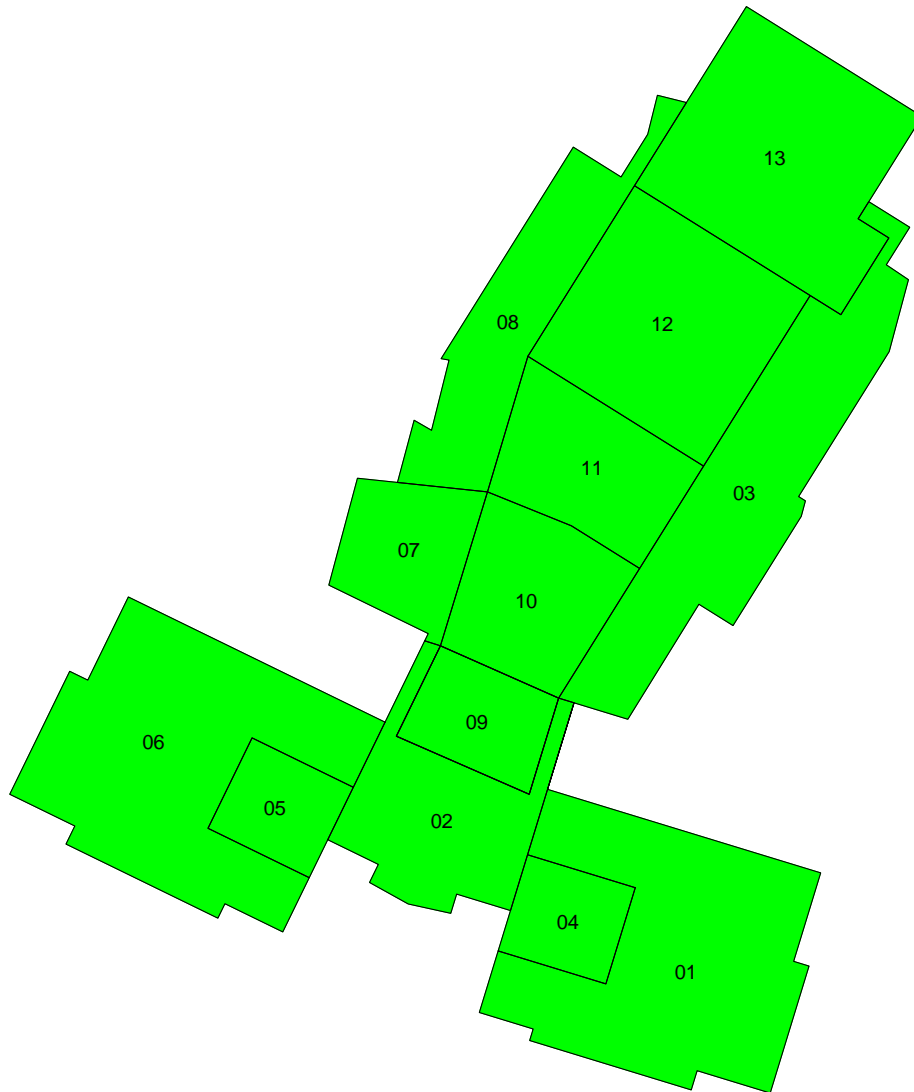
2401 Karol Kay Blvd.

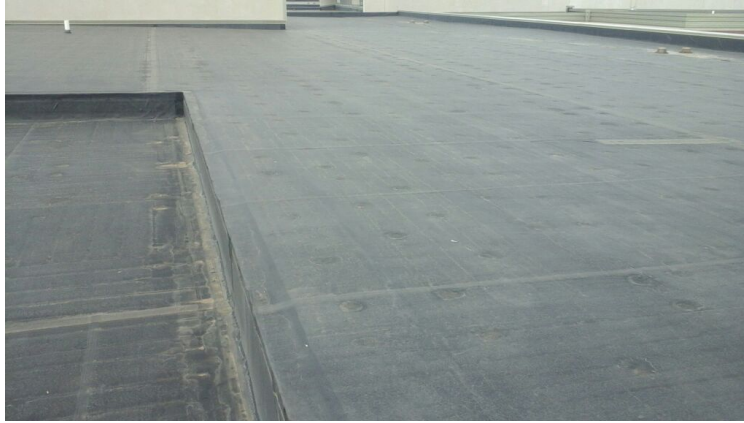
Photo showing overview of Area 01 Roof.

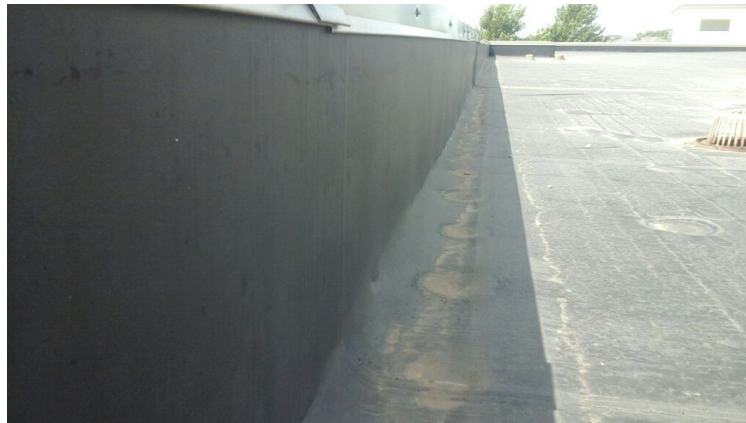
Photo showing condition of the perimeter flashings.

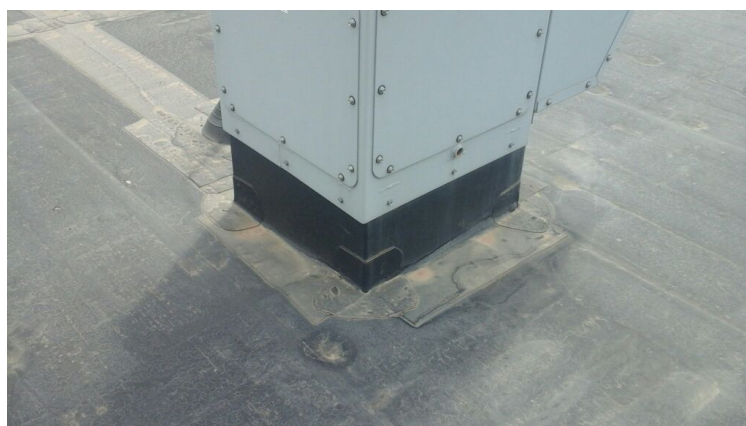
Photo showing condition of projection flashings.

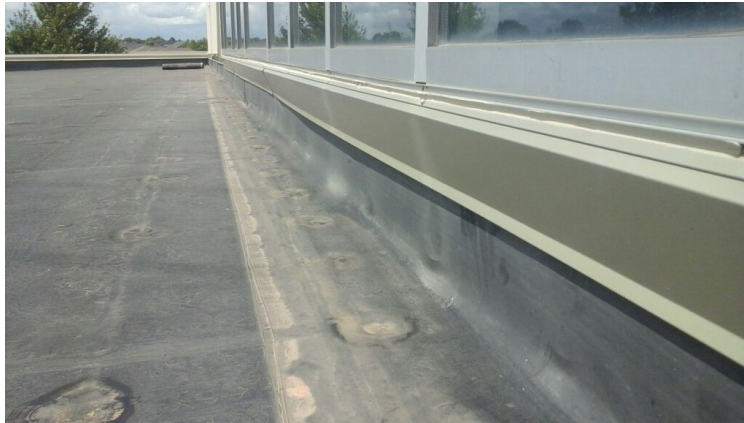
Photo showing condition of the counter flashing under the window wall.

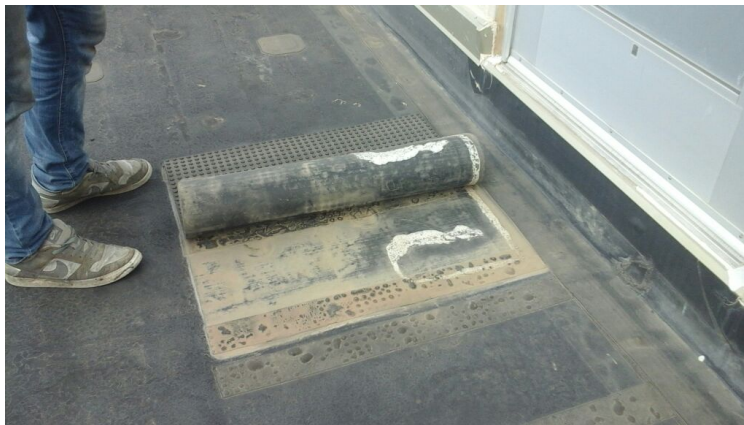
Photo showing walk pad pulling up at door.

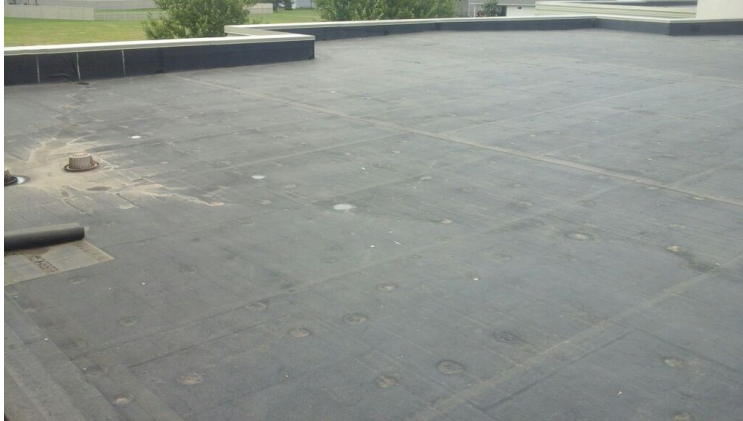
Photo showing overview of Area 02 Roof.

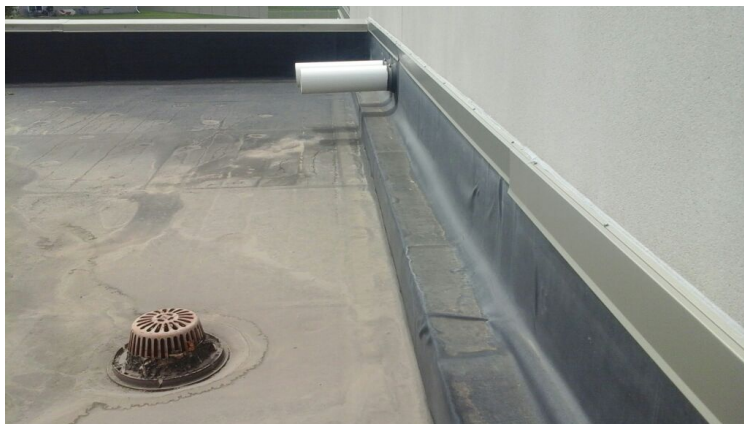
Photo showing condition of the perimeter flashings.

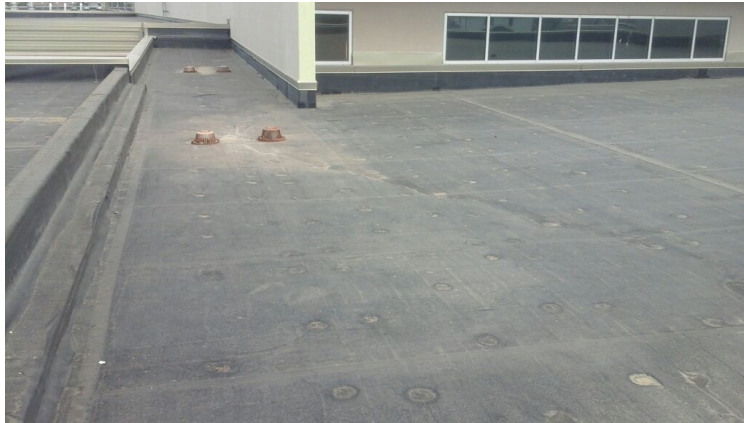
Photo showing additional overview of Area 02 Roof.

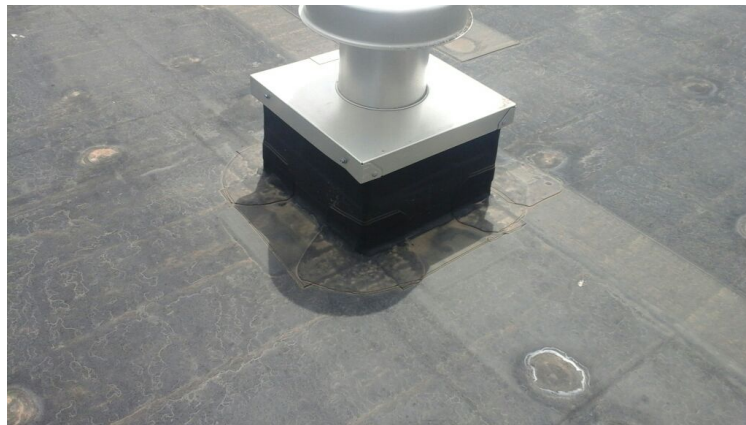
Photo showing condition of projection flashings.

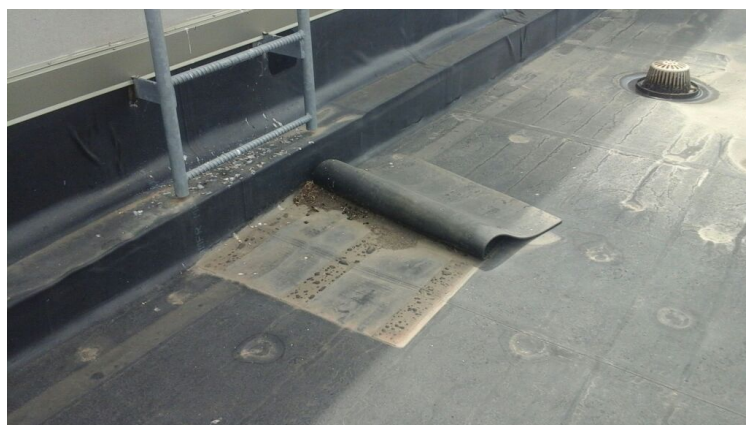
Photo showing walk pad under ladder pulling loose.

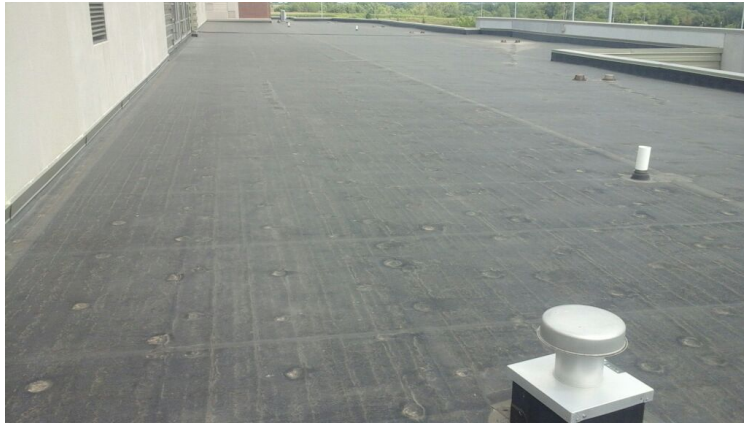
Photo showing overview of Area 03 Roof.

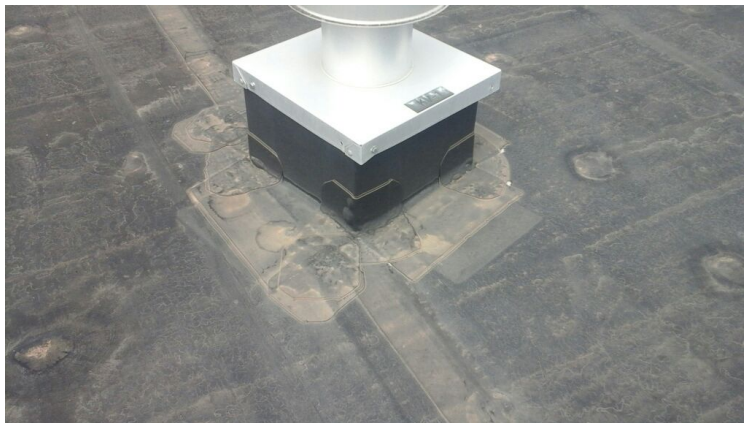
Photo showing condition of projection flashings.

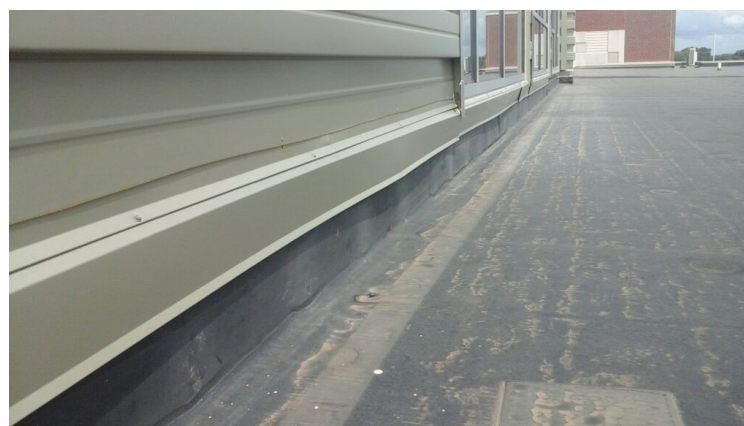
Photo showing condition of counter flashing under windows.

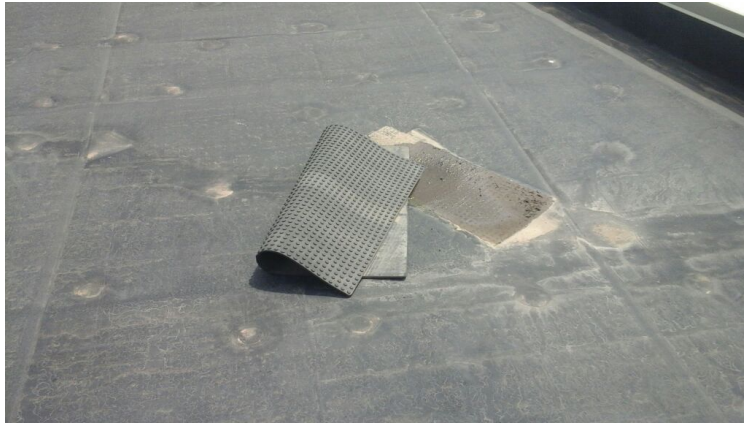
Photo showing loose walk pad.

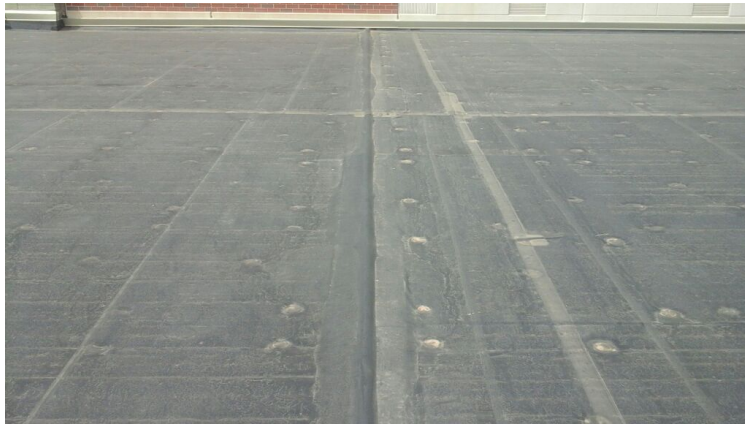
Photoshowing condition of the expansion joint.

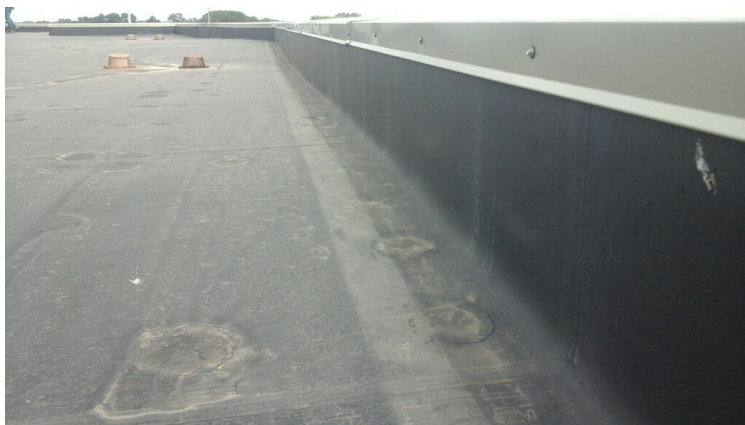
Photo showing condition of the perimeter flashings.

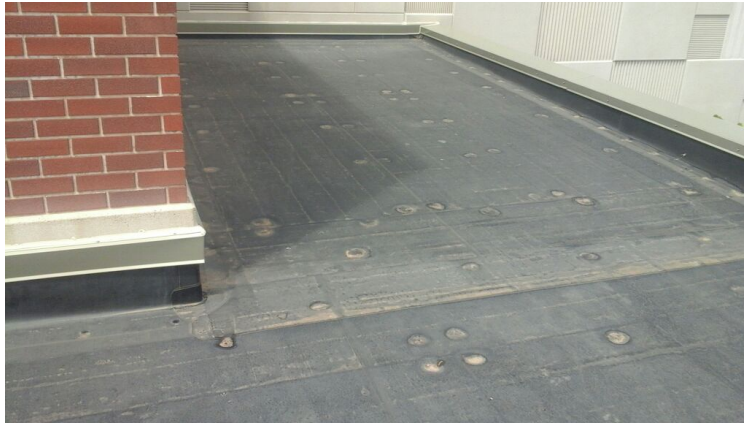
Photo showing additional overview of Area 03 Roof.

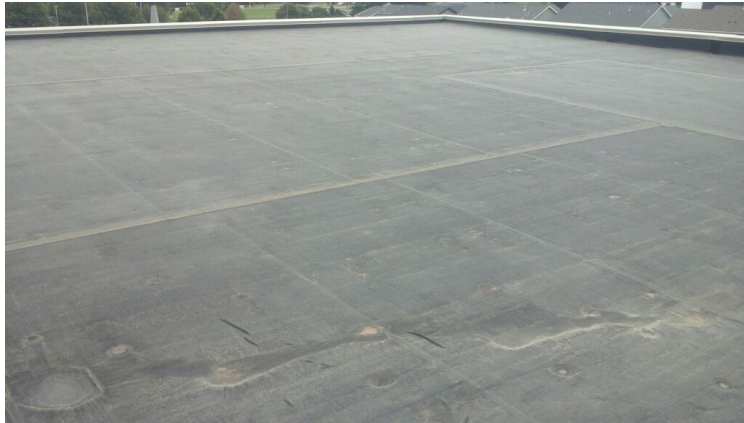
Photo showing overview of Area 04 Roof.

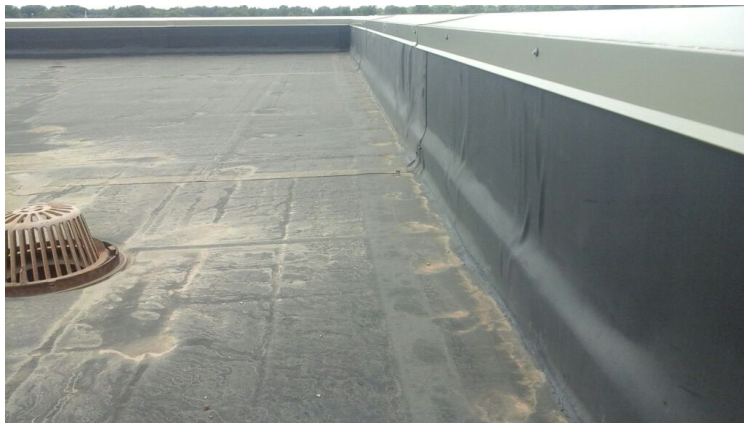
Photo showing condition of the perimeter flashings.

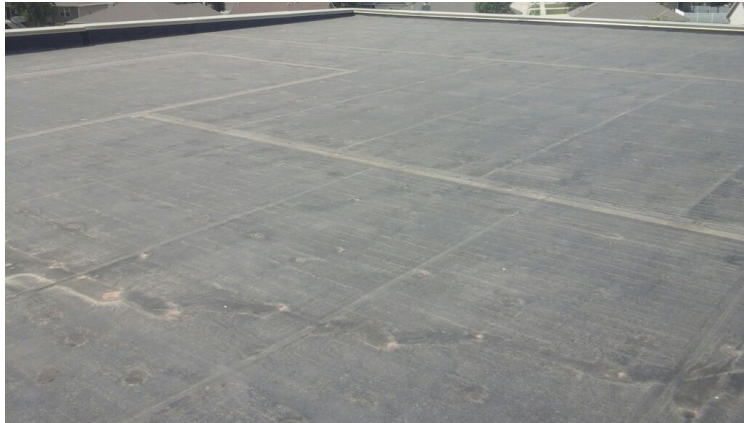
Photo showing overview of Area 05 Roof.

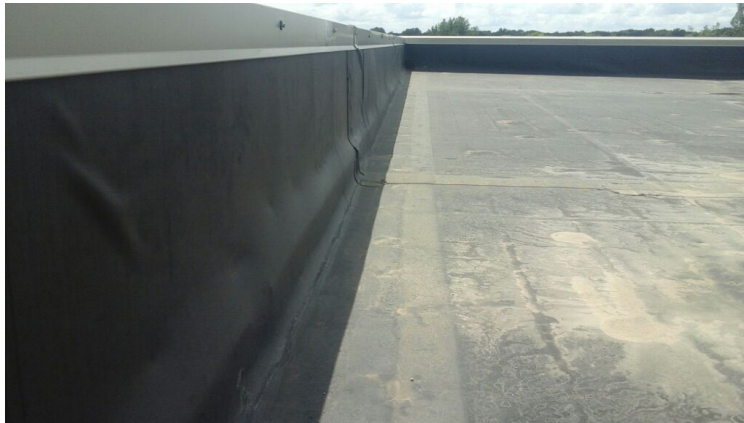
Photo showing condition of the perimeter flashings.

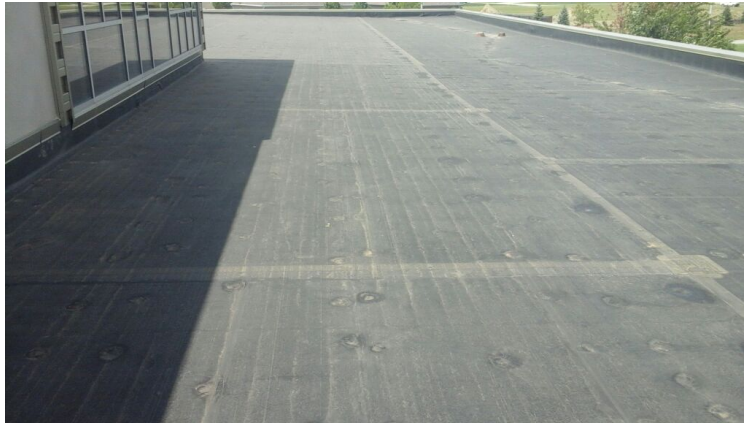
Photo showing overview of Area 06 Roof.

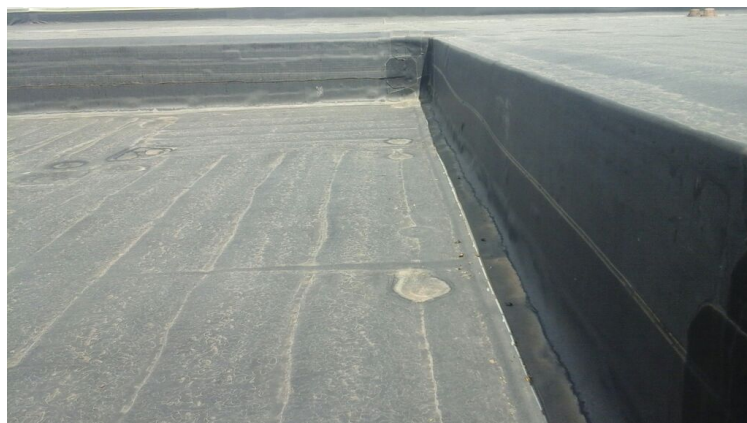
Photo showing condition of the interior flashings.

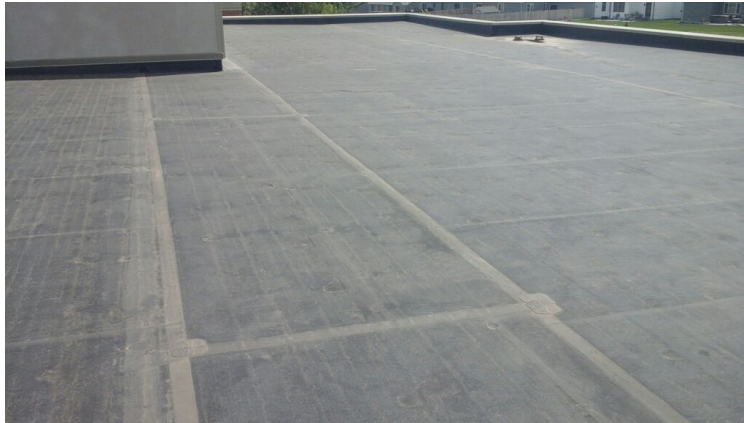
Photo showing additional overview of Area 06 Roof.

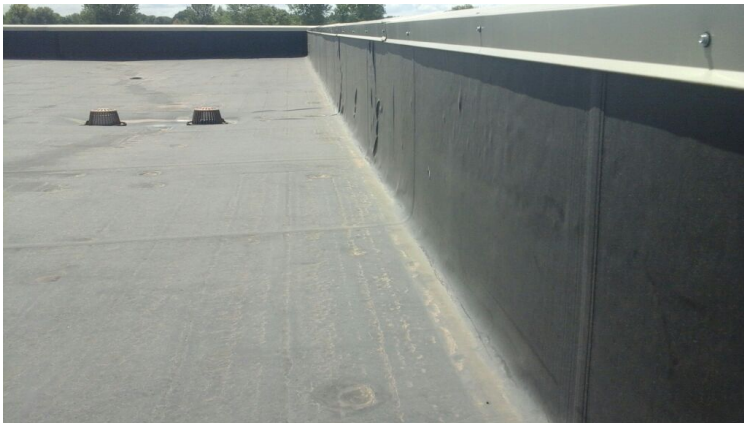
Photo showing condition of the perimeter flashings.

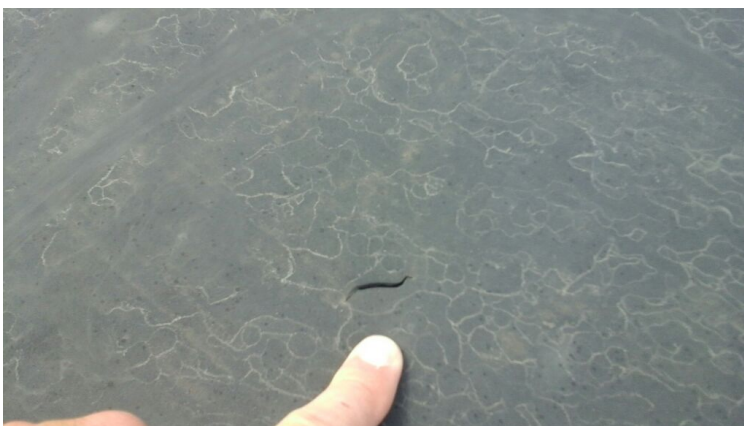
Photo showing a hole in the field membrane that is allowing water to penetrate interior.

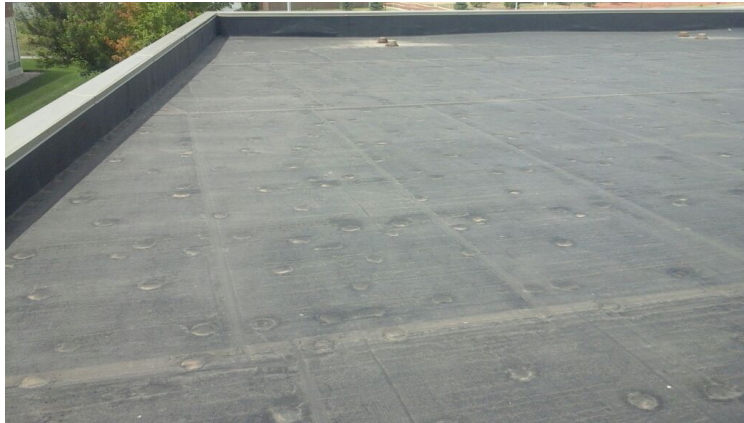
Photo showing overview of Area 07 Roof.
