Board of Education Study Session

School District of Seward

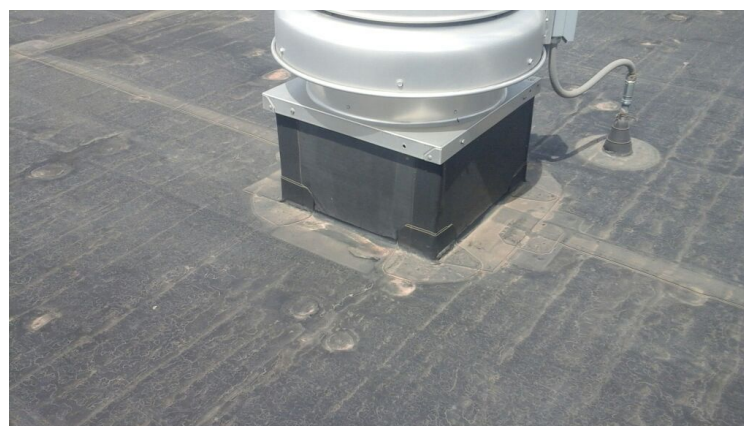
Photo showing condition of projection flashings.

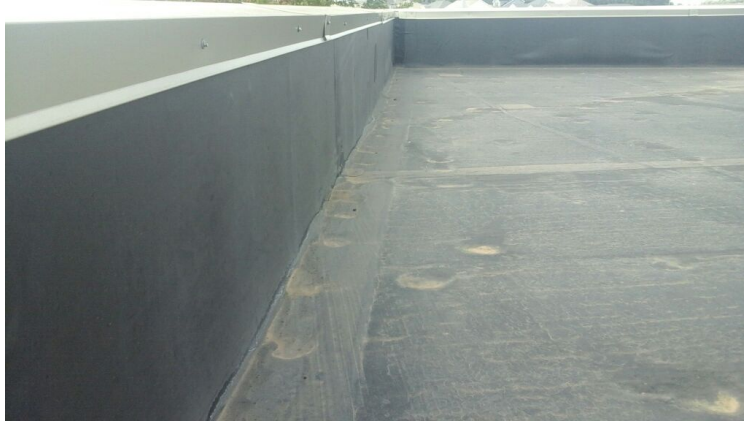
Photo showing condition of the perimeter flashings.

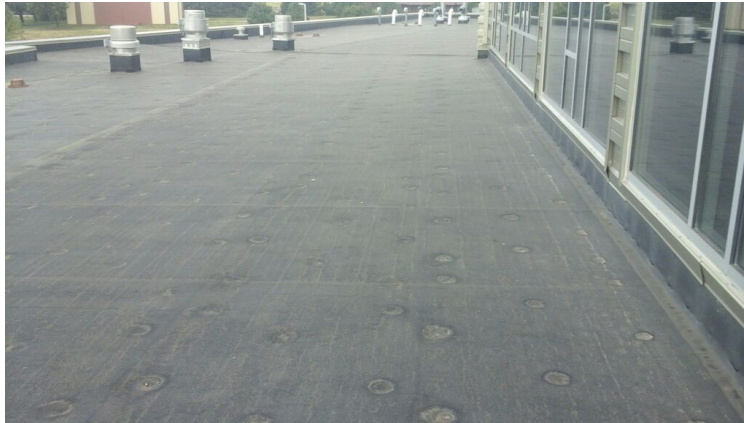
Photo showing overview of Area 08 Roof.

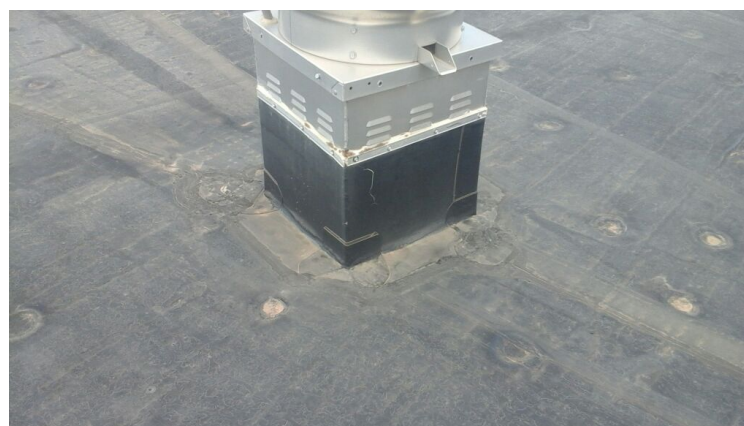
Photo showing condition of projection flashings.

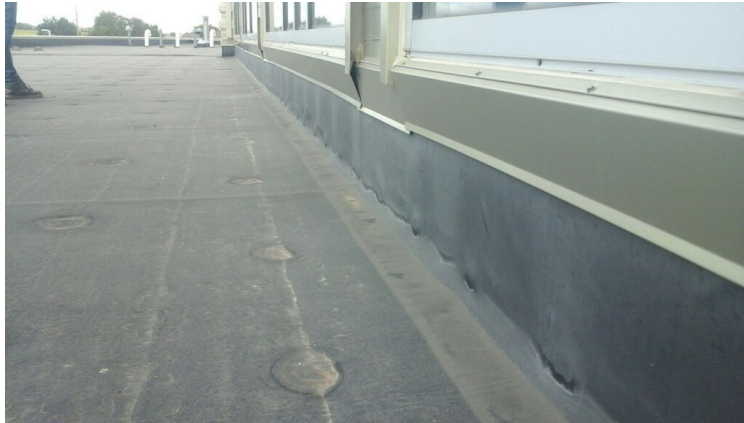
Photo showing condition of the counter flashing along the window wall.

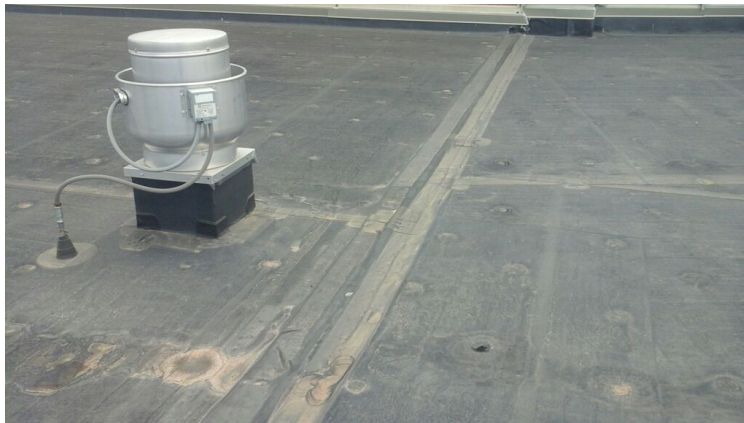
Photo showing condition of the expansion joint.

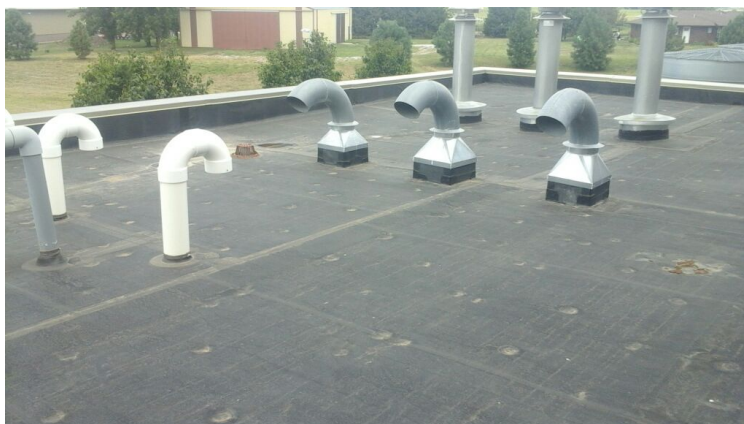
Photo showing condition of the projection flashings.

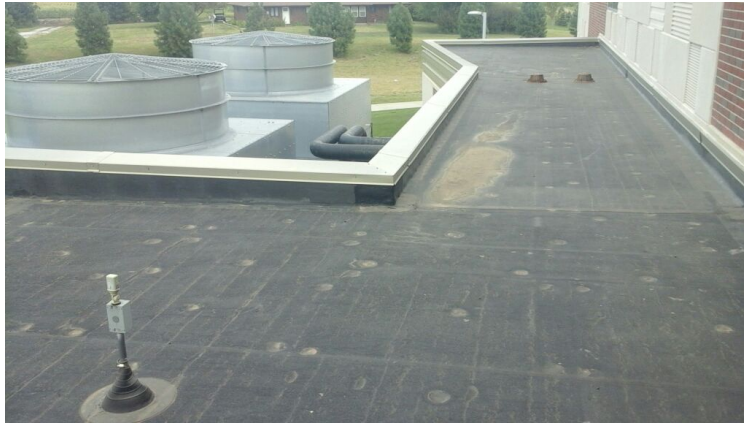
Photo showing additional overview of Area 08 Roof.

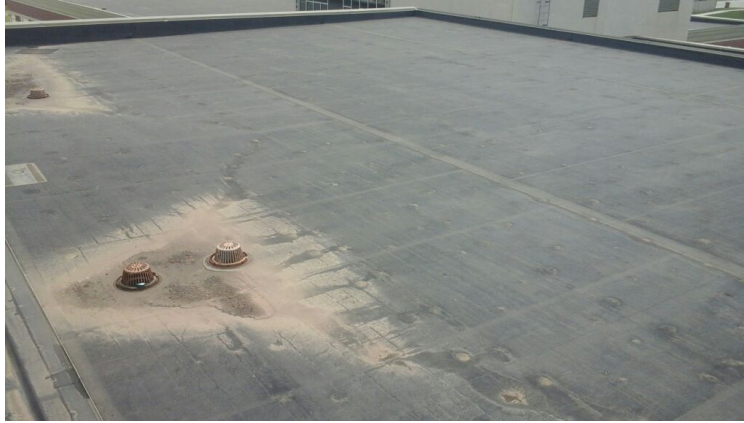
Photo showing overview of Area 09 Roof.

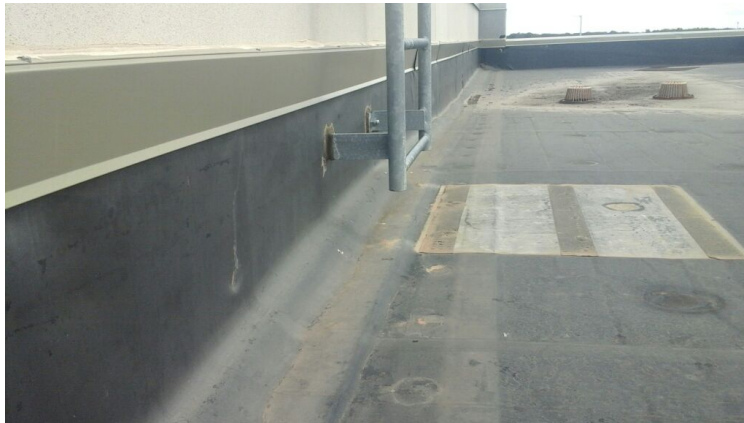
Photo showing condition of the perimeter flashings under ladder.

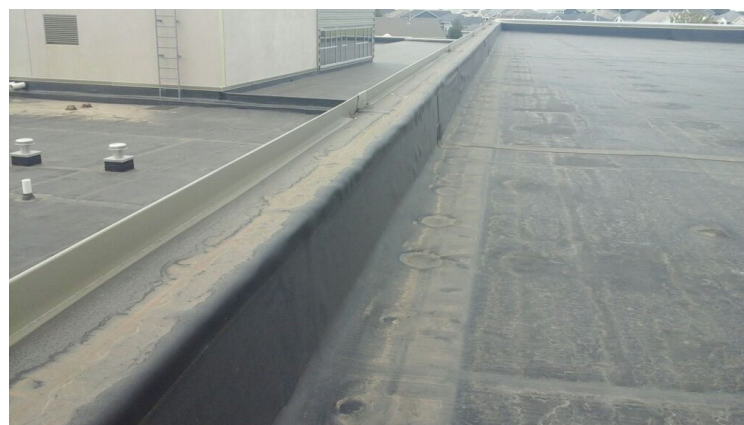
Photo showing condition of the form flashings.

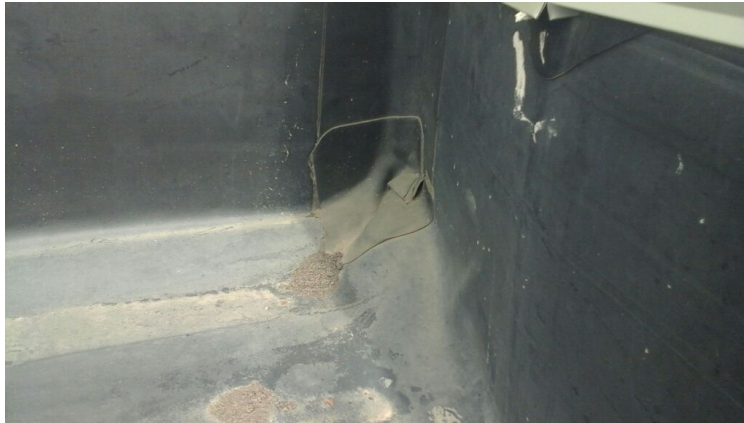
Photo showing minor tenting in the corner of the perimeter flashings.

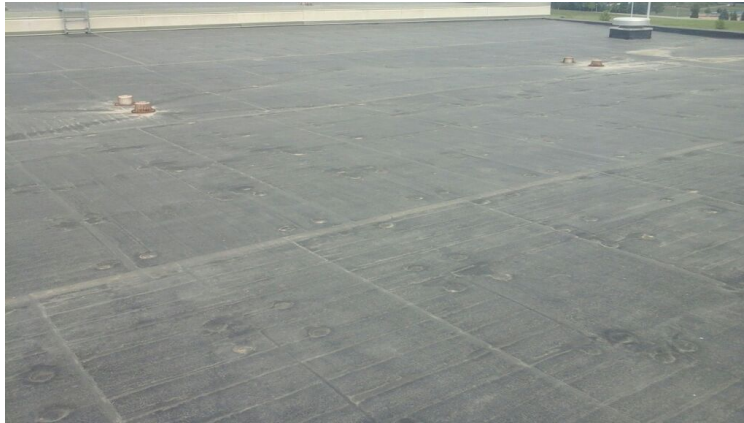
Photo showing overview of Area 10 Roof.

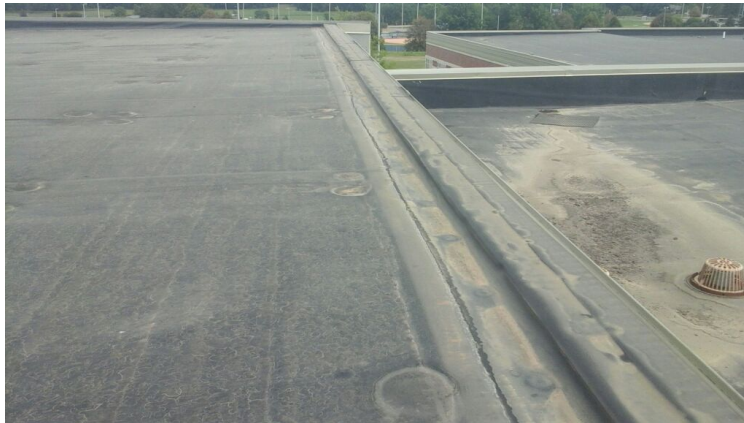
Photo showing condition of the form flashings.

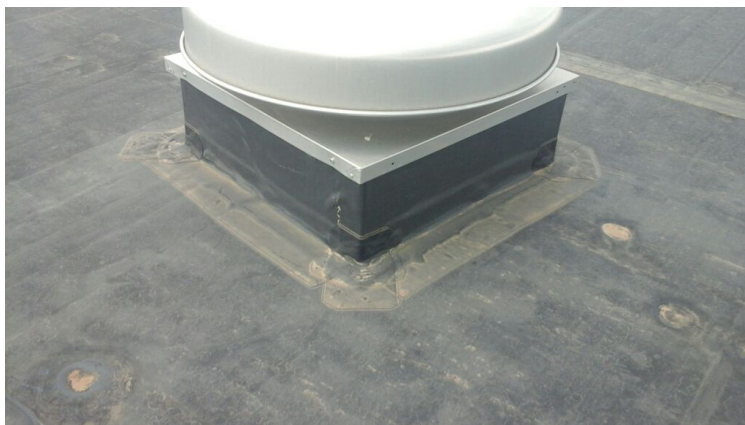
Photo showing condition of projection flashings.

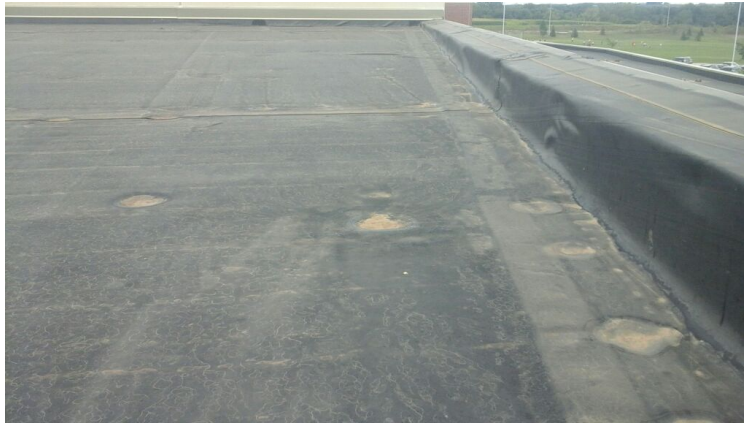
Photo showing condition of the perimeter flashings.

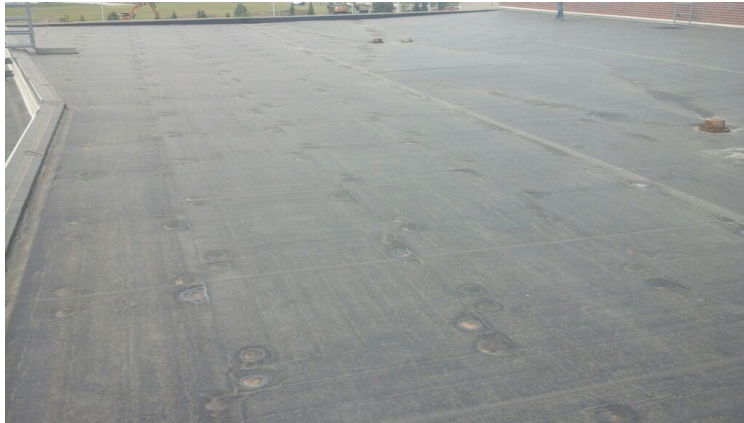
Photo showing overview of Area 11 Roof.

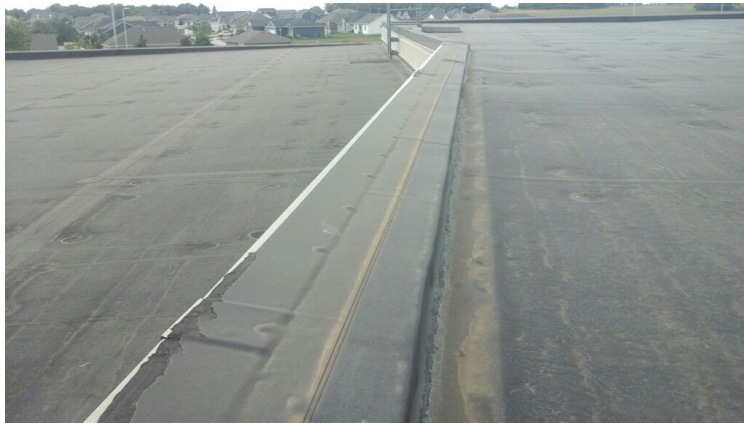
Photo showing condition of the form flashings.

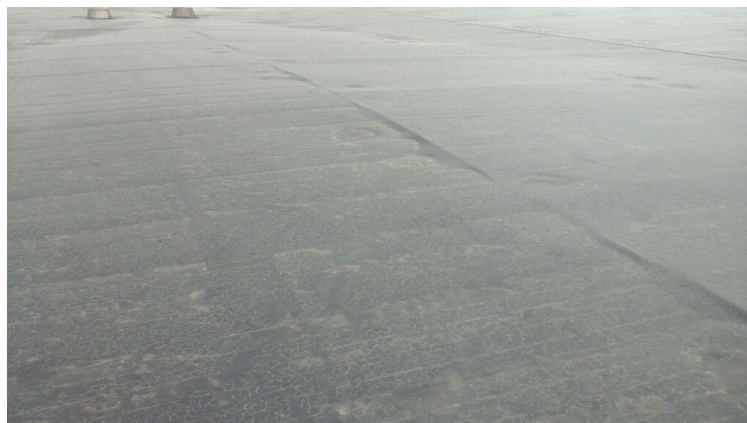
Photo showing minor cover board extrusion along cricket peak.

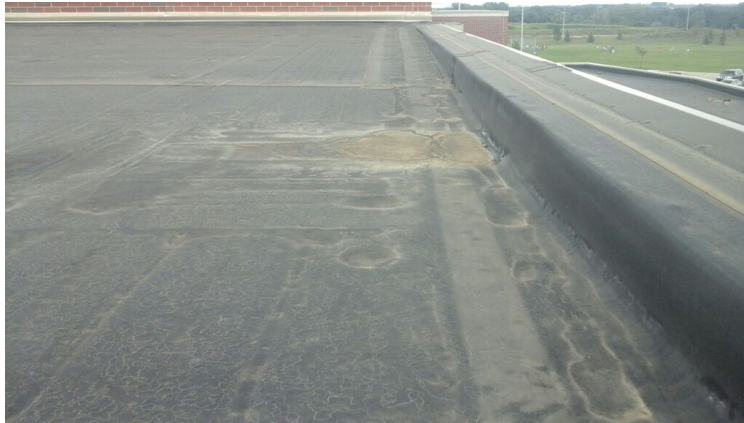
Photo showing condition of the perimeter flashings.

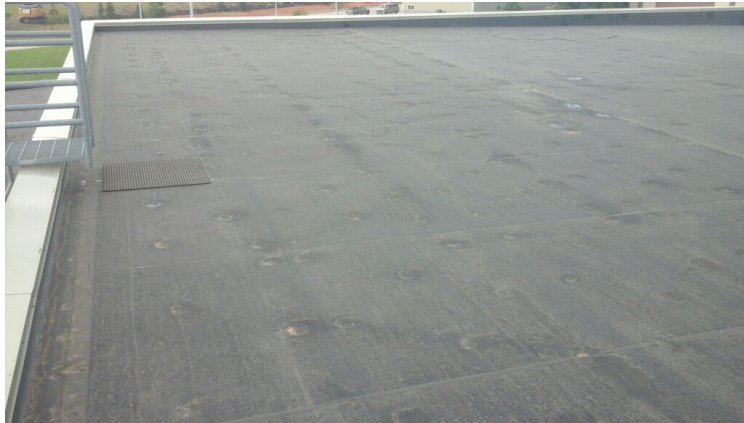
Photo showing overview of Area 12 Roof.

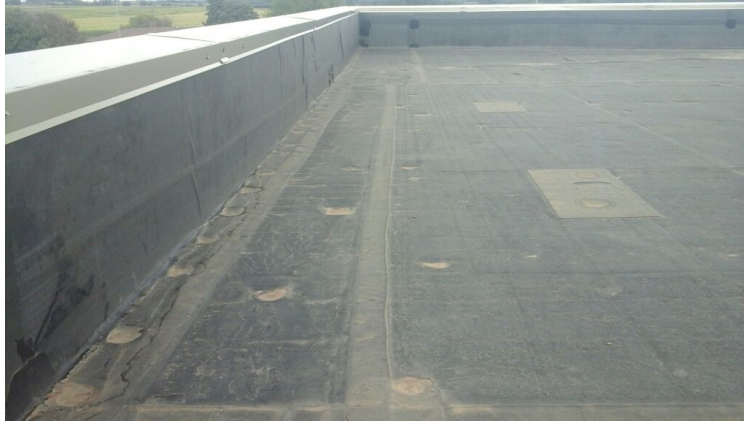
Photo showing condition of the perimeter flashings.

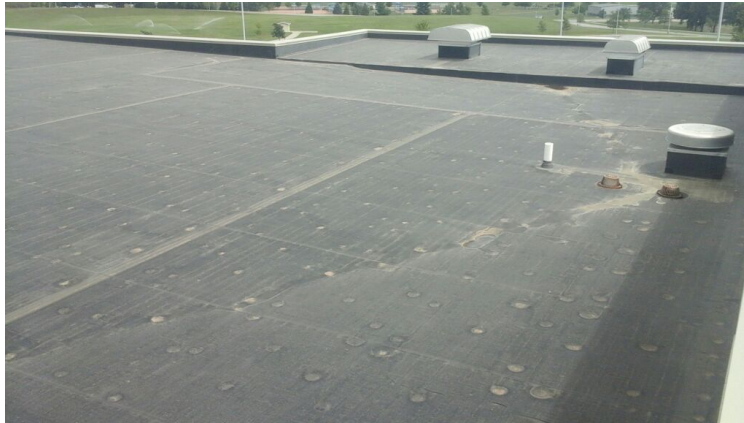
Photo showing overview of Area 13 Roof.

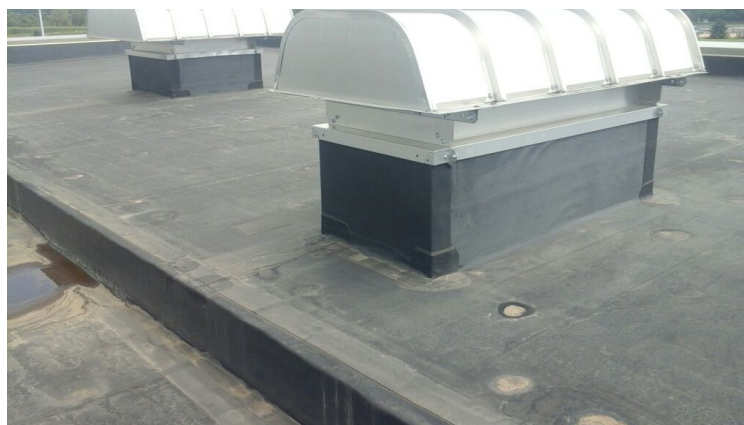
Photo showing condition of projection flashings.

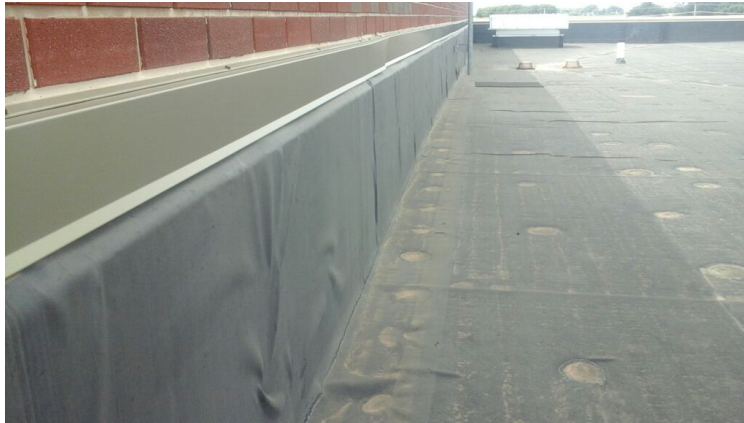
Photo showing condition of the perimeter flashings along brick wall.

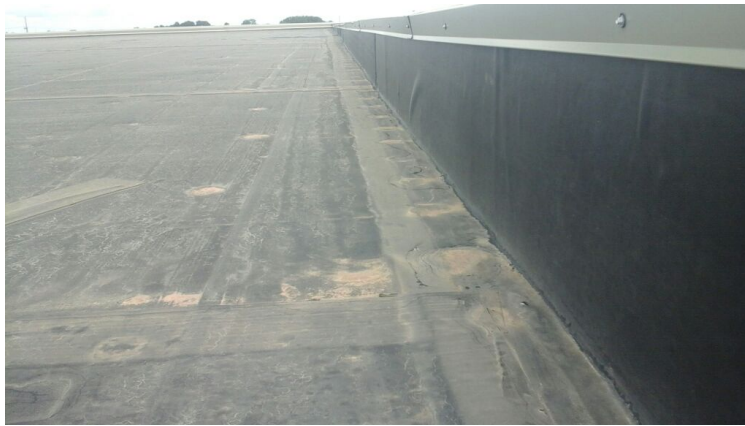
Photo showing condition of the perimeter flashings.

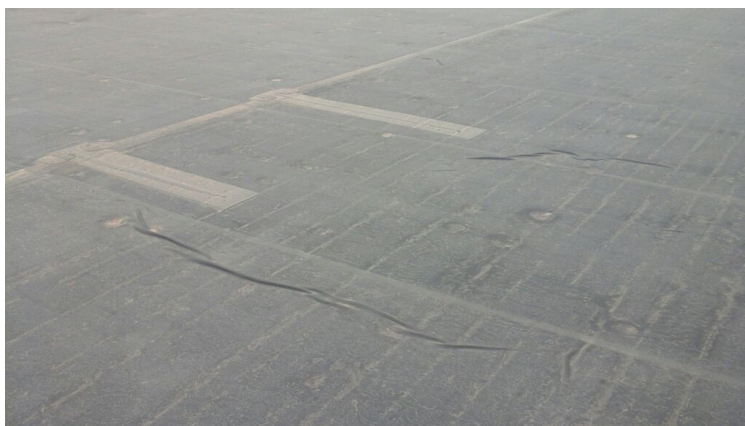
Photo showing minor wrinkles in the field membrane.

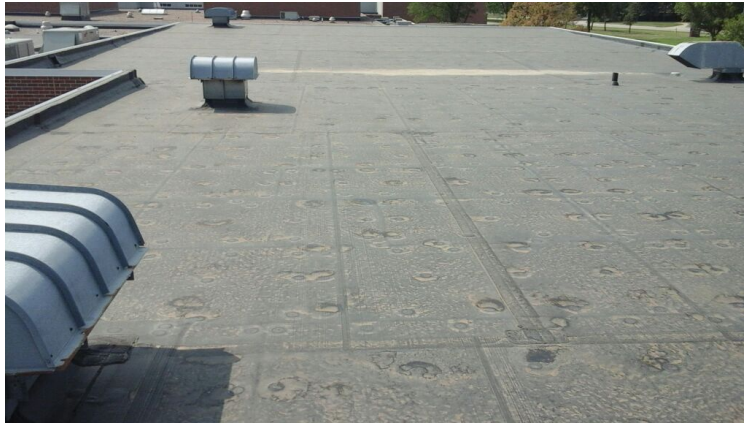
Photo showing overview of Area 01 Roof.

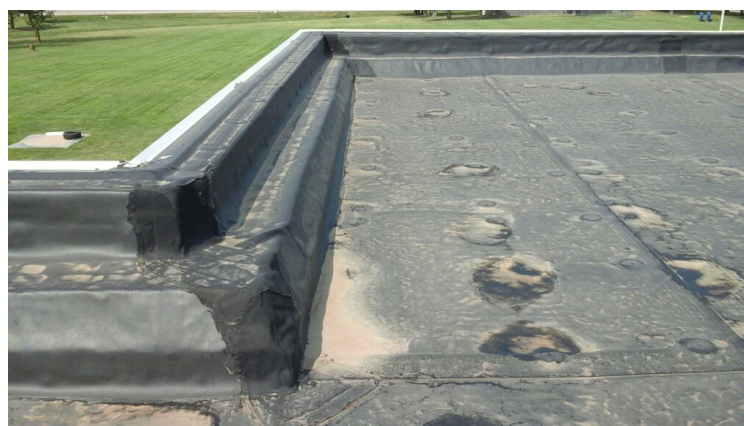
Photo showing condition of the perimeter flashings.

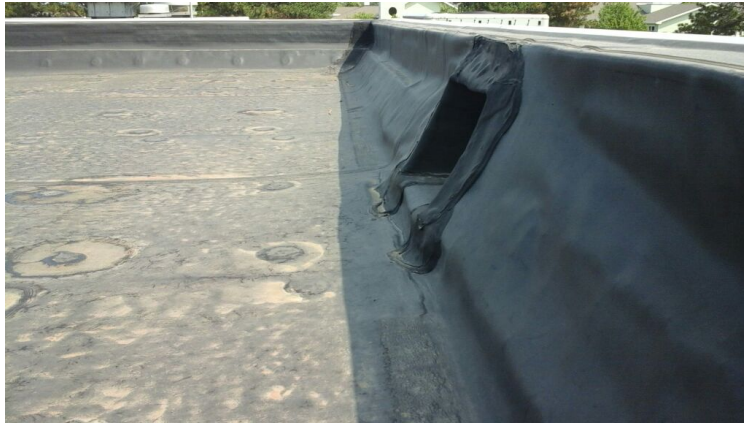
Photo showing condition of the perimeter flashings.

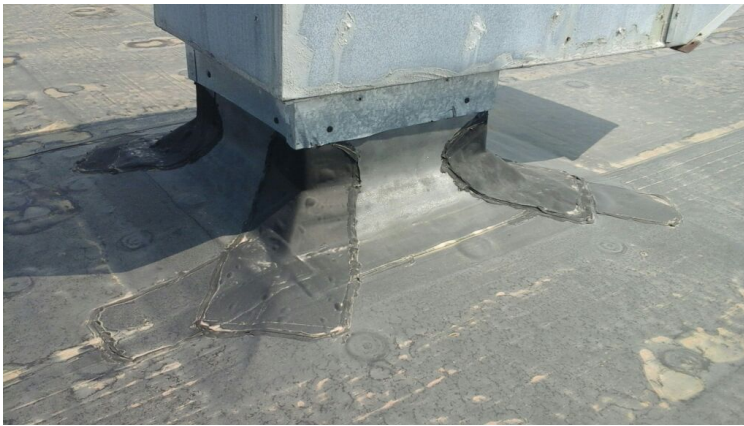
Photo showing condition of the projection flashings.

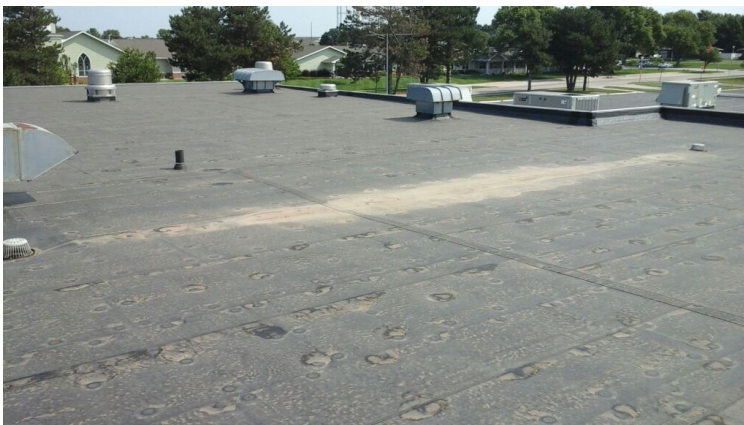
Photo showing evidence of ponding water in the drain valley.

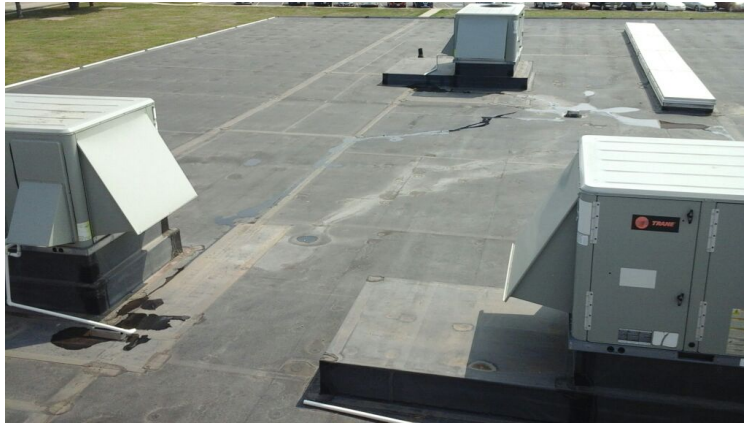
Photo showing overview of Area 02 Roof.

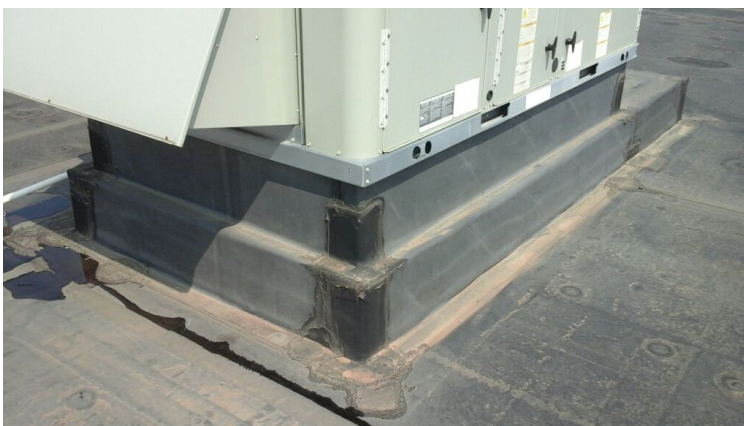
Photo showing condition of projection flashings.

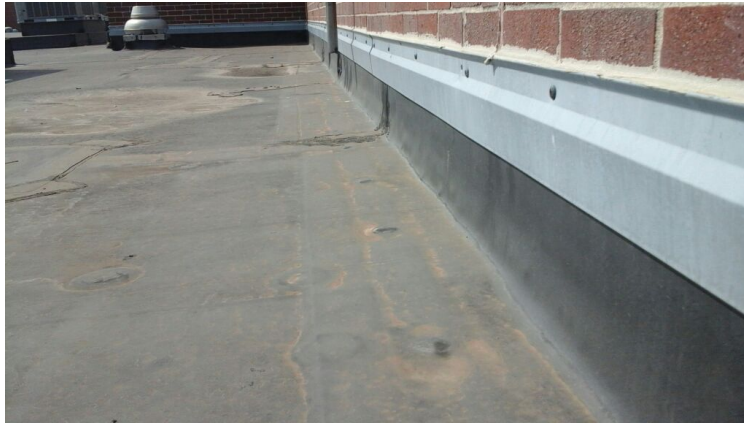
Photo showing condition of the perimeter flashings.

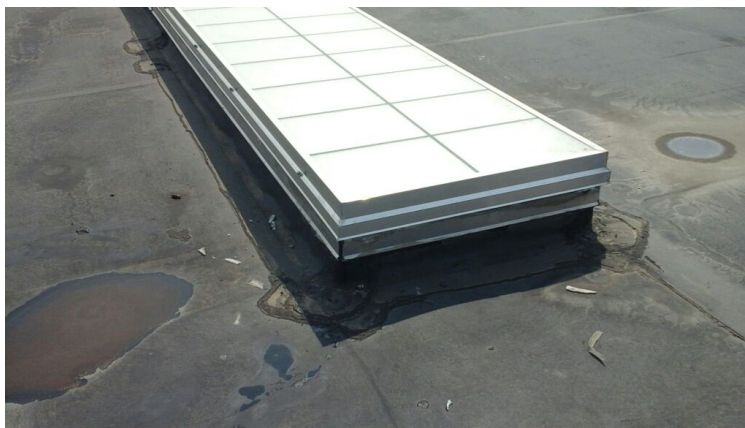
Photo showing condition of the skylight. Underside of counter flashing is caulked and likely preventing water from escaping. I recommend removing the excess caulking.

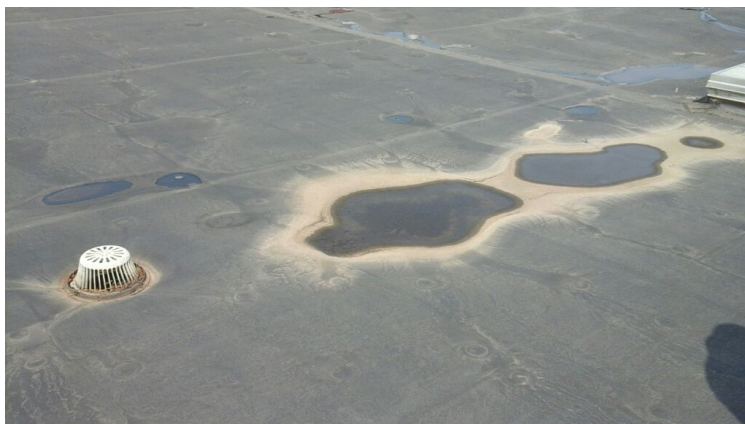
Photo showing minor ponding in the drain valley.

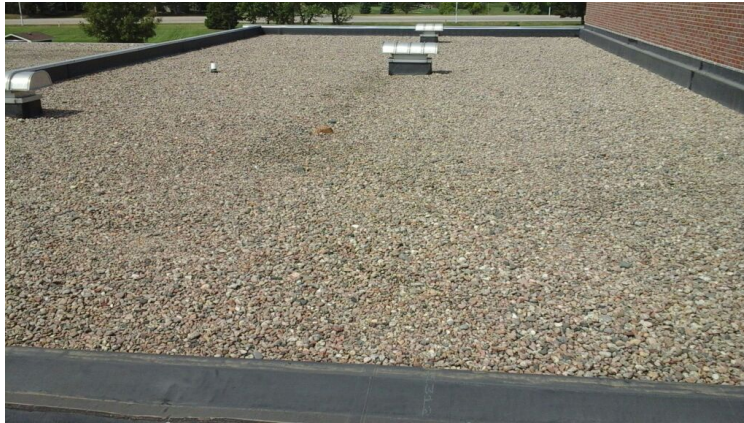
Photo showing overview of Area 03 Roof.

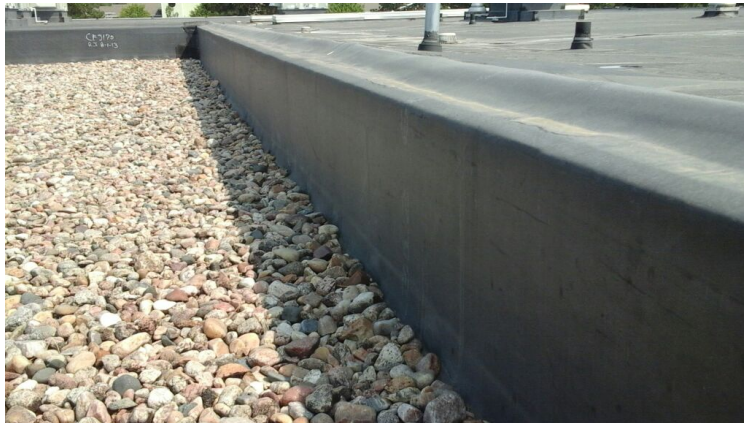
Photo showing condition of the perimeter flashings.

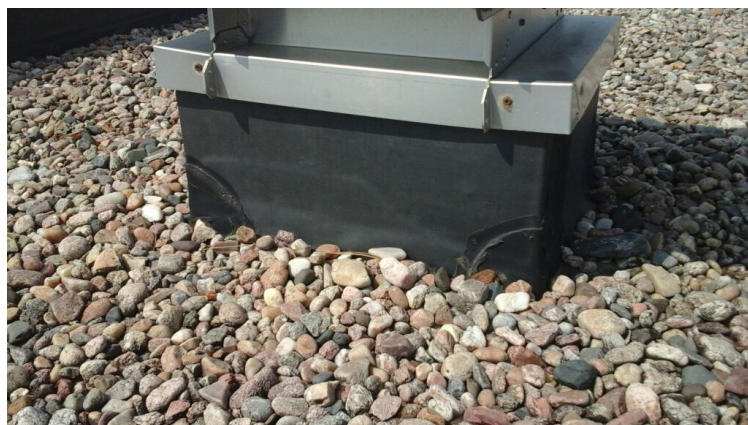
Photo showing condition of projection flashings.

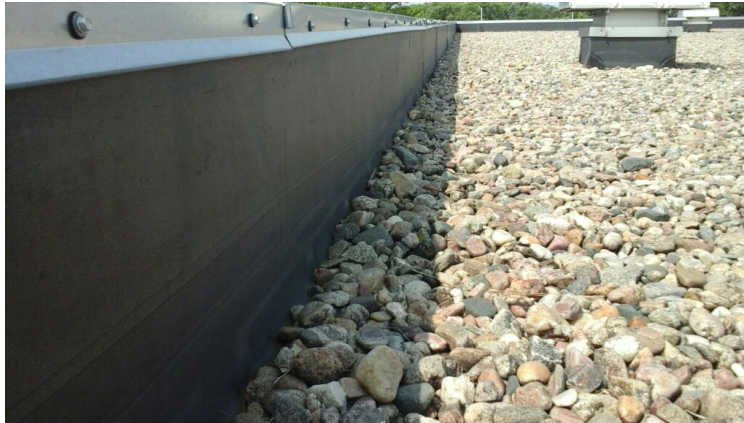
Photo showing condition of the perimeter flashings.

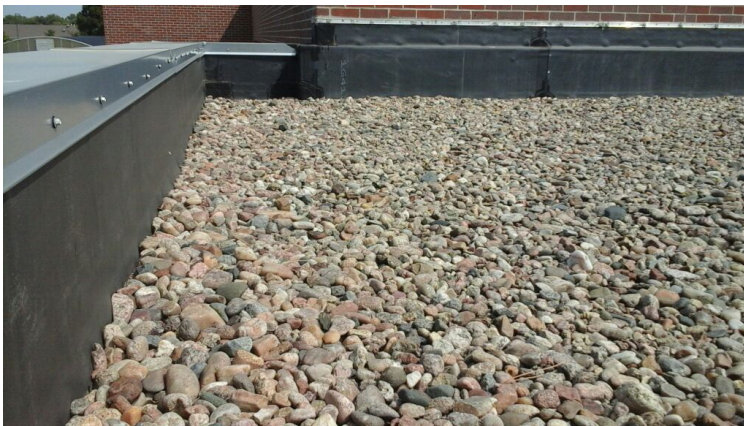
Photo showing condition of the perimeter flashings.

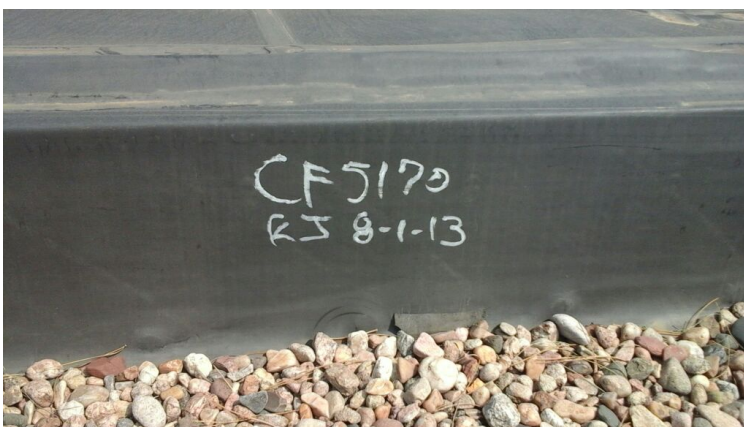
Photo showing contractor signature.

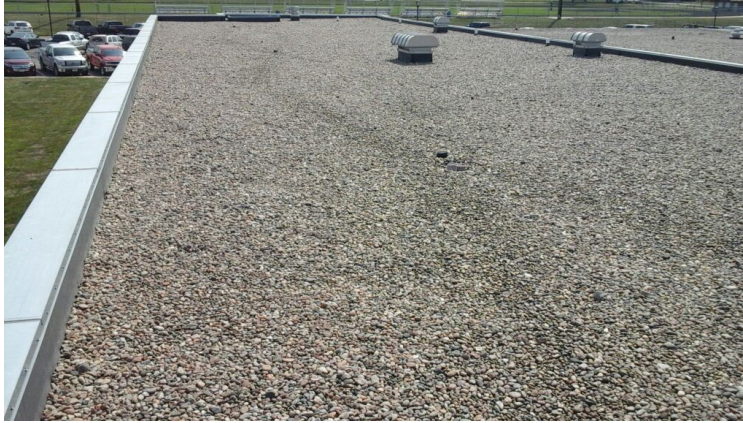
Photo showing overview of Area 04 Roof.

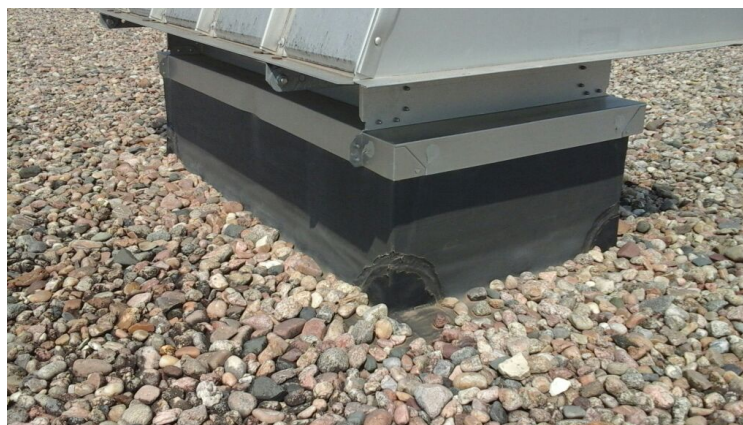
Photo showing condition of projection flashings.

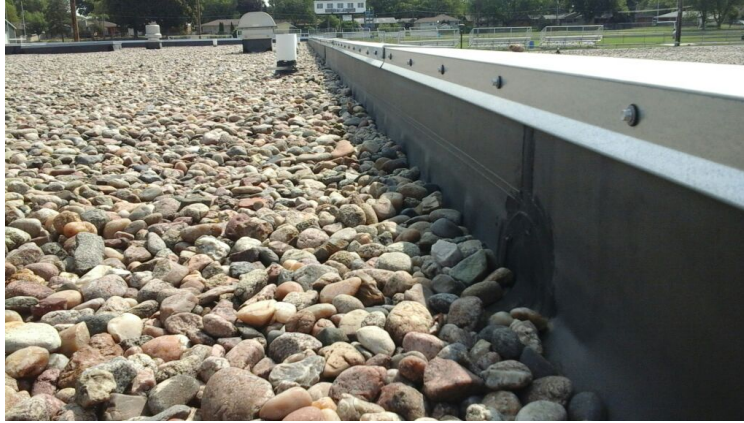
Photo showing condition of the perimeter flashings.

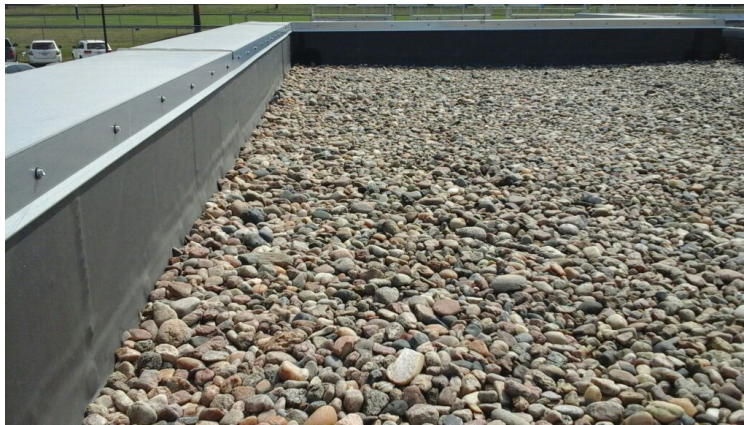
Photo showing condition of the perimeter flashings.

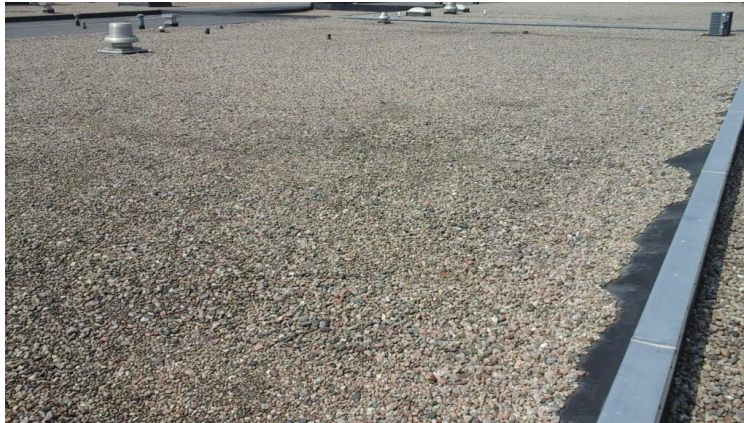
Photo showing overview of Area 05 Roof.

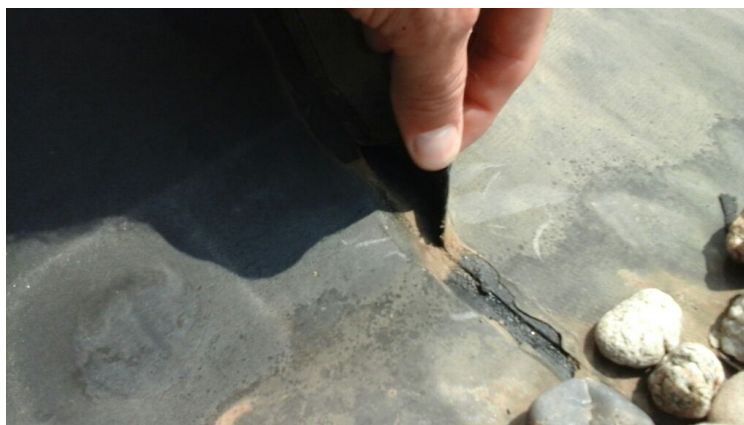
Photo showing additional blowout patch on perimeter pulling loose.

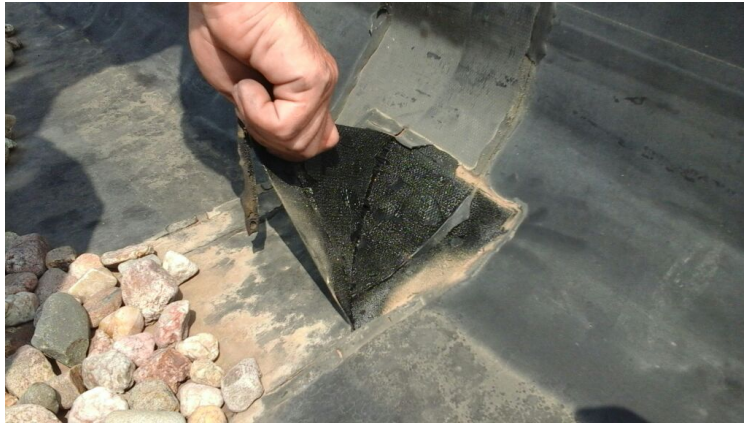
Photo showing a blowout patch on the perimeter flashing pulling loose.

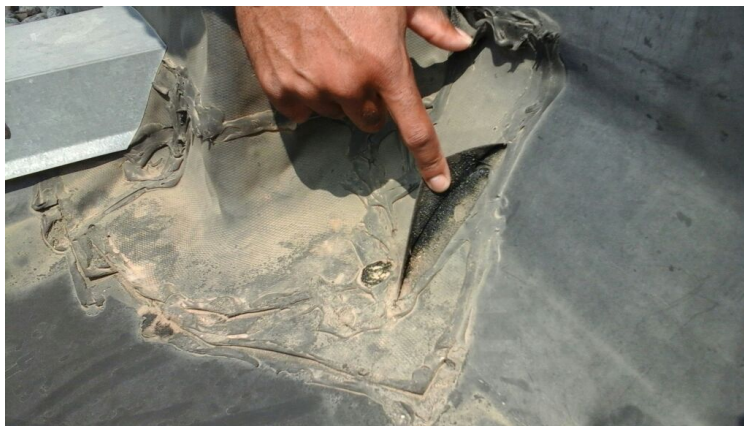
Photo showing additional blowout patch pulling loose.

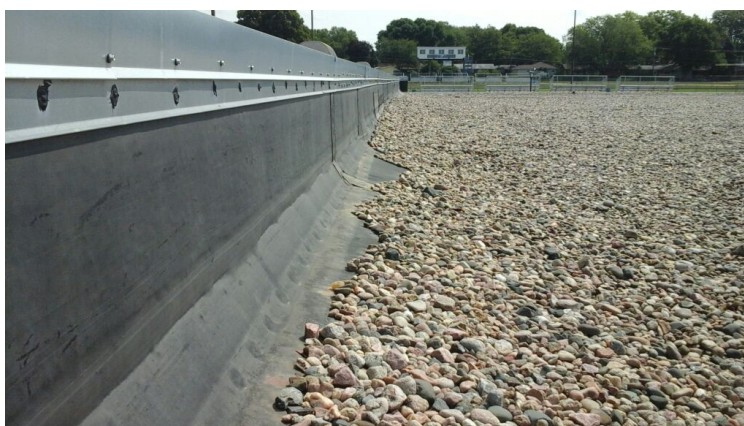
Photo showing condition of the perimeter flashings.

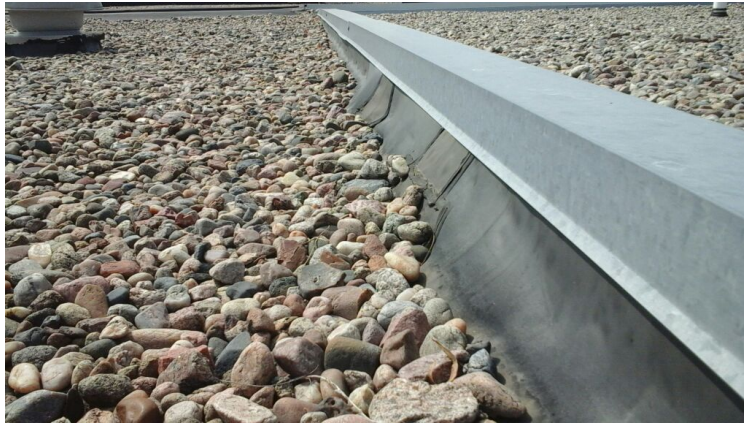
Photo showing tenting along the expansion joint.

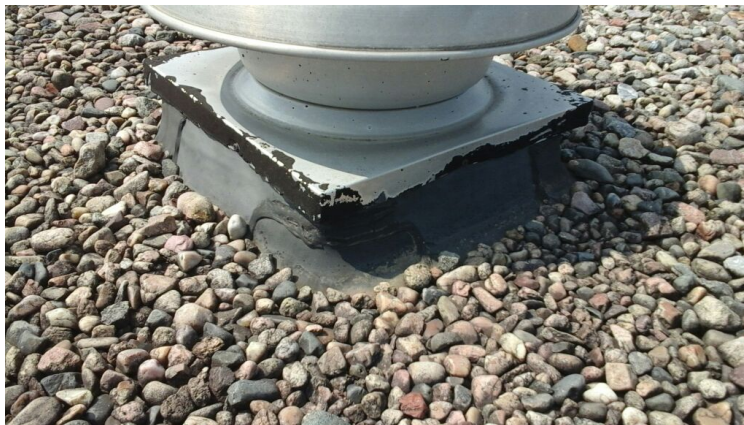
Photo showing condition of projection flashings.

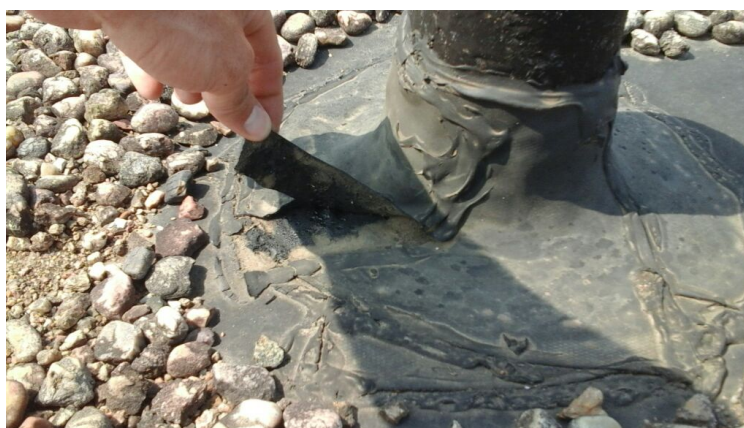
Photo showing flashing around soil stack beginning to pull loose.

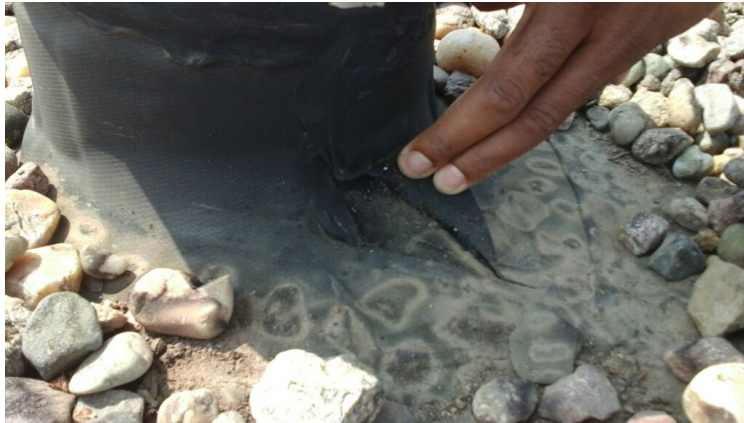
Photo showing flashing around projection that is pulling loose.

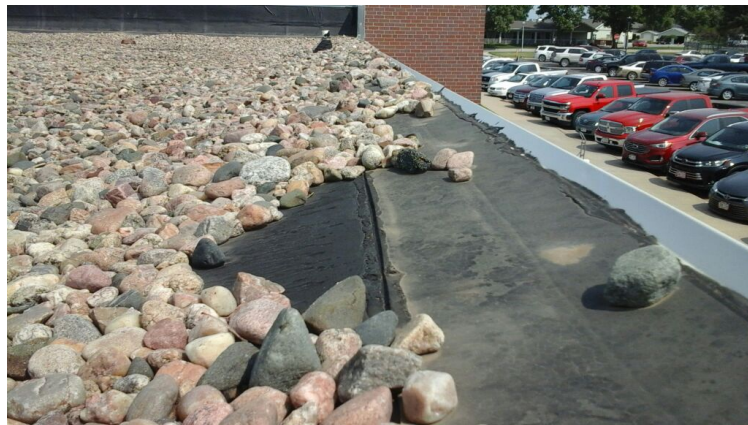
Photo showing condition of form flashing along perimeter edge.

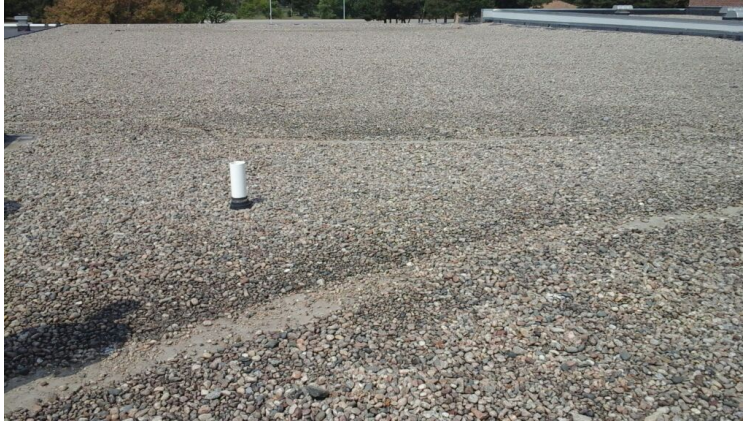
Photo showing overview of Area 06 Roof.

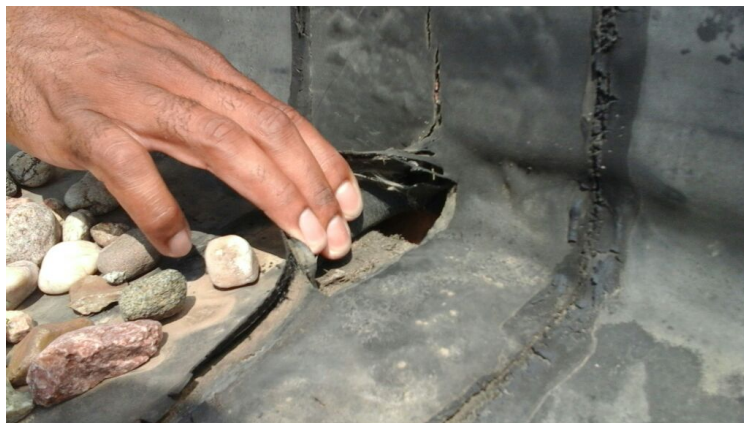
Photo showing a hole in the perimeter flashing. The decking is exposed and this is almost certainly a leak.

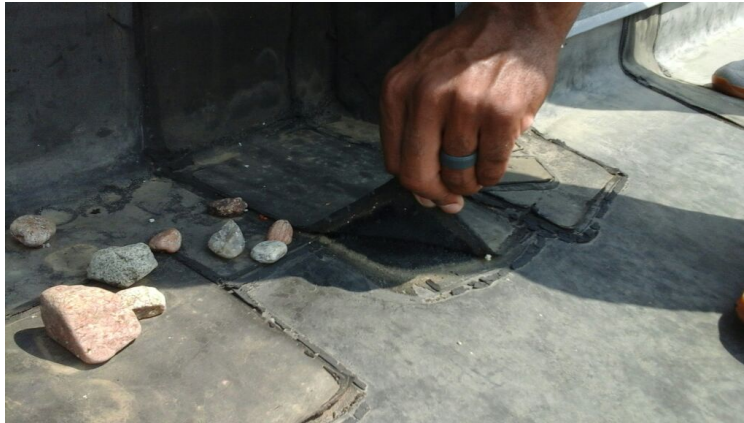
Photo showing a blowout patch in the perimeter flashing beginning to pull loose.

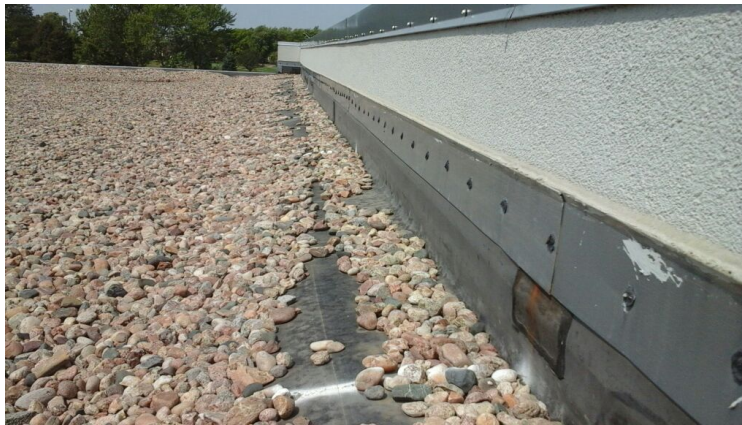
Photo showing condition of the perimeter flashings.

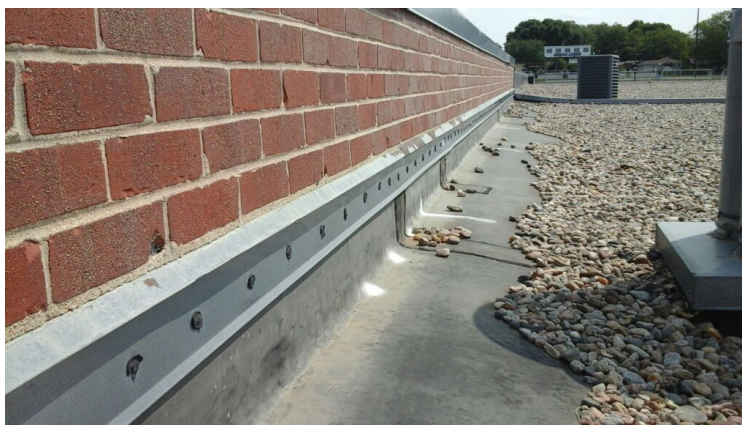
Photo showing condition of the perimeter flashings.

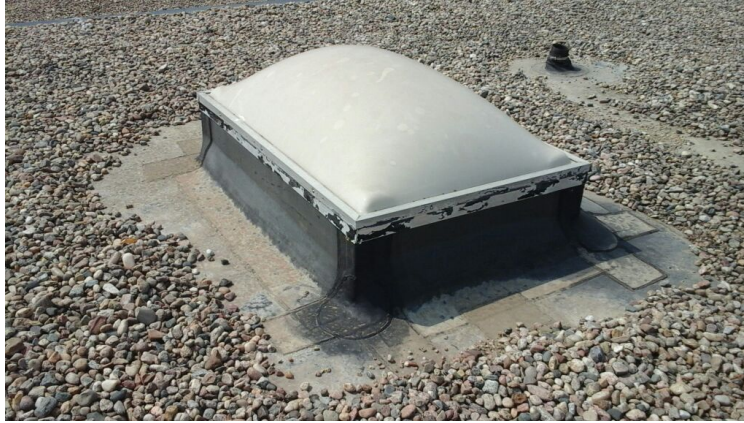
Photo showing condition of the skylights.

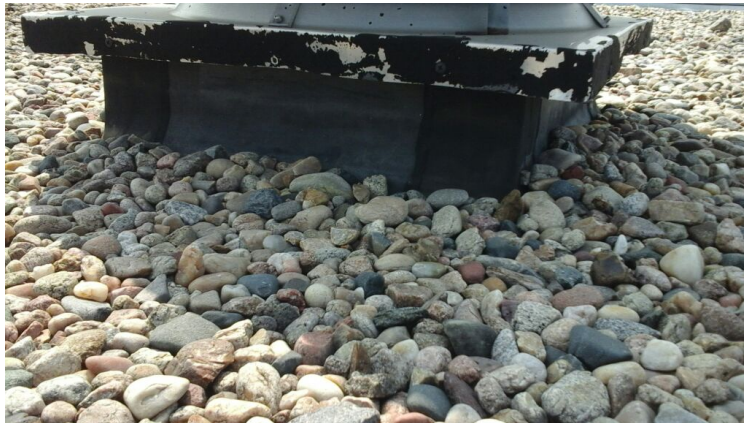
Photo showing condition of projection flashings.

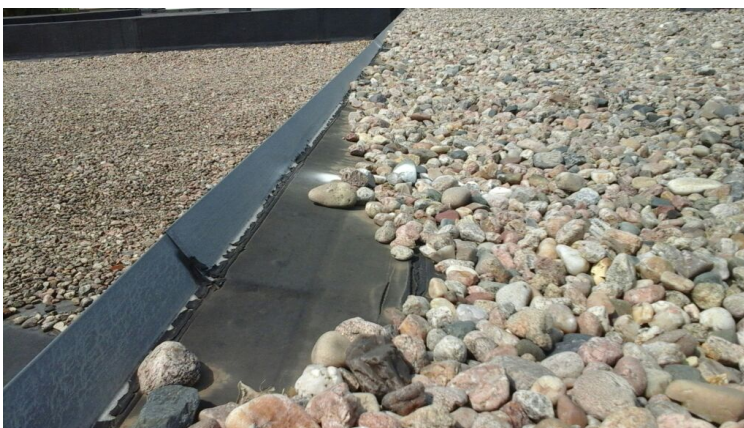
Photo showing condition of the form flashings.

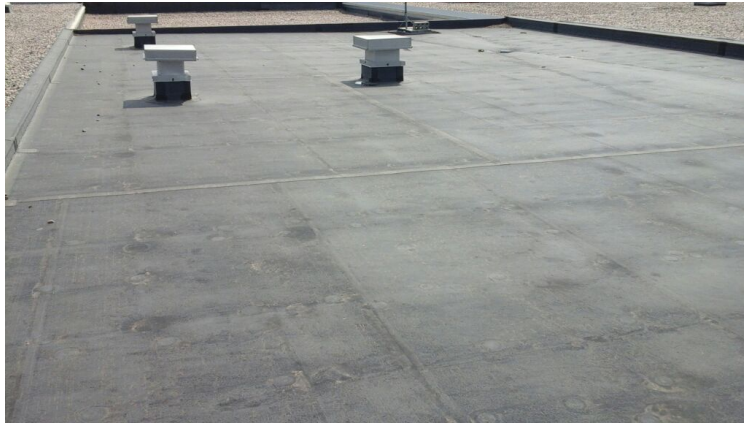
Photo showing overview of Area 07 Roof.

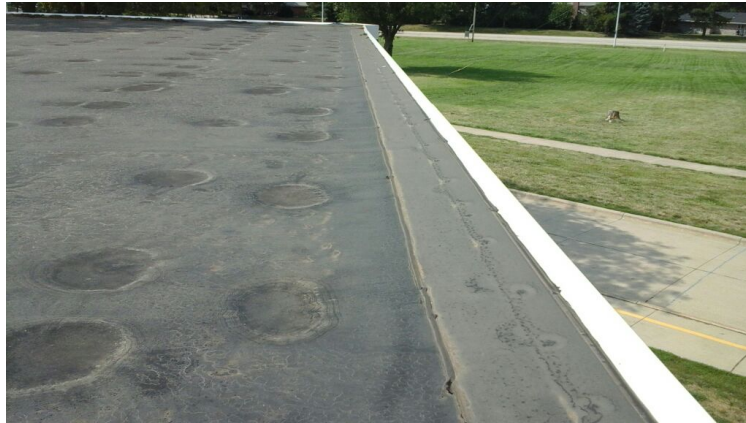
Photo showing condition of the form flashings.

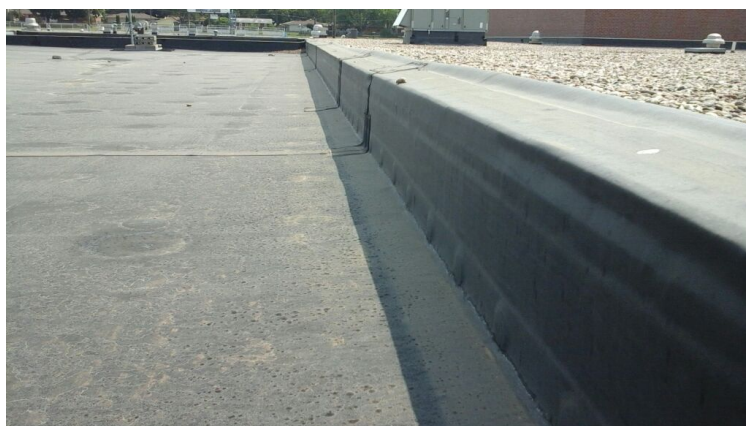
Photo showing condition of the perimeter flashings.

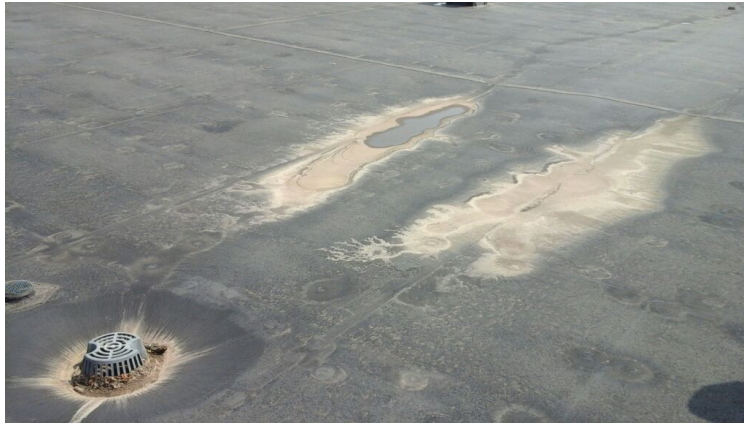
Photo showing evidence of ponding water in the drain valley.

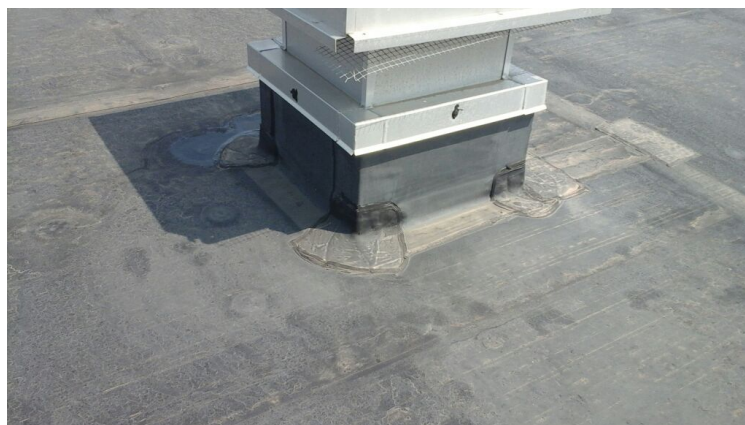
Photo showing condition of projection flashings.
