Board of Education Study Session

School District of Seward

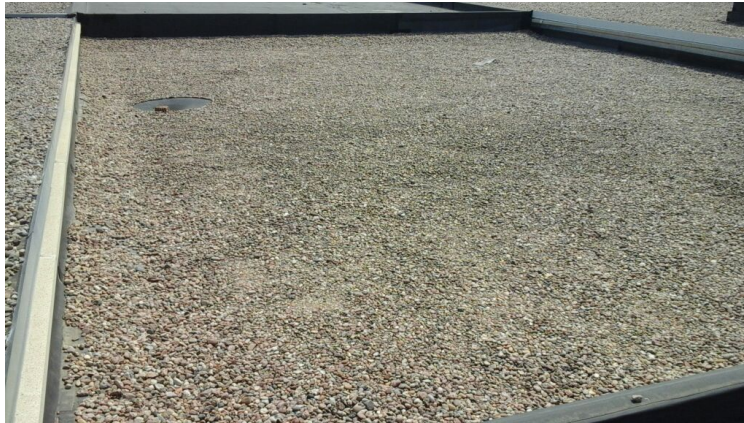
Photo showing overview of 08 Roof.

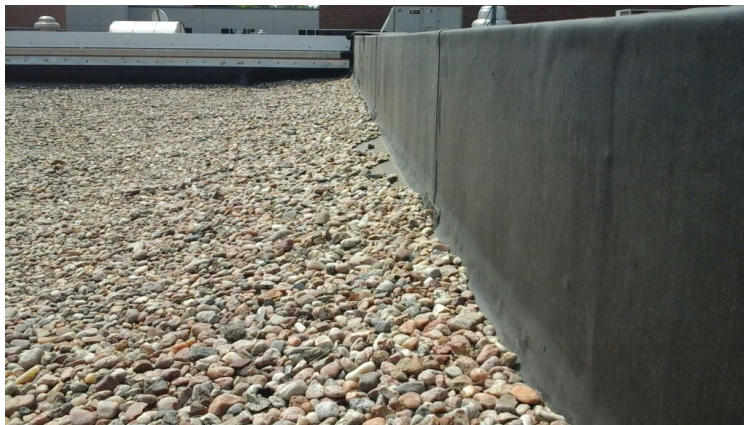
Photo showing condition of the perimeter flashings.

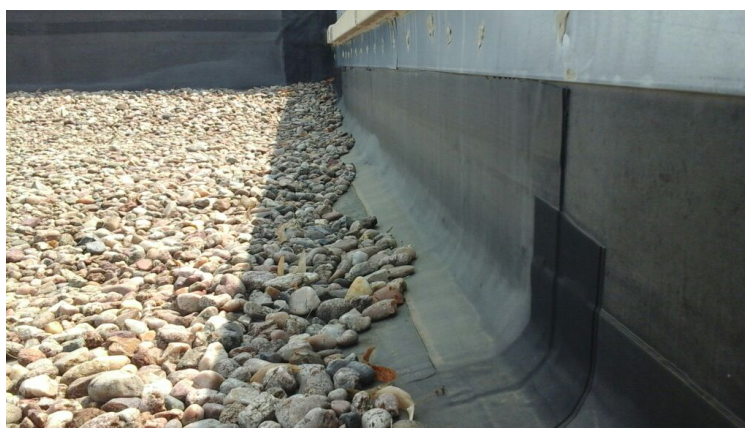
Photo showing minor tenting along the perimeter flashings.

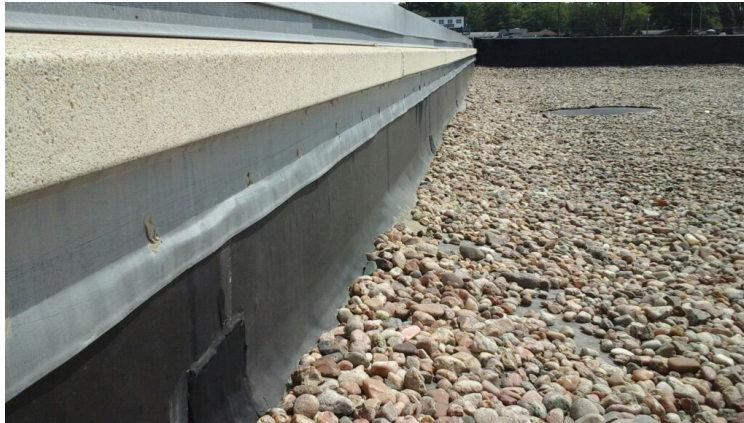
Photo showing condition of the perimeter flashings.

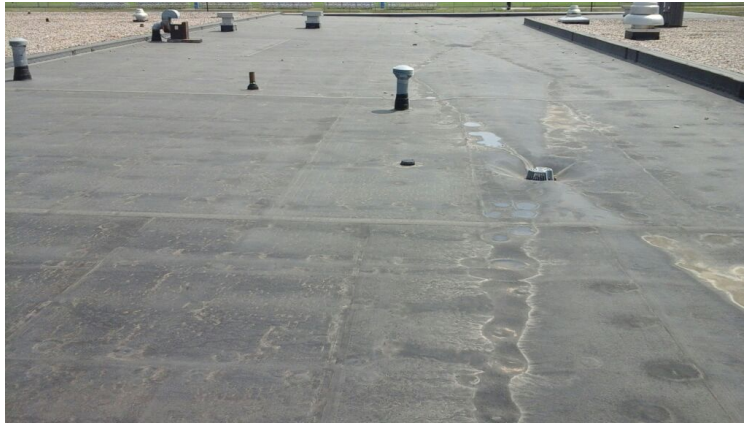
Photo showing overview of Area 09 Roof.

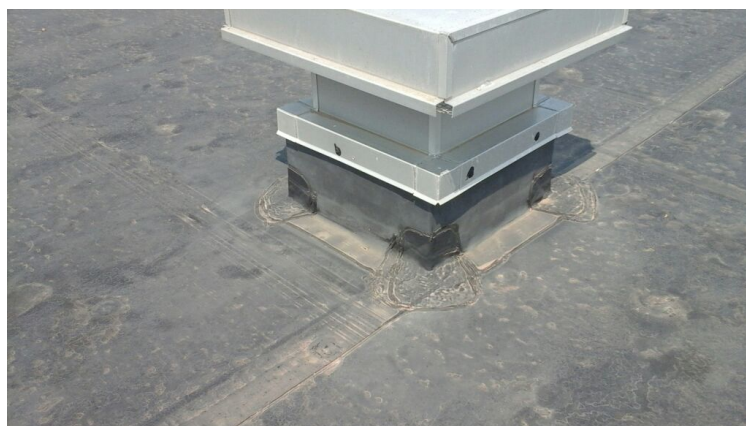
Photo showing condition of projection flashings.

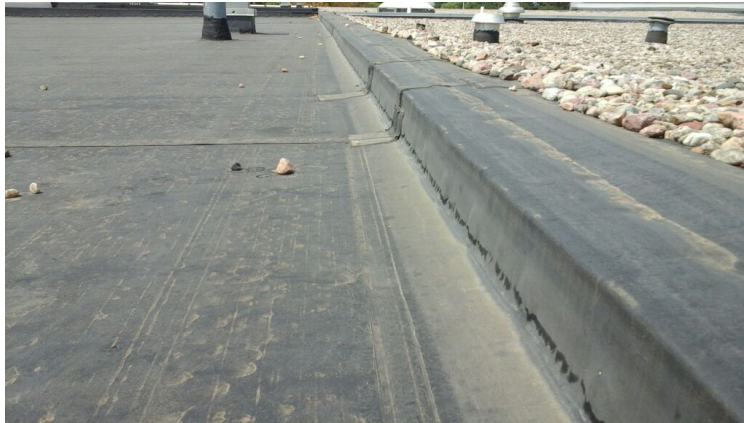
Photo showing condition of the perimeter flashings.

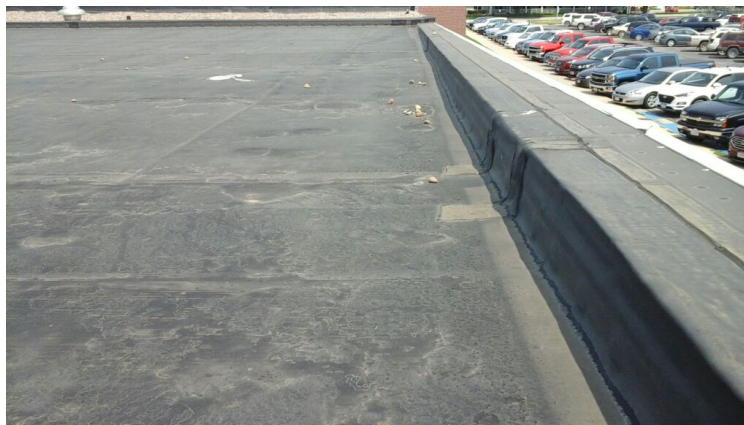
Photo showing condition of the form flashings.

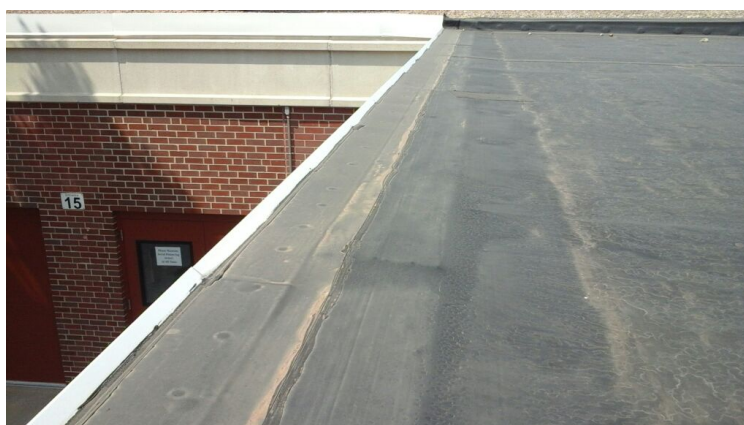
Photo showing condition of the form flashings.

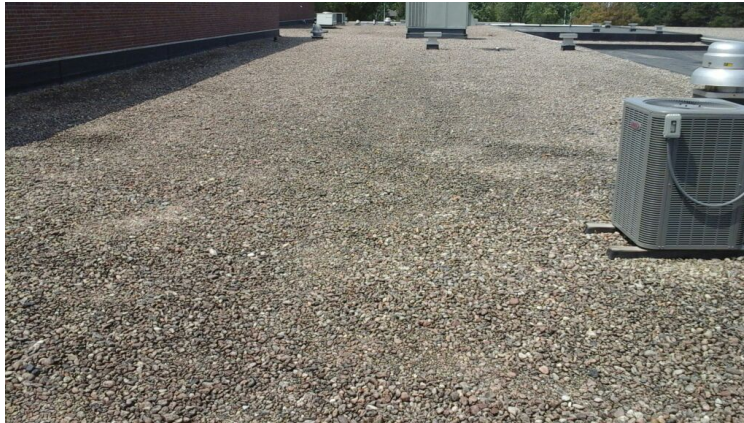
Photo showing overview of Area 10 Roof.

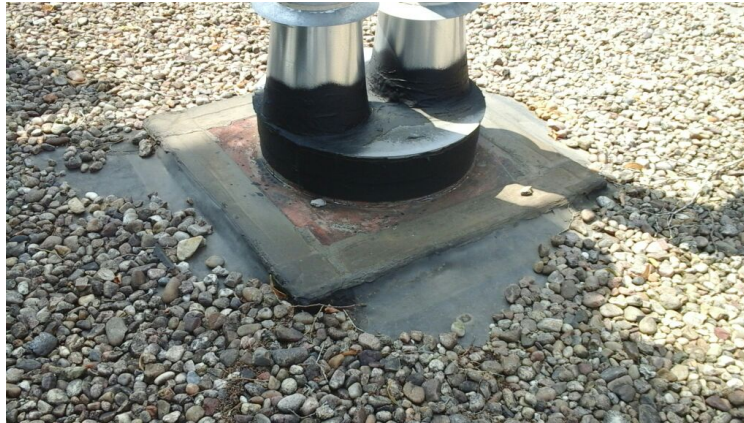
Photo showing condition of low projection flashings.

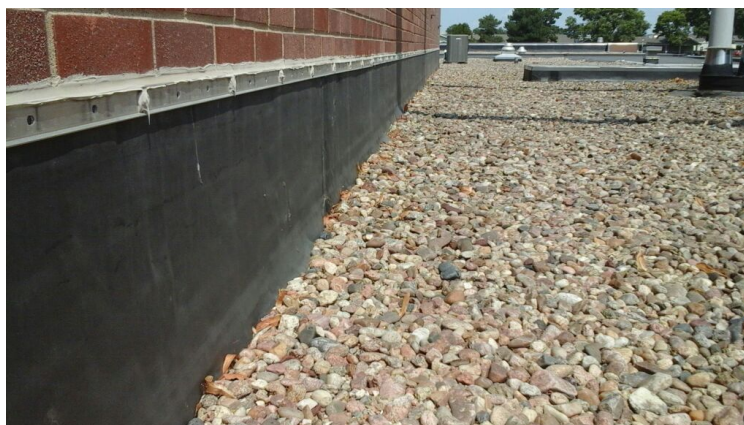
Photo showing condition of the perimeter flashings.

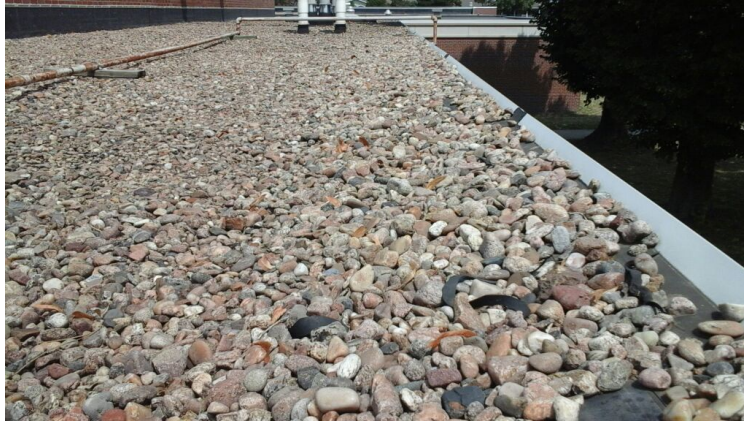
Photo showing condition of the form flashings.

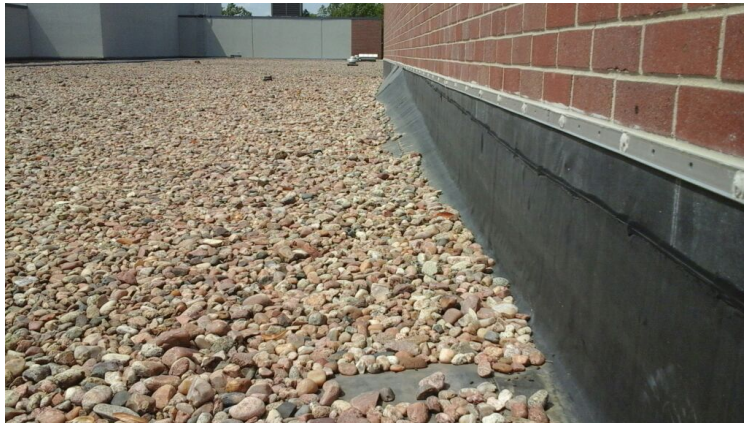
Photo showing tenting along the perimeter flashings.

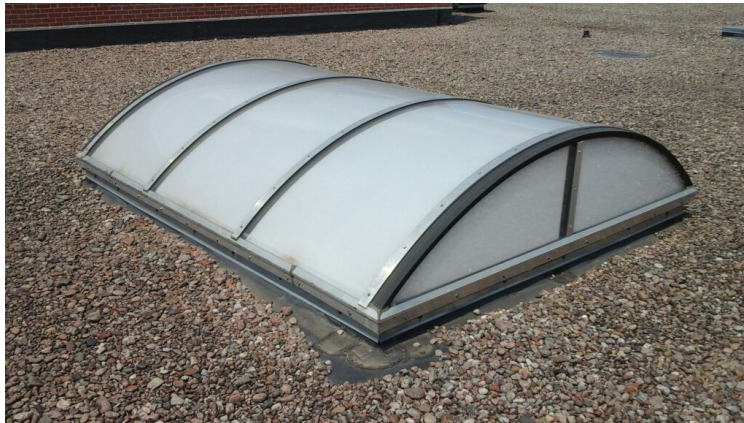
Photo showing condition of the skylight.

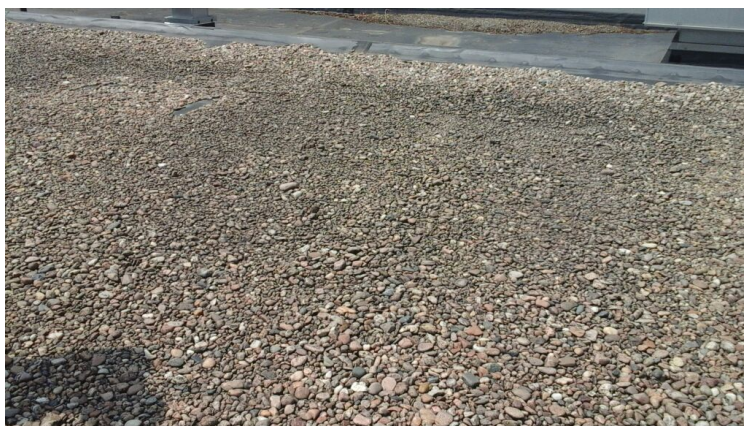
Photo showing evidence of ponding water.

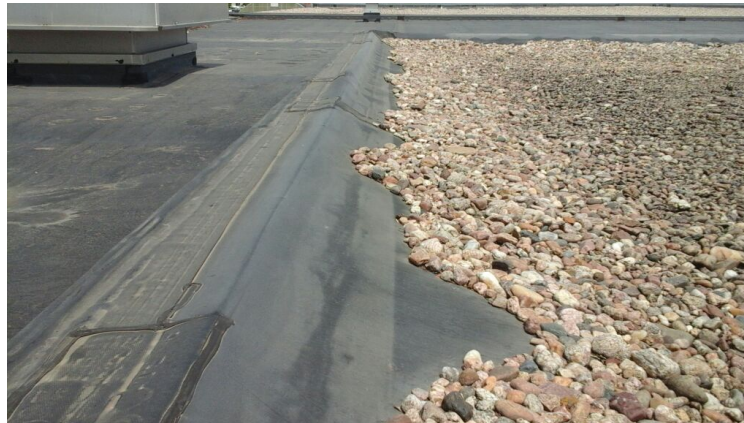
Photo showing condition of expansion joint.

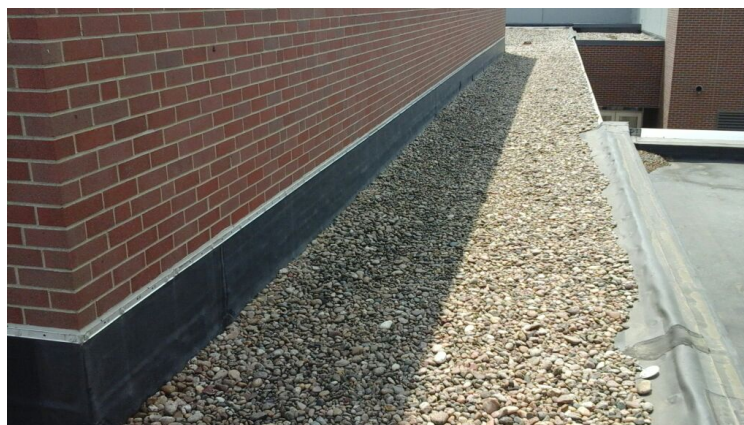
Photo showing additional overview of Area 10 Roof.

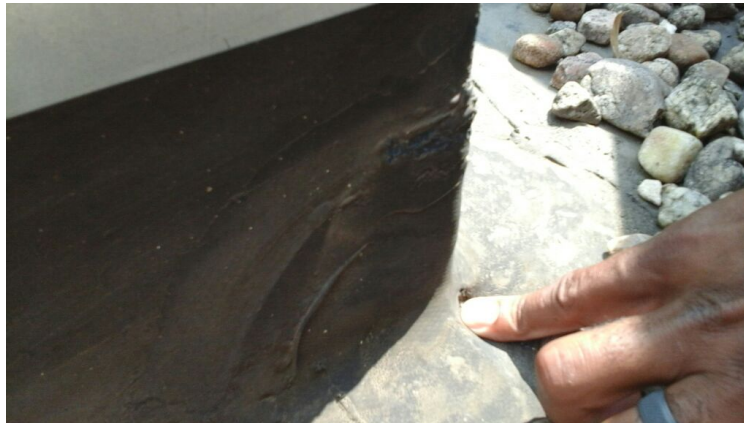
Photo showing another hole in a projection flashing.

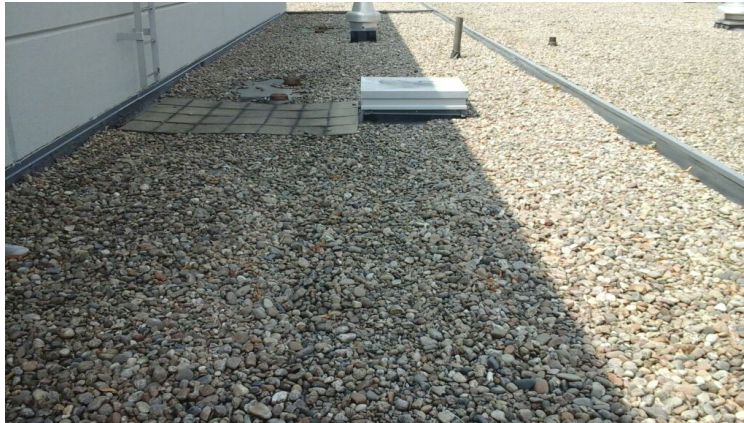
Photo showing overview of Area 11 Roof.

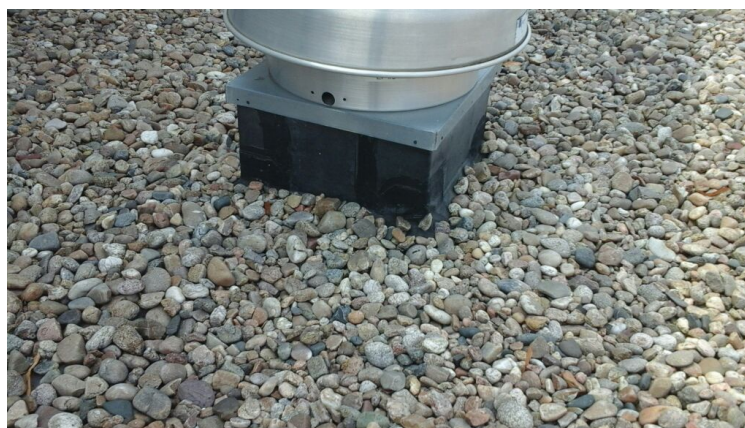
Photo showing condition of projection flashings.

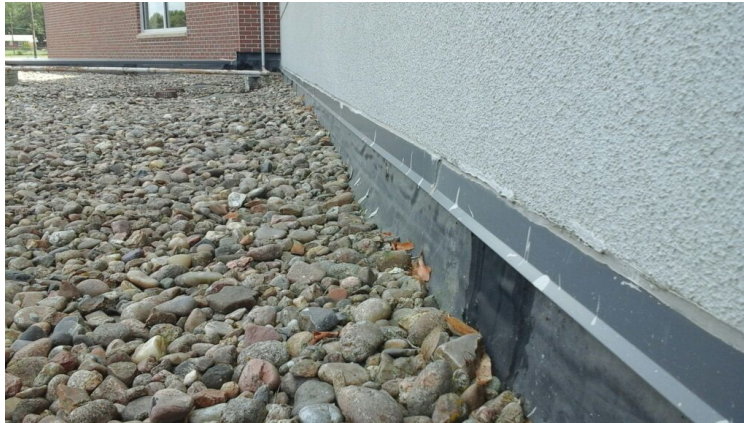
Photo showing condition of the perimeter flashings along the EIFS wall.

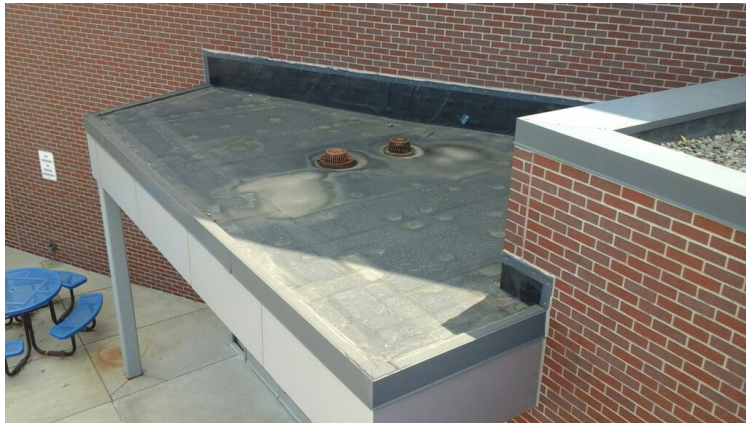
Photo showing overview of small Fully-adhered EPDM area adjacent to Area 11 Roof.

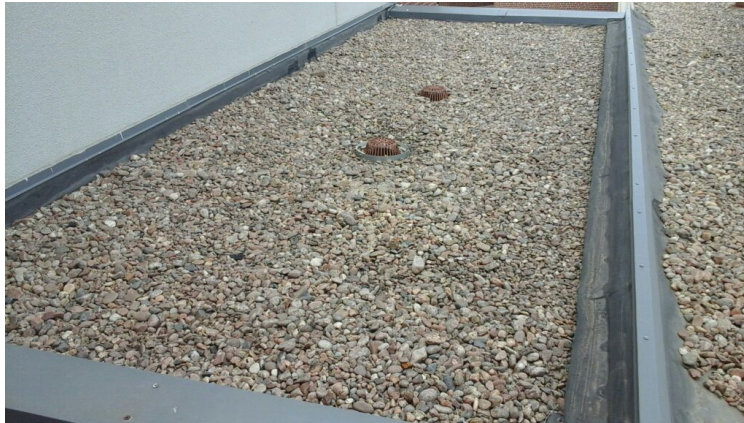
Photo showing overview of Area 12 Roof.

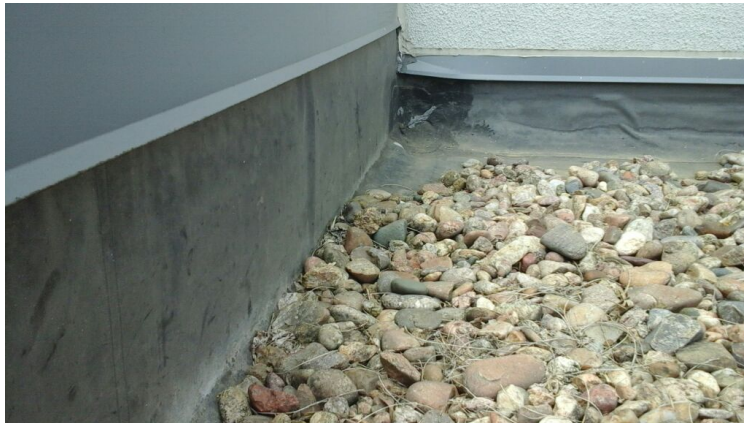
Photo showing condition of the perimeter flashings.

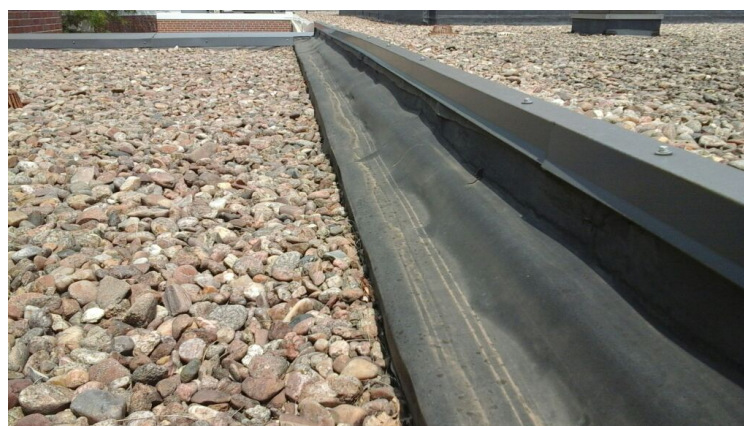
Photo showing condition of the expansion joint.

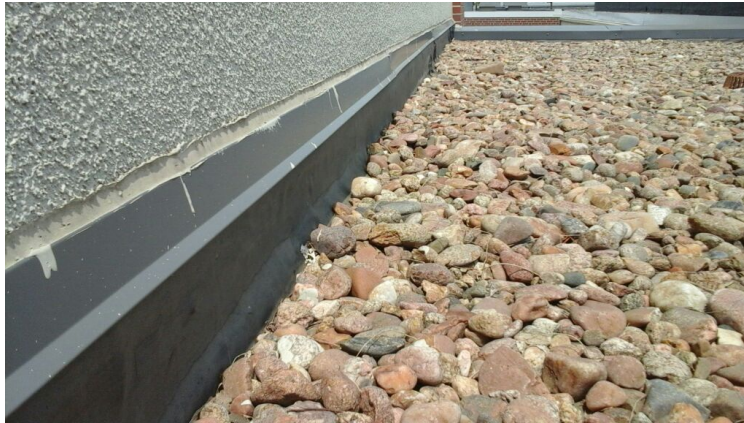
Photo showing condition of the perimeter flashings under the EIFS.

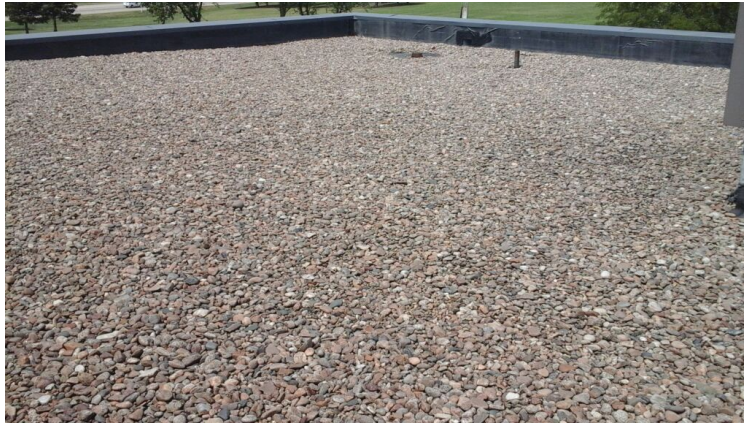
Photo showing overview of Area 13 Roof.

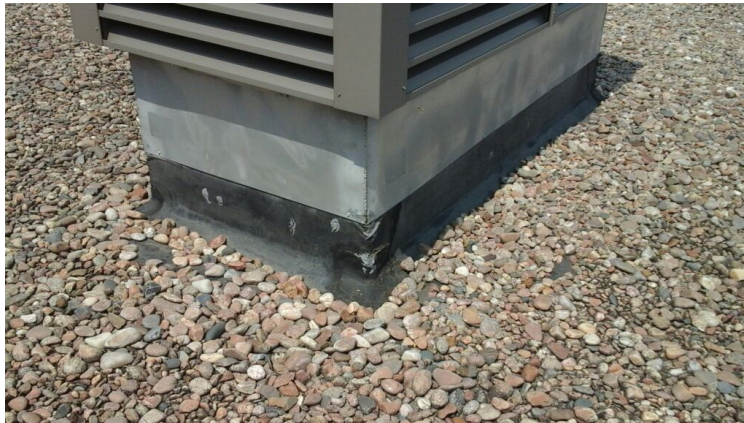
Photo showing condition of projection flashings.

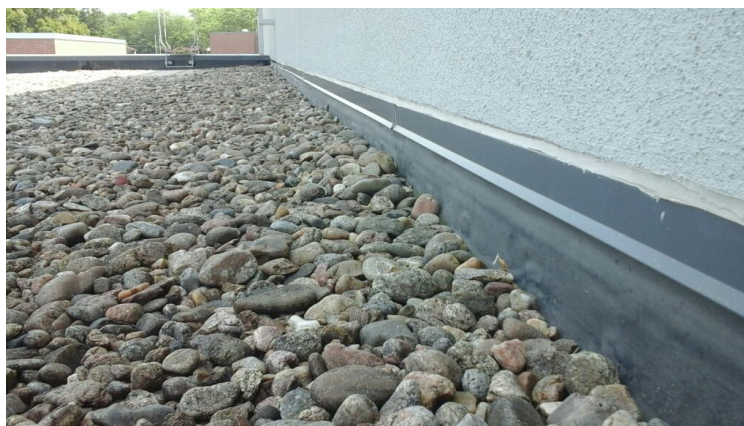
Photo showing condition of the perimeter flashings along the EIFS wall.

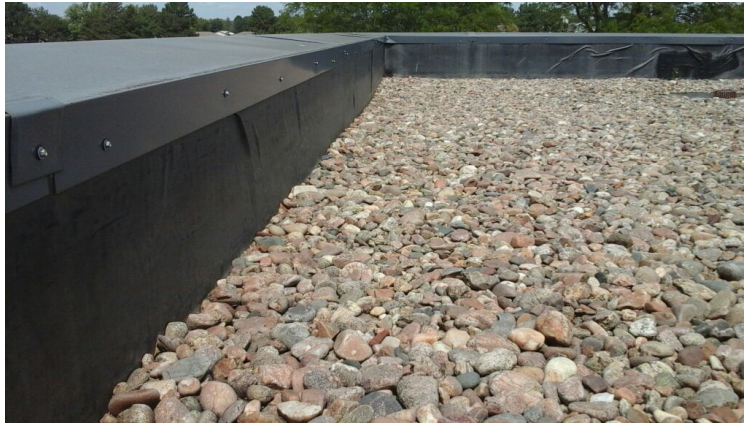
Photo showing condition of the perimeter flashings.

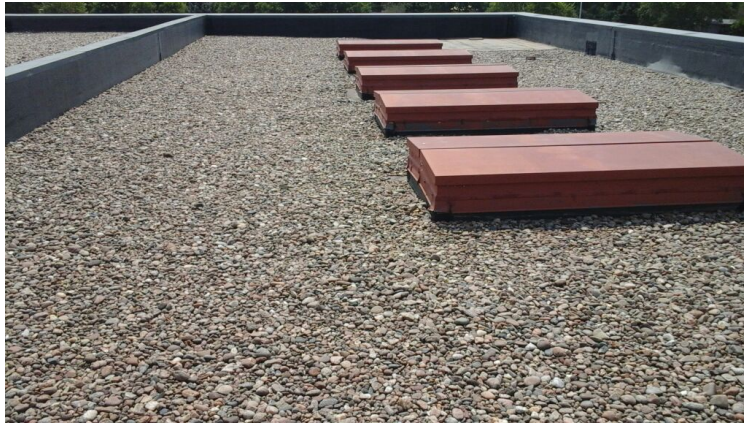
Photo showing overview of Area 14 Roof.

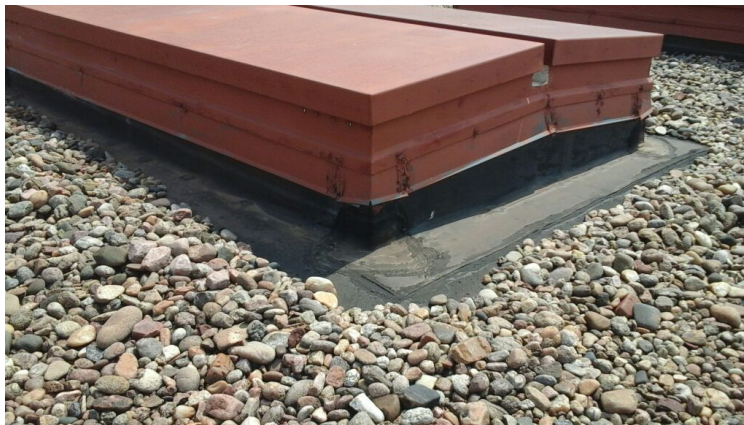
Photo showing condition of projection flashings.

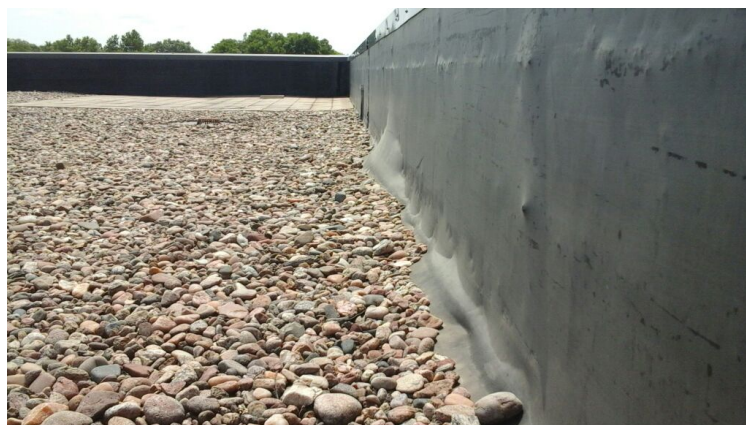
Photo showing minor tenting along the perimeter flashings.

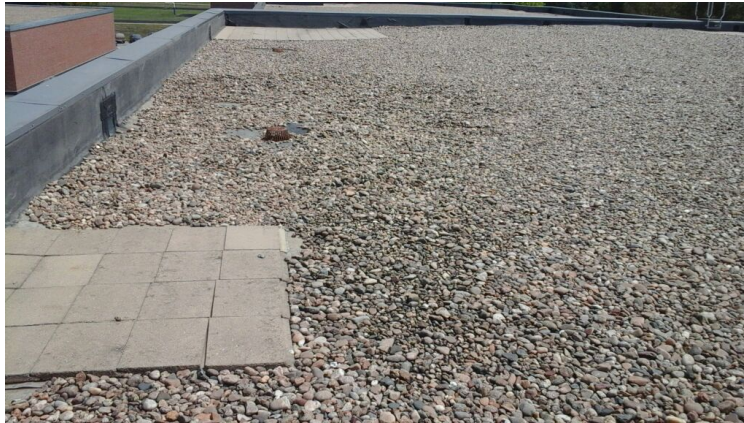
Photo showing overview of Area 15 Roof.

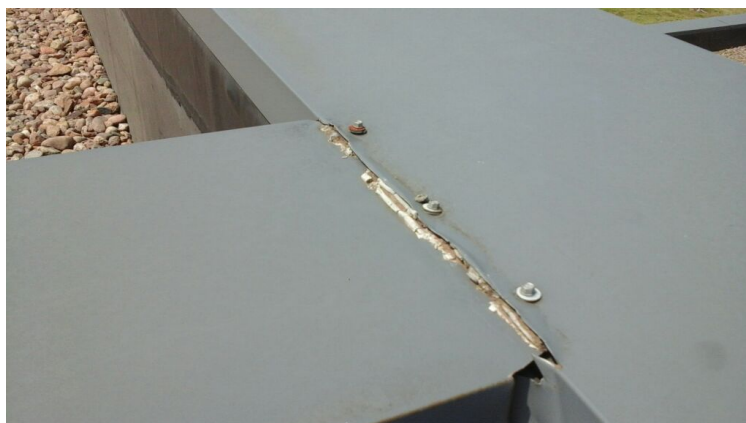
Photo showing caulking beginning to deteriorate on metal.

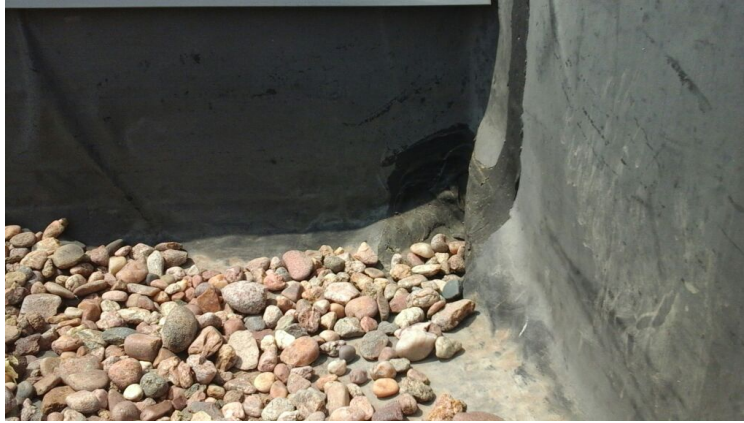
Photo showing tenting occurring in the corner of the perimeter flashings.

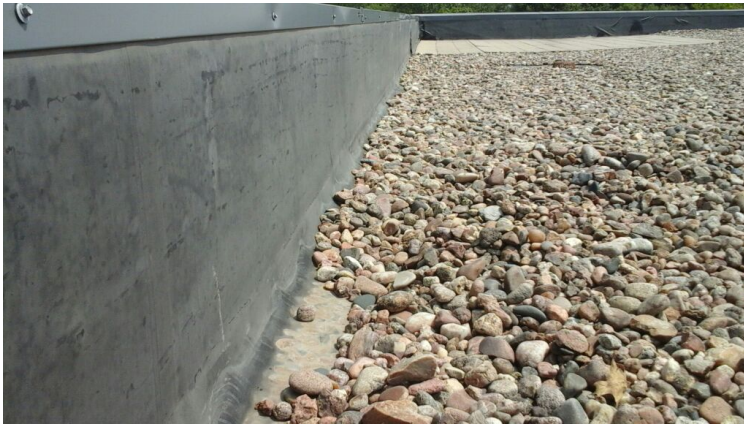
Photo showing condition of the perimeter flashings.

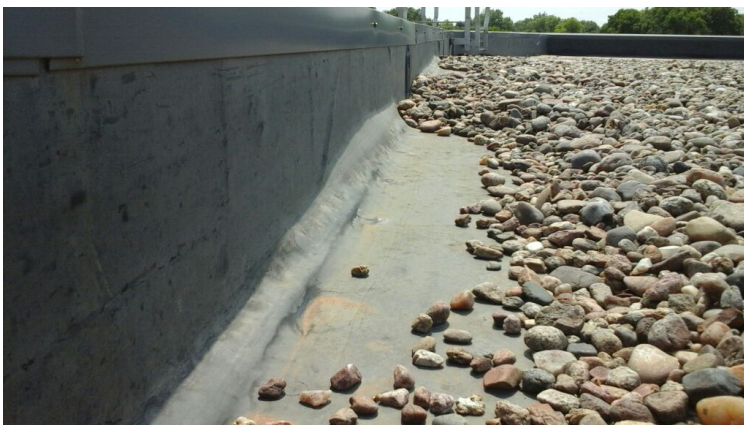
Photo showing minor tenting along the perimeter flashings.

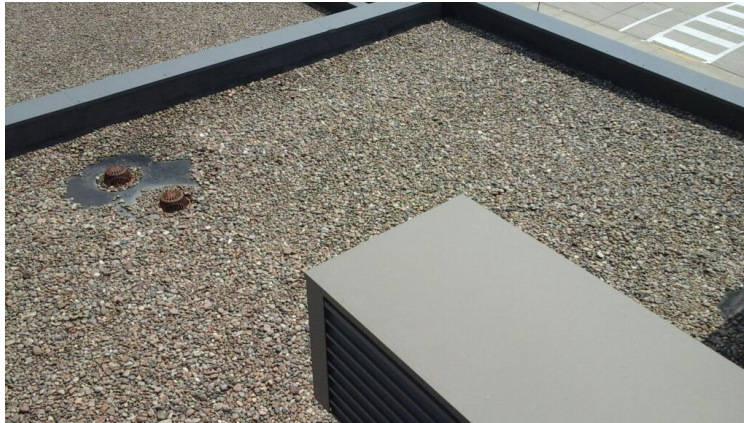
Photo showing overview of Area 16 Roof.

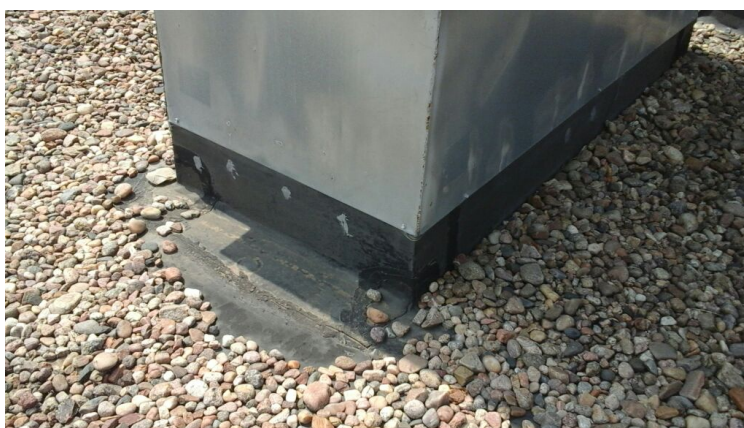
Photo showing condition of projection flashings.

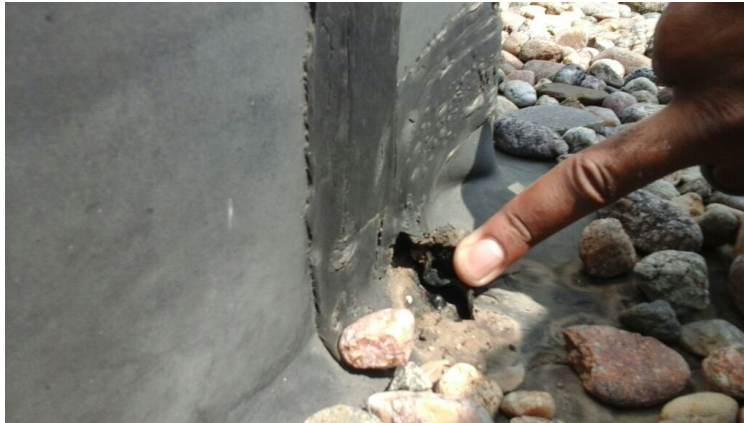
Photo showing projection flashings beginning to pull loose.

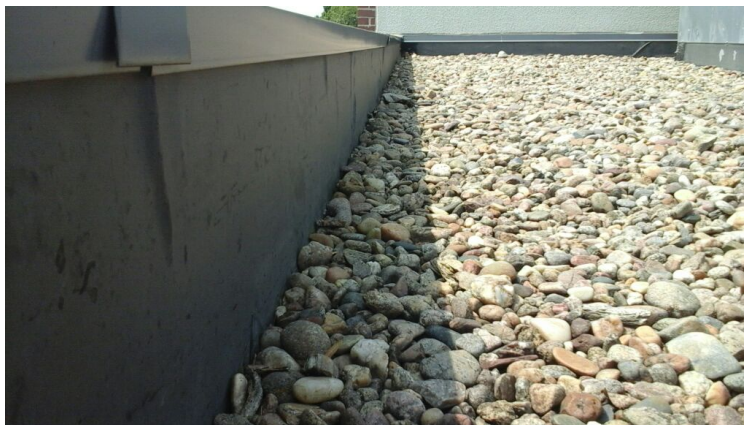
Photo showing condition of the perimeter flashings.

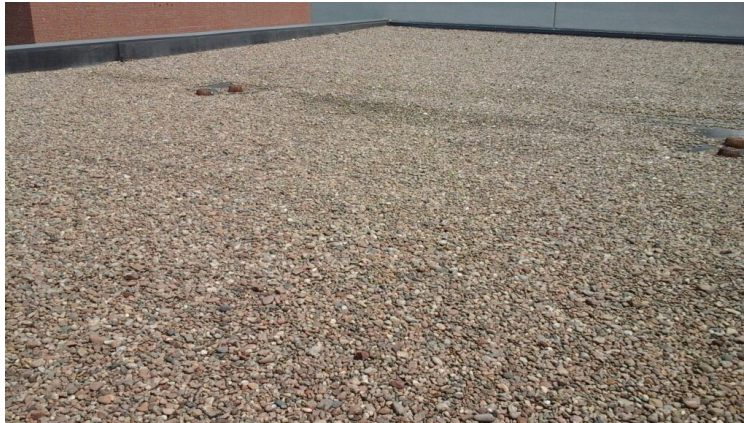
Photo showing overview of Area 17 Roof.

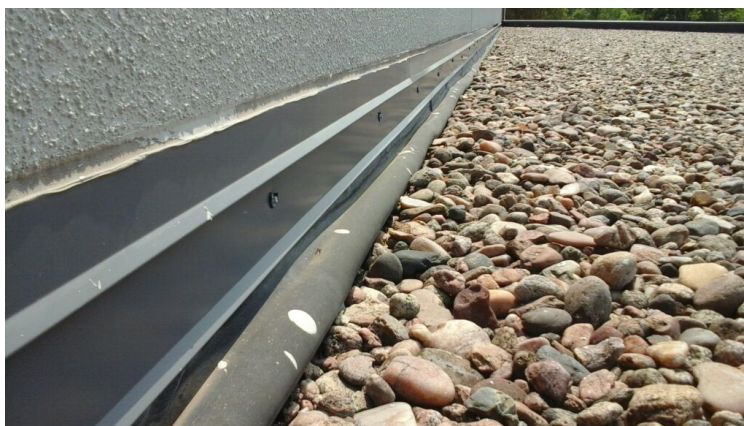
Photo showing condition of the perimeter flashings along the EIFS wall.

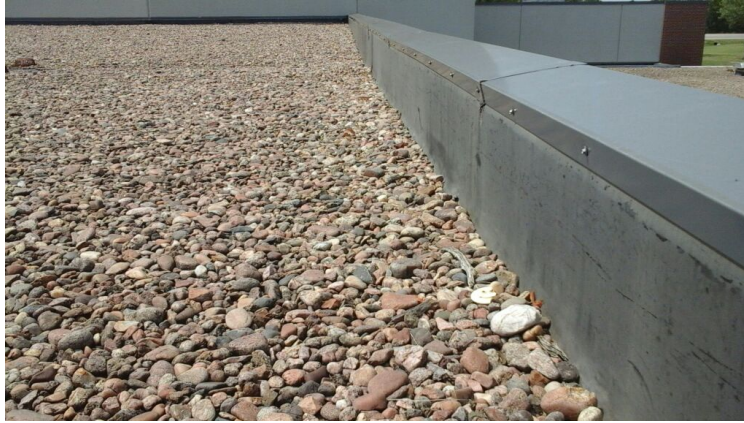
Photo showing condition of the perimeter flashings.

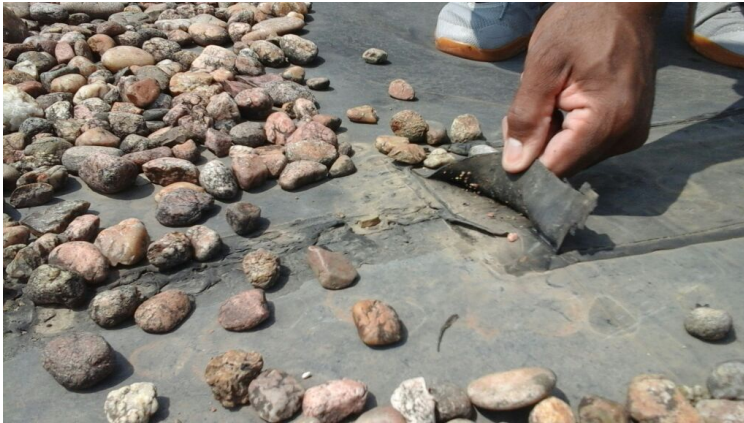
Photo showing patch pulling up along the seam.

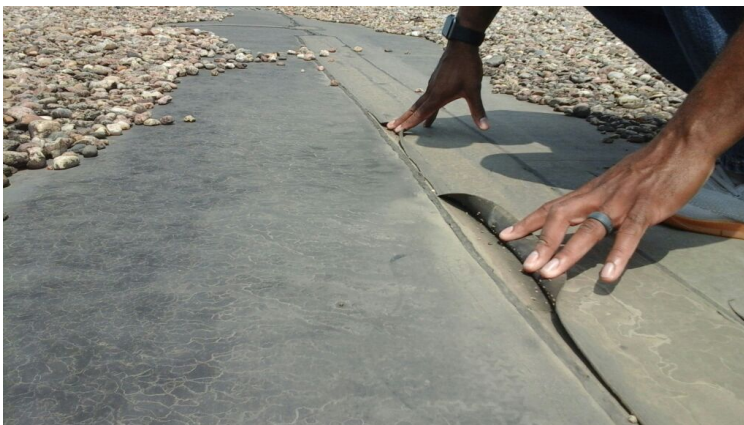
Photo showing patch along seam beginning to pull loose.

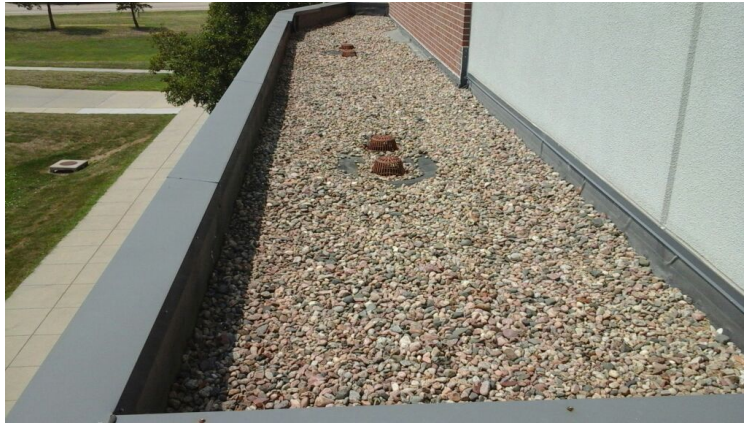
Photo showing overview of Area 18 Roof.

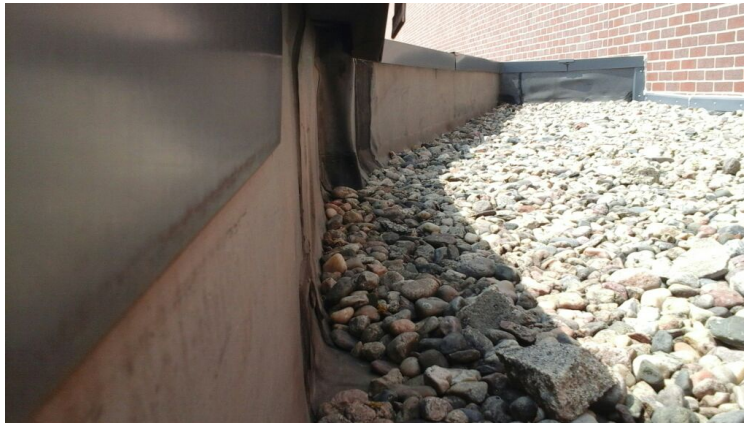
Photo showing condition of the perimeter flashings.

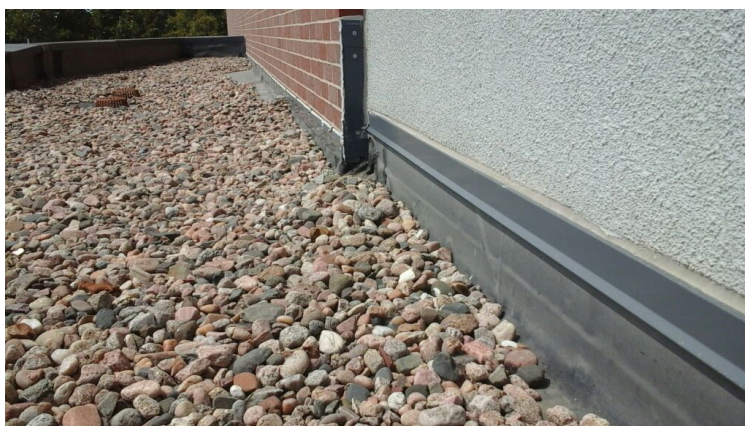
Photo showing condition of the perimeter flashings along the EIFS wall.

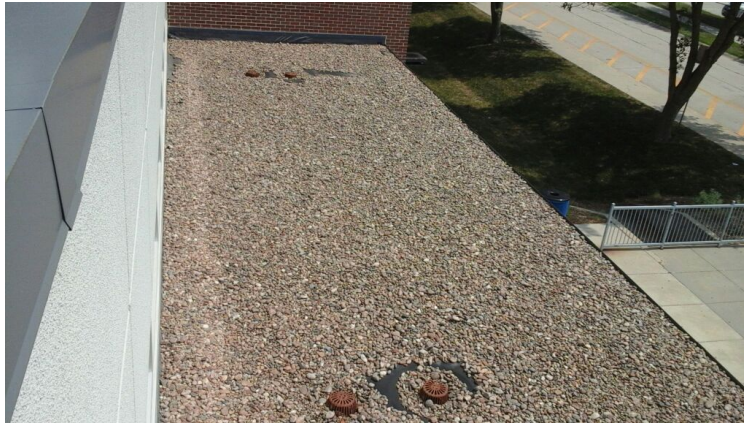
Photo showing overview of Area 19 Roof.

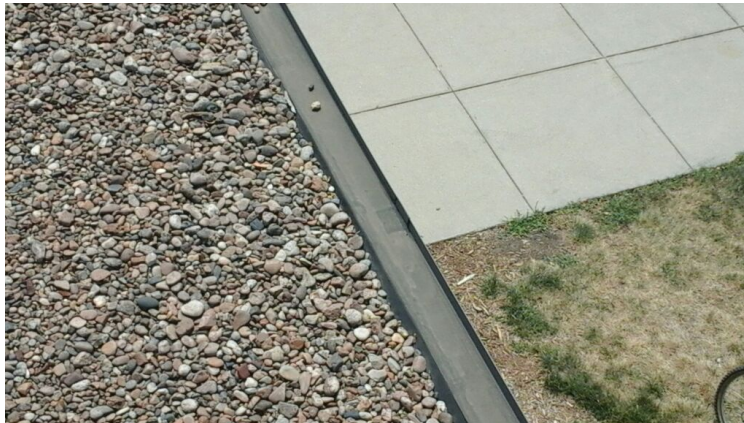
Photo showing condition of the form flashings.

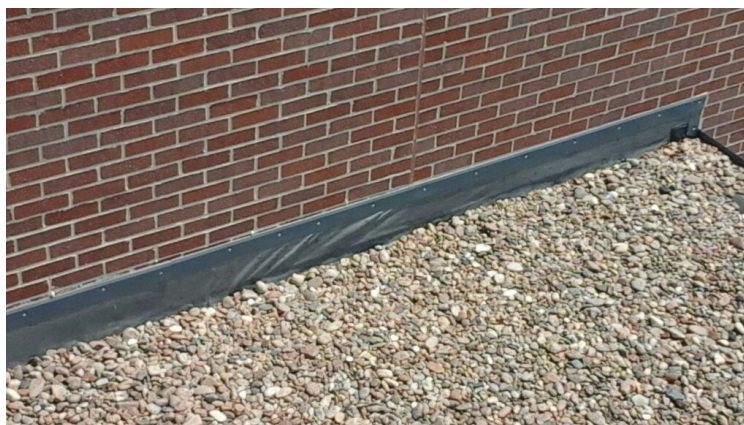
Photo showing condition of the perimeter flashings.

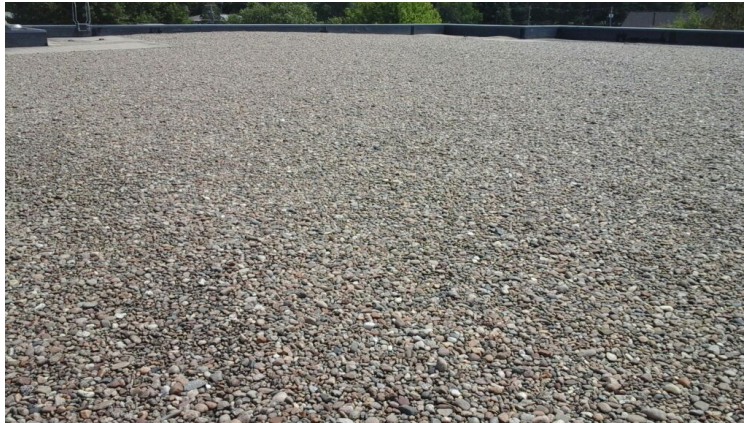
Photo showing overview of Area 20 Roof.

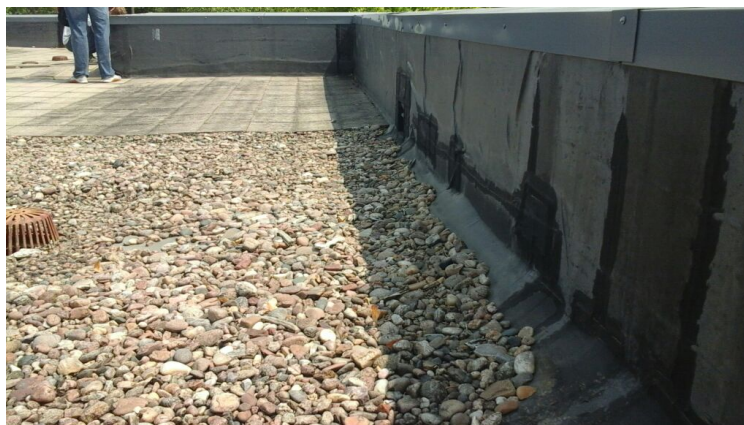
Photo showing condition of the perimeter flashings.

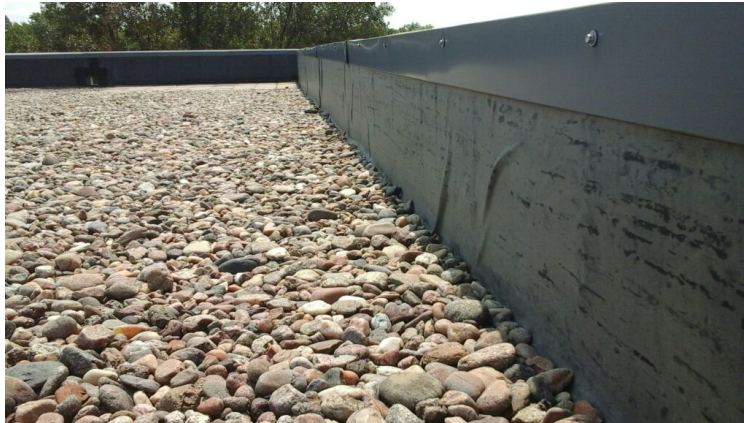
Photo showing condition of the perimeter flashings.

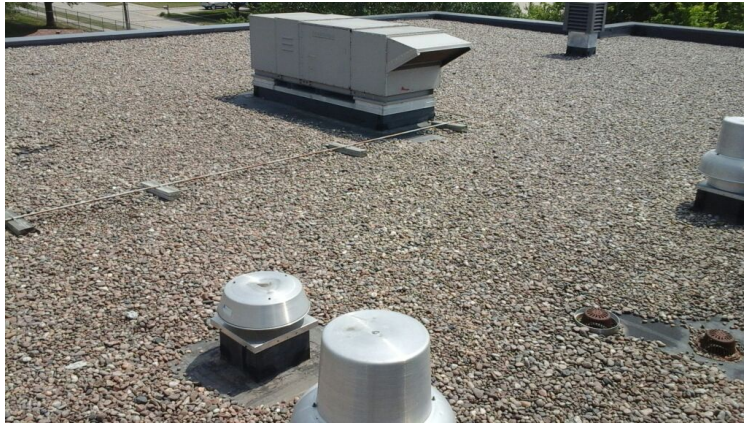
Photo showing overview of Area 21 Roof.

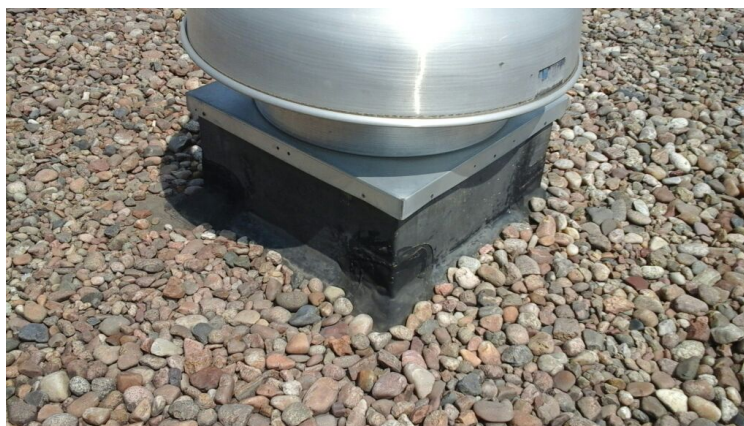
Photo showing condition of projection flashings.

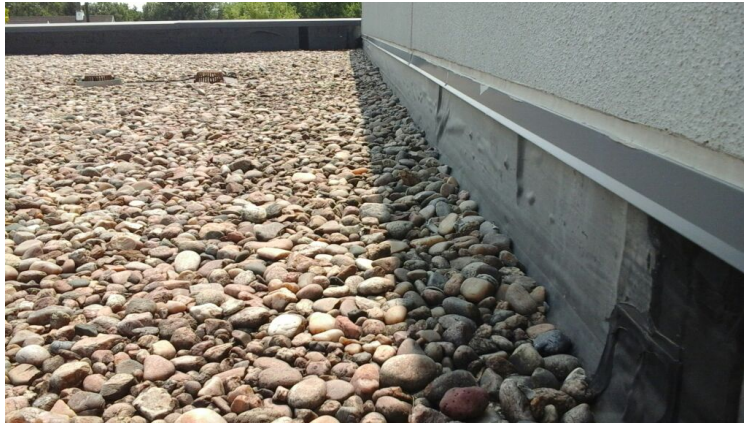
Photo showing condition of the perimeter flashings along the EIFS wall.

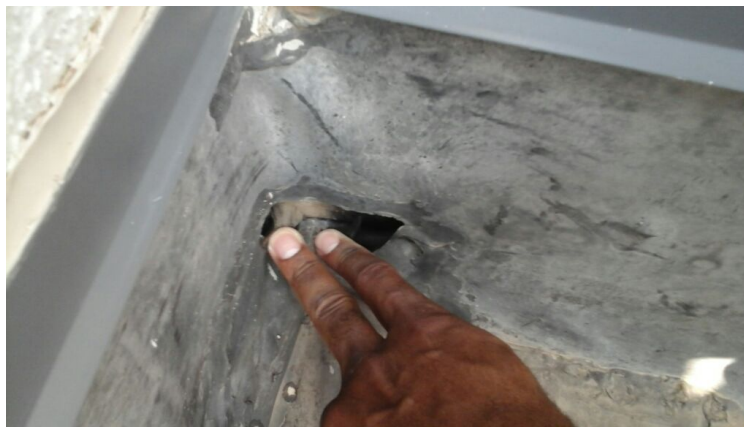
Photo showing patch in the perimeter flashing pulling loose.

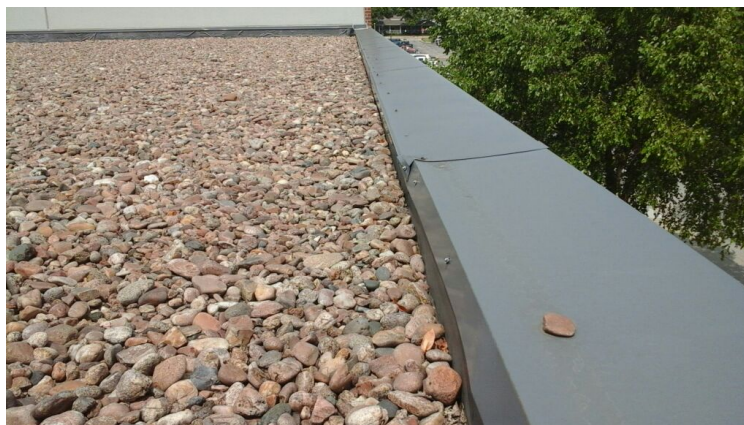
Photo showing mismatched metal sizes.

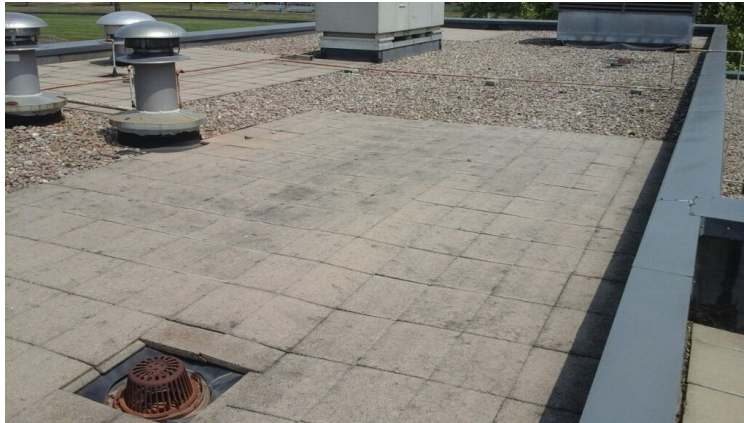
Photo showing overview of Area 22 roof.

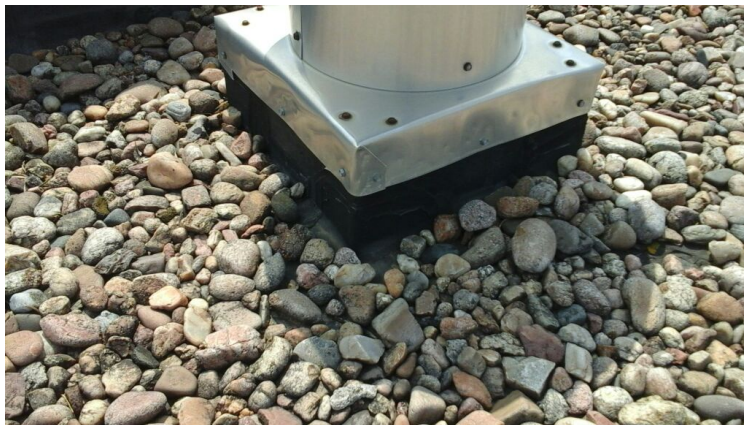
Photo showing condition of projection flashings.

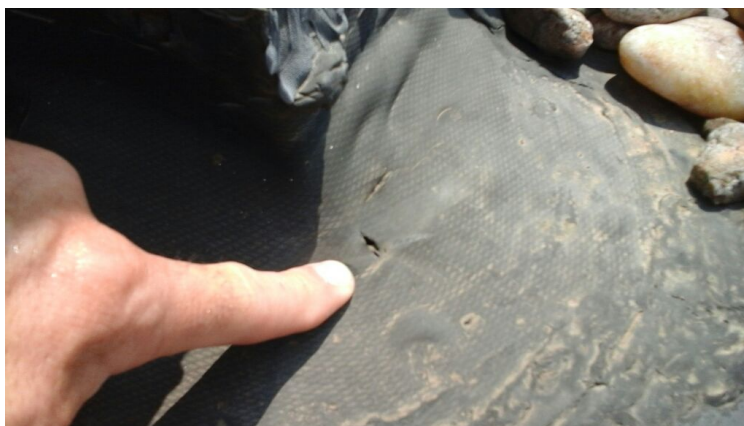
Photo showing a hole in the projection flashing.

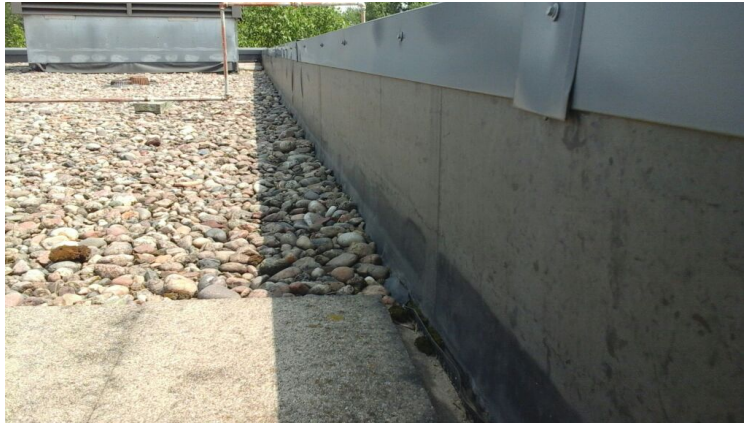
Photo showing condition of the perimeter flashings.

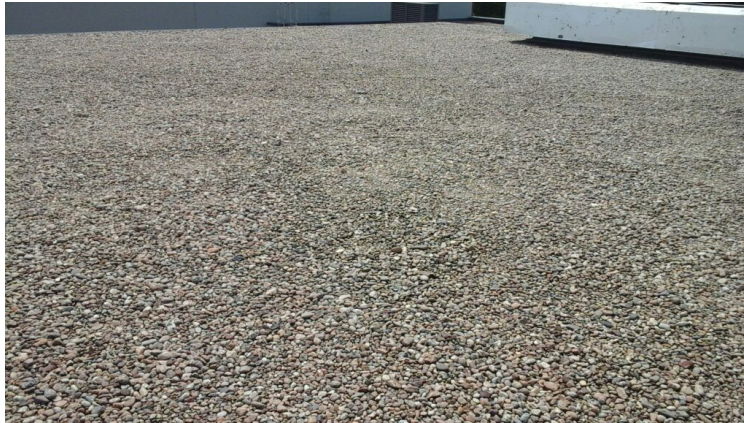
Photo showing overview of Area 23 Roof.

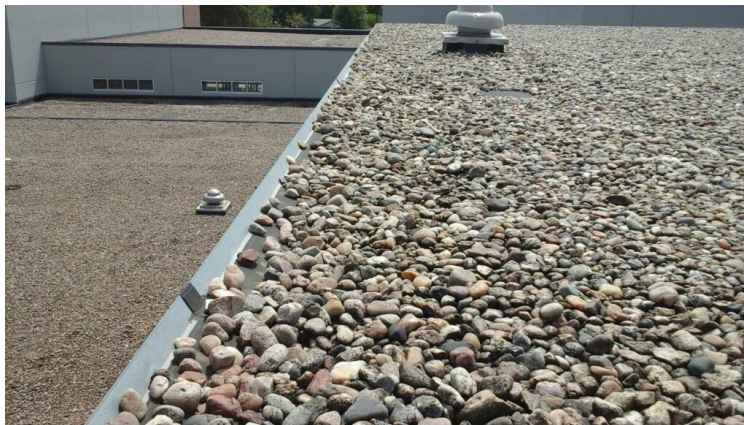
Photo showing condition of the form flashings.

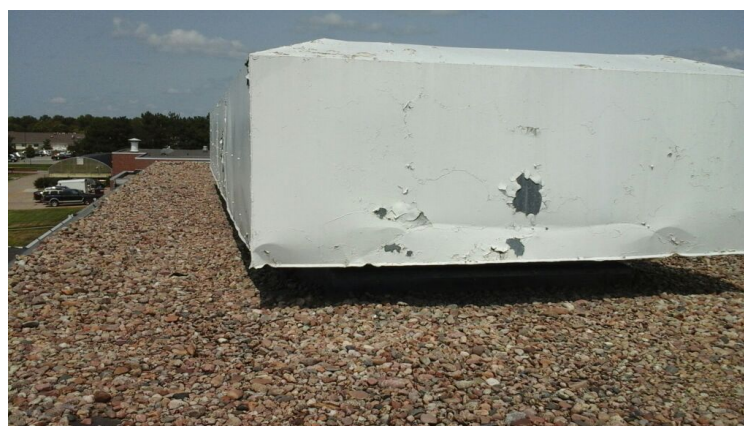
Photo showing condition of projection.

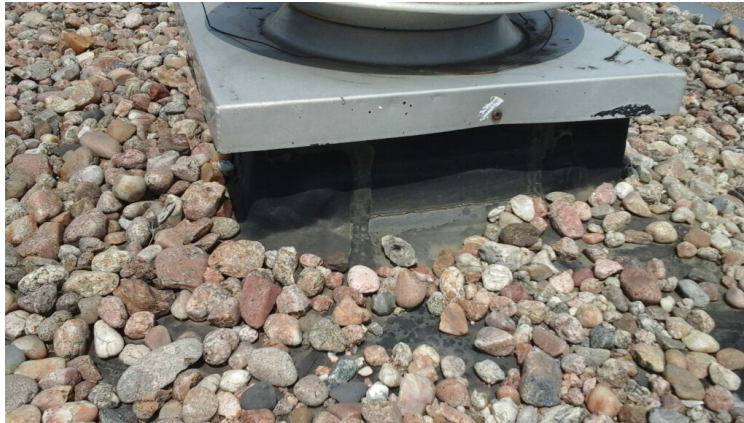
Photo showing condition of projection flashings.
