Board of Education Study Session

School District of Seward

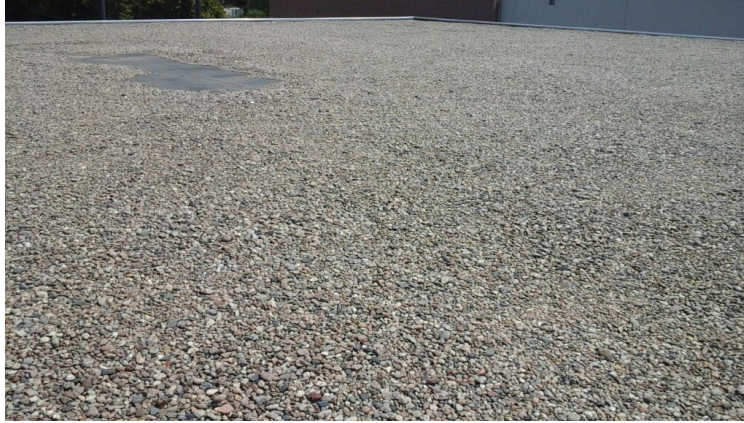
Photo showing overview of Area 24 roof.

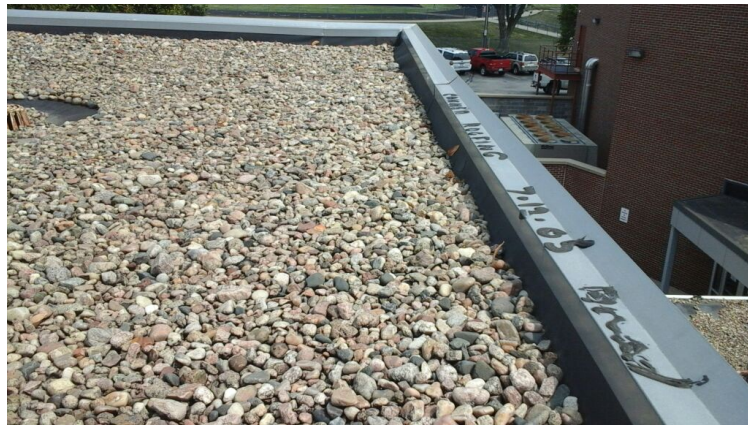
Photo showing condition of perimeter flashings.
