# OAC Meeting Summary

March 5, 2026

The meeting provided a six-week construction update for the Ravenna Public School OAC project, covering construction progress, schedule revisions, budget items, and signage procurement. The construction team reported steel joists and decking are on site, steel erection is scheduled to start next week, and a roof penetration is planned later in the week pending weather. The school calendar for Ravenna Public Schools may shift 3.5 days earlier if no snow days occur, with the board set to finalize start and end dates for the 26-27 school calendar at its next meeting.

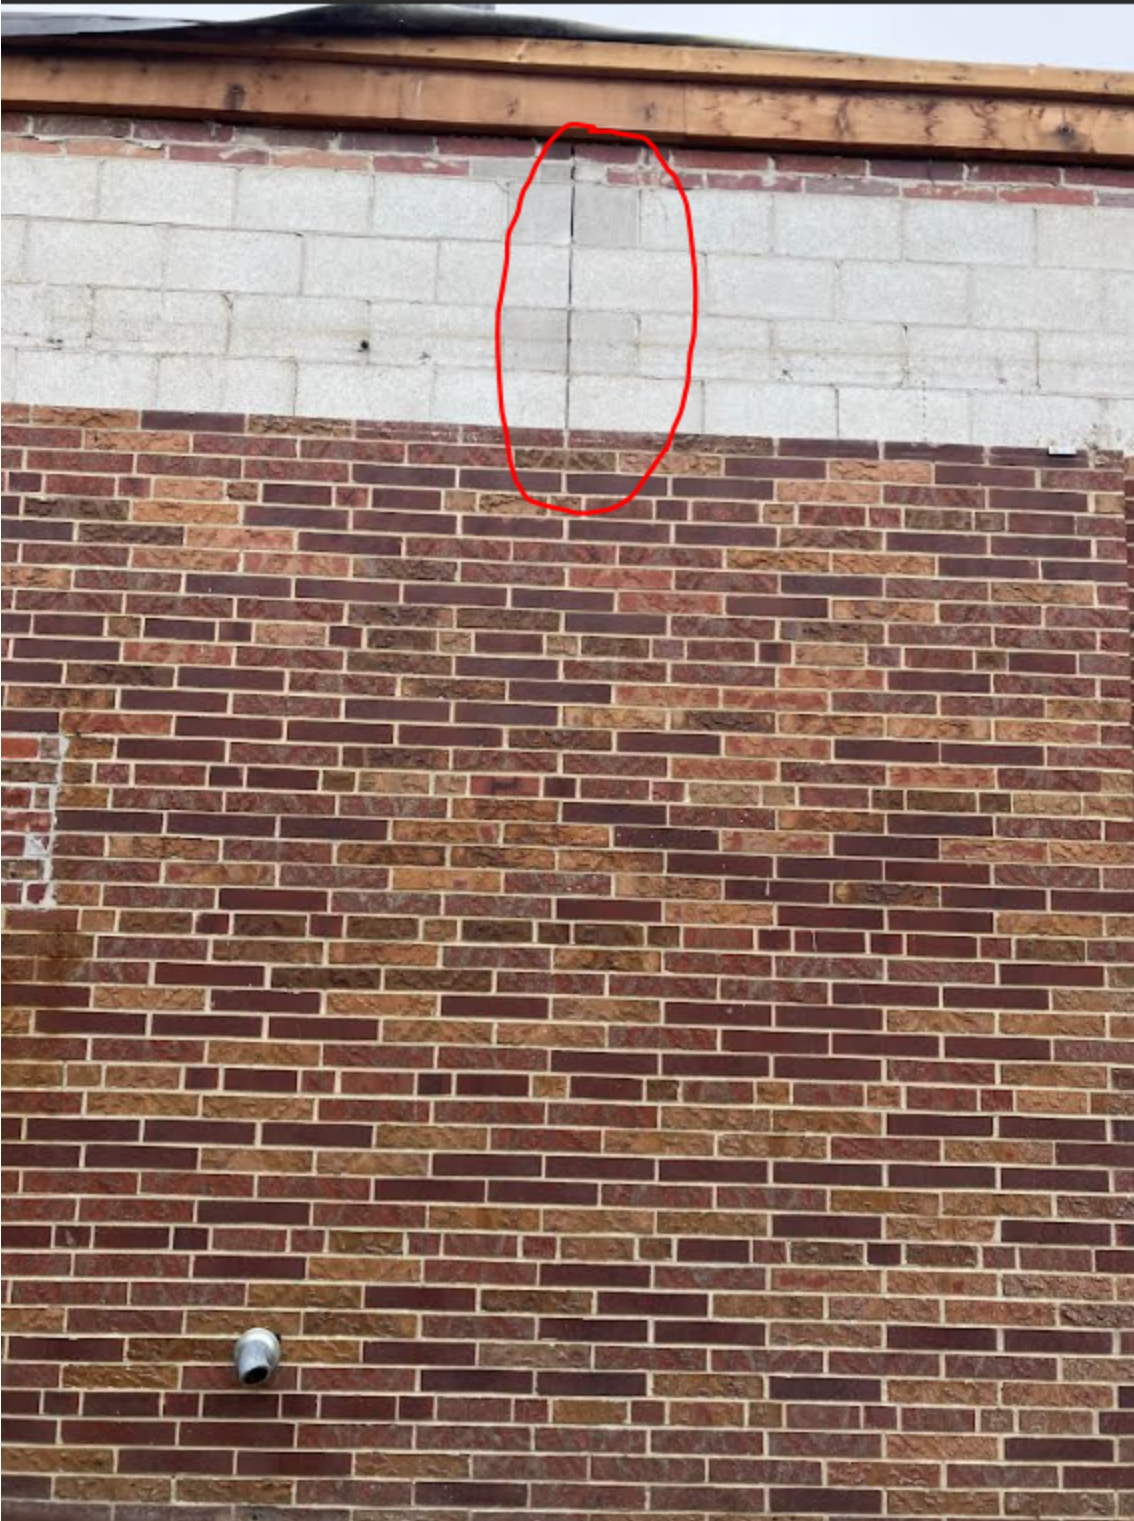
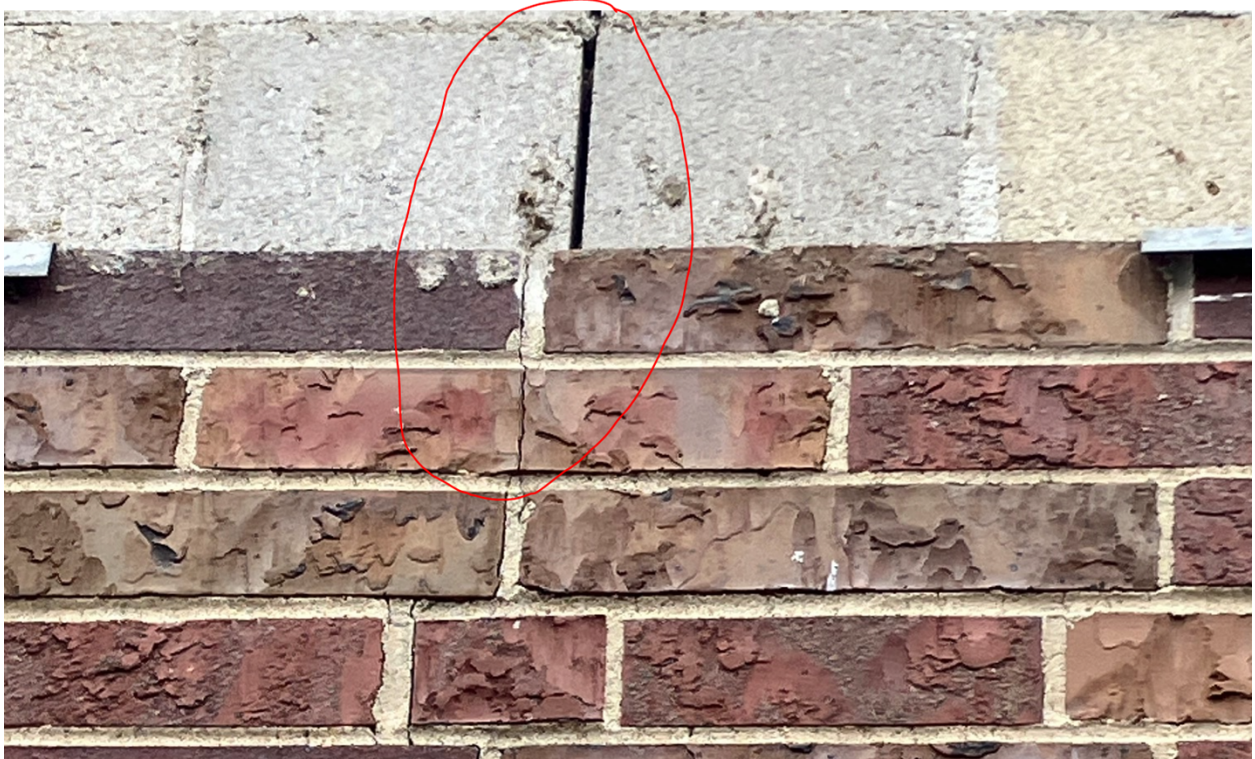
- There are 10 control joints that could be installed on the exterior of the building, to prevent future cracking. There was some cracking along on the control joints, which the board was made aware of at the February Board Meeting. Installing the additional control joints obviously carries an additional cost, but would be preventative maintenance. The other control joints haven’t developed cracks after 60 years. You basically have 1 out of 11 control joints that developed the crack. Below, you can see how at one of the control joints the face brick cracked. There was a lot of heavy machinery in this area and they were using a soil compaction machine, which vibrates the earth. The other joints seem to be doing fine, with no signs of cracks developing. The one joint that did crack will be replaced with a control joint (sawed open and filled with butyl material to create an expansion joint).

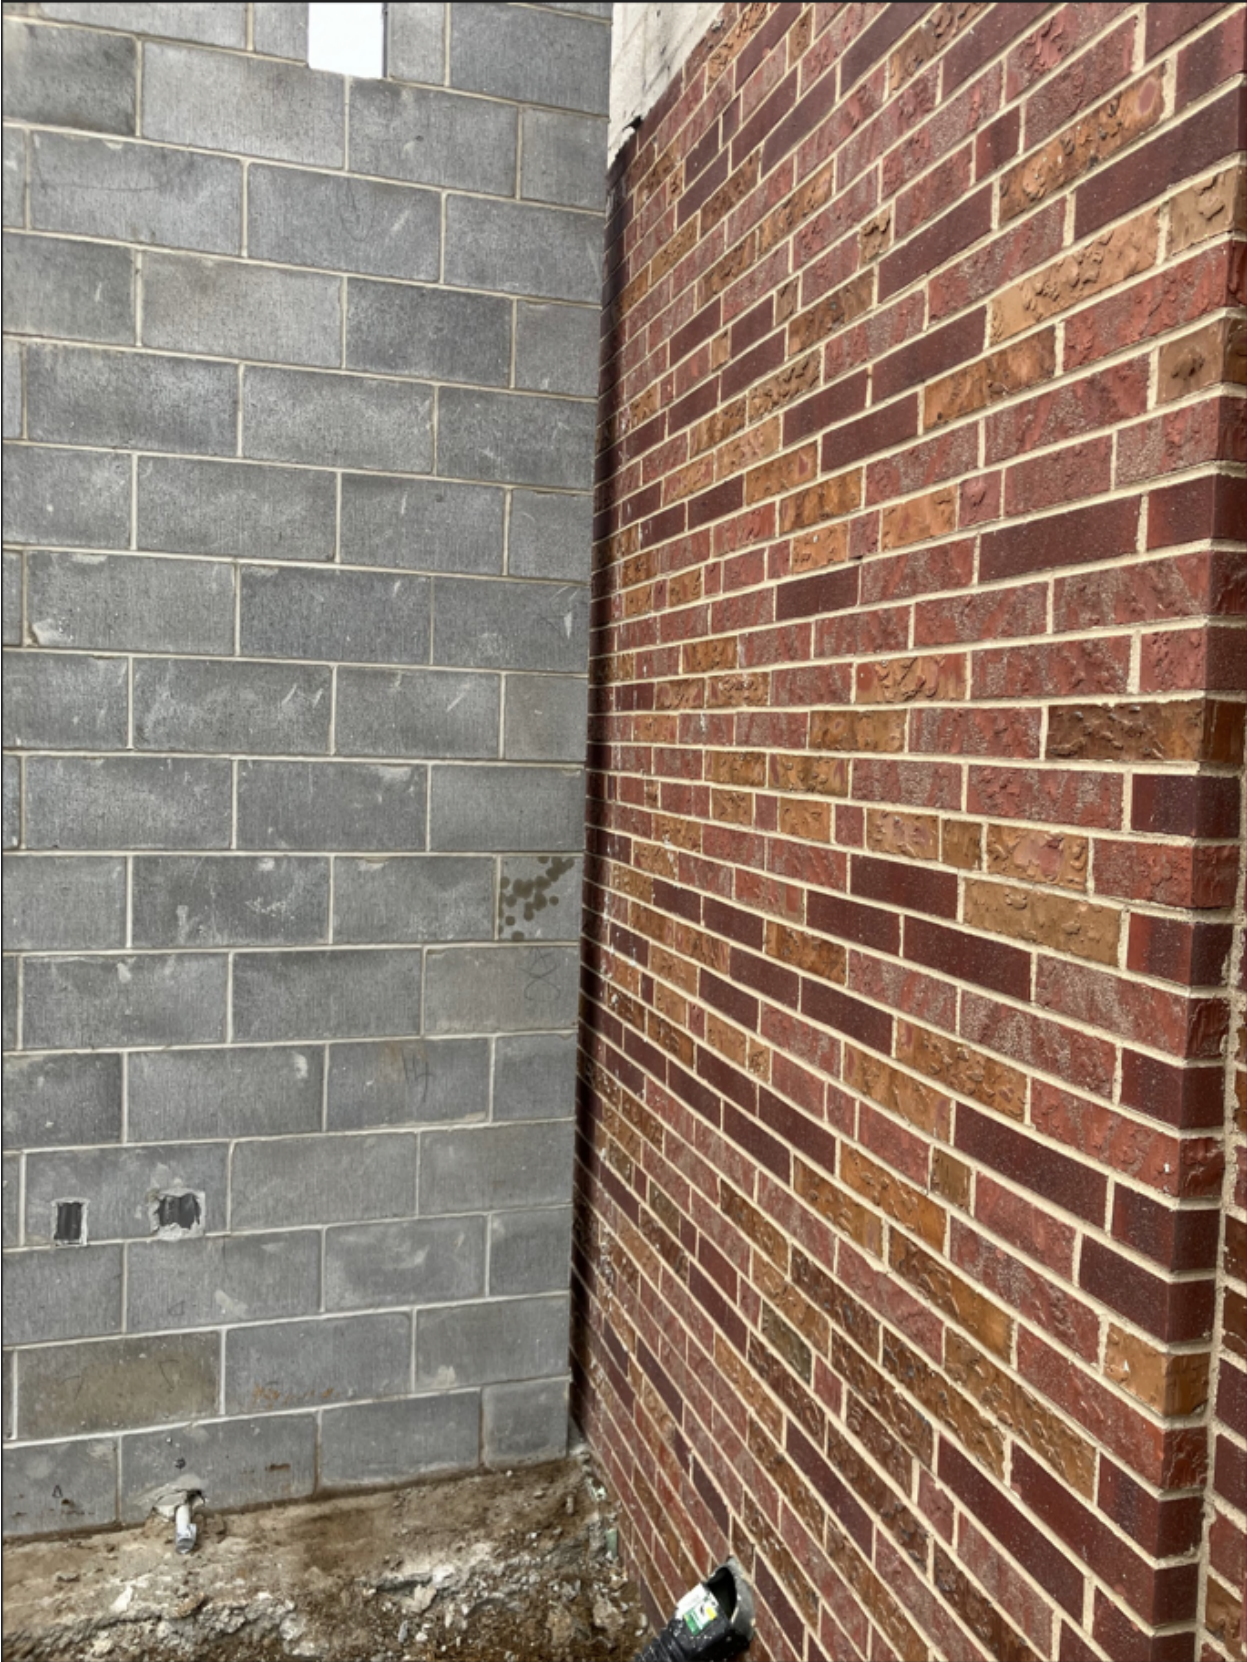
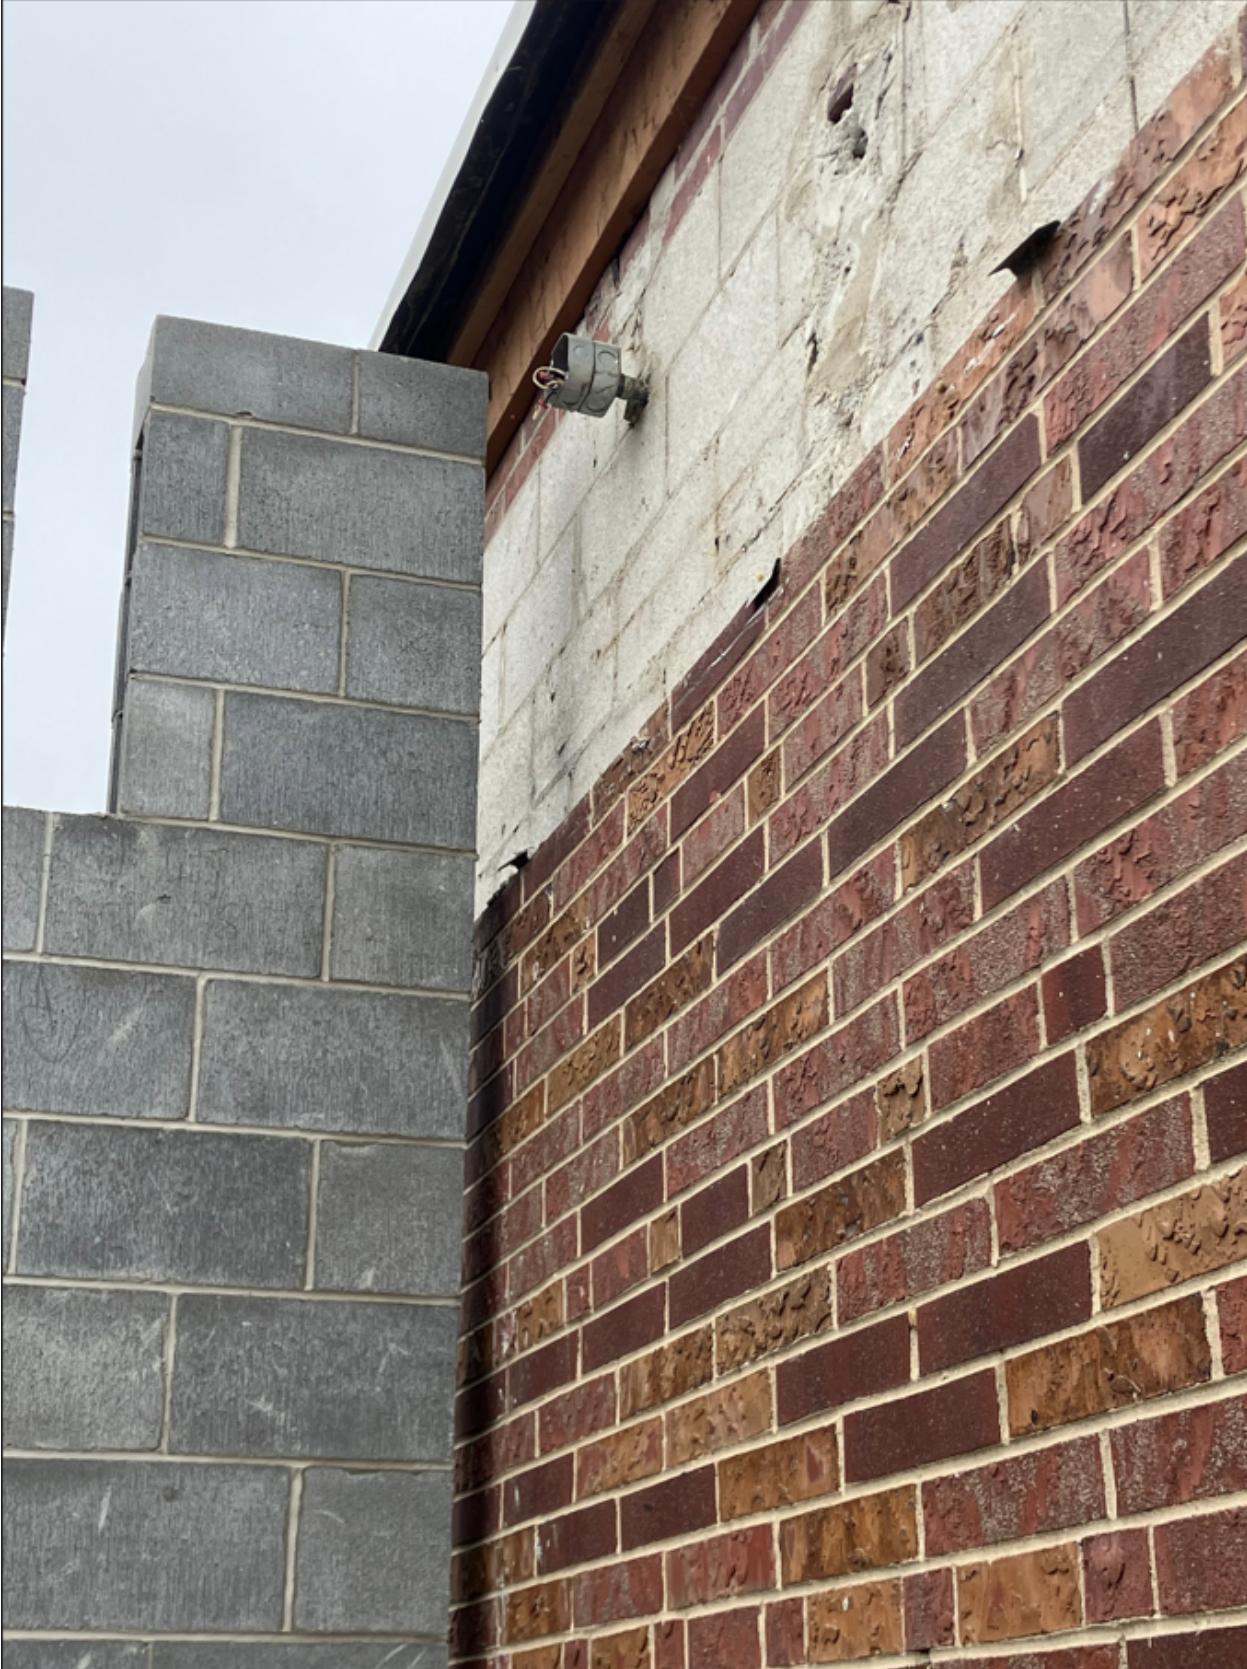
- There was additional work and cost discovered during the removal of the parapet wall and framing at the top of the building. The brick did not come all of the way out to meet the other face brick behind the parapet wall. This created a substantial gap and would have created an interesting wall contour in weight room, art room, and north hallway corridor. It would have looked pretty goofy to fill the area in with drywall, brick, or any other material. It also would have caused problems with entry ways and spots where the new part of the building was tying into the old part of the building, so for \$27,340. The area will be filled with face brick to match the other face brick and create an even and uniform surface.
