WAUSA PUBLIC SCHOOLS MASTER STRATEGIC PLAN

The investigation centered on the original 1913 brick structure but also includes some comments on the adjacent structures built afterwards. The report includes descriptions of the structure, observations, survey information, various conclusions related to the continued use of the building and some recommendations with rough cost estimates of some proposed alternative actions.

Wausa Public Schools Structural Facility Assessment September 8, 2017

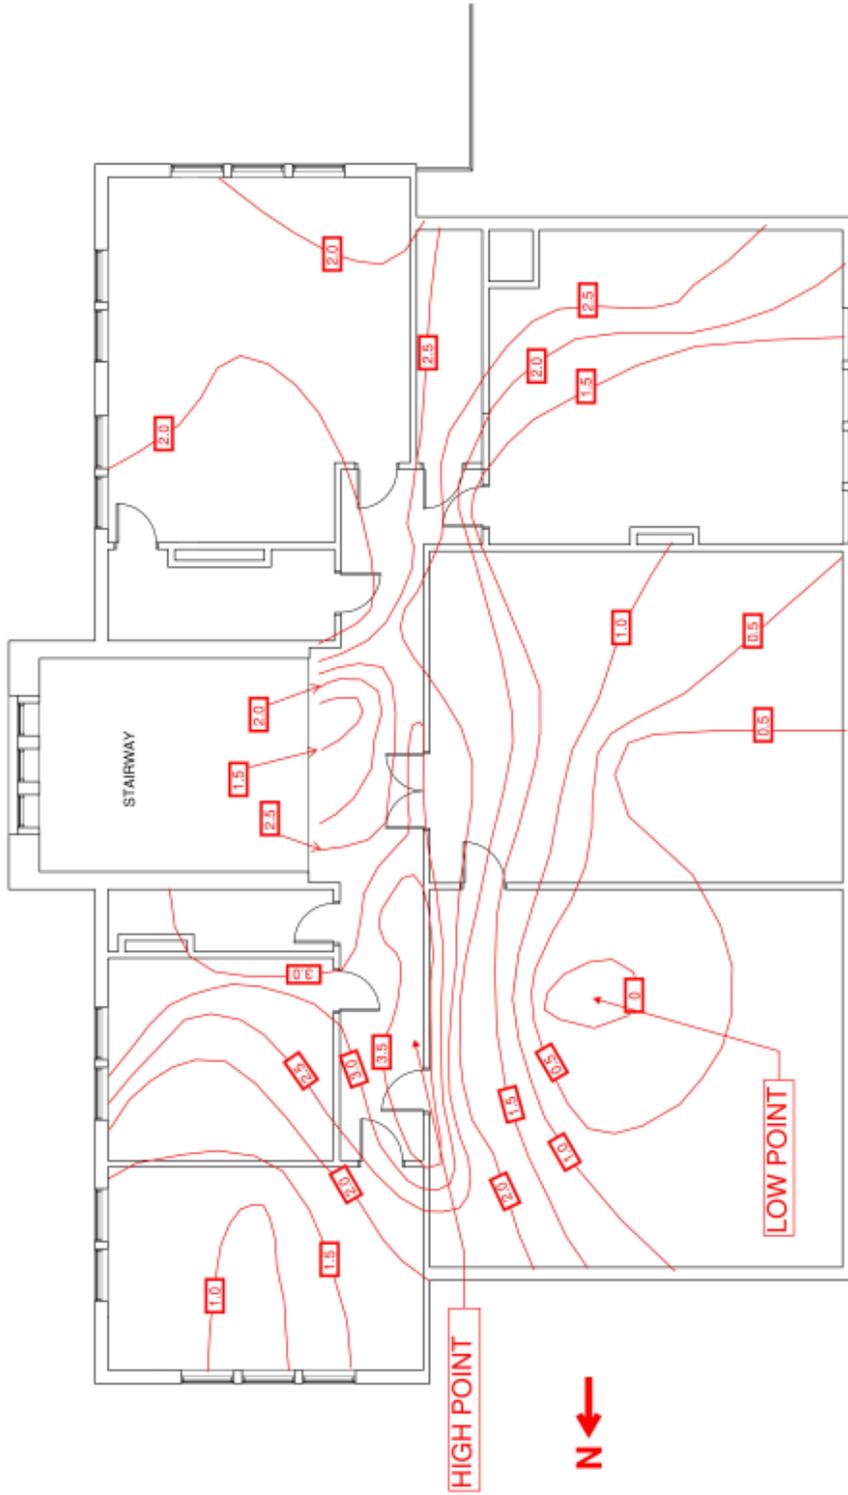
WAUSA PUBLIC SCHOOLS
 FLOOR SURVEY OF THIRD FLOOR
 1913 SCHOOL BUILDING

- ii. Also observed were low areas (- 1 1/2”) in the four corners of the central core area.
 - iii. In the rear central break room area there was a ridge-line hump running east-west down the center of the room with low areas in the four room corners as well. This center hump appeared to align with a major steel floor beam below it (see item 4.b. below)

- i. Variations in floors can be attributed to both long term creep in the wood while under load and possibly some overall foundation settlements.
 - ii. A structural wood member subjected to an applied load will immediately deflect. This is known as instantaneous deflection. After the initial deflection has occurred, additional deflection will occur in the floor joist under long-term loading. This additional deflection is known as "creep". Initially, creep deflection occurs at a high rate and then decreases over time. The total amount of creep deflection is dependent on the environment and loading conditions.

- iv. Foundation settlements are suggested by some of the floor elevations found in our survey. No significant wall cracks or other evidences were seen otherwise.

The deflections are from wood creep over time and possibly some foundation settlements. On-going creep can still occur with further deflections in the future. Options to consider for this:

1. Do nothing
 - a. Floor irregularities are a nuisance but not currently to an extent that would prohibit use of the space.
 - b. No cost associated with this.
2. Provide local repairs to floor areas with significant irregularities – low areas only

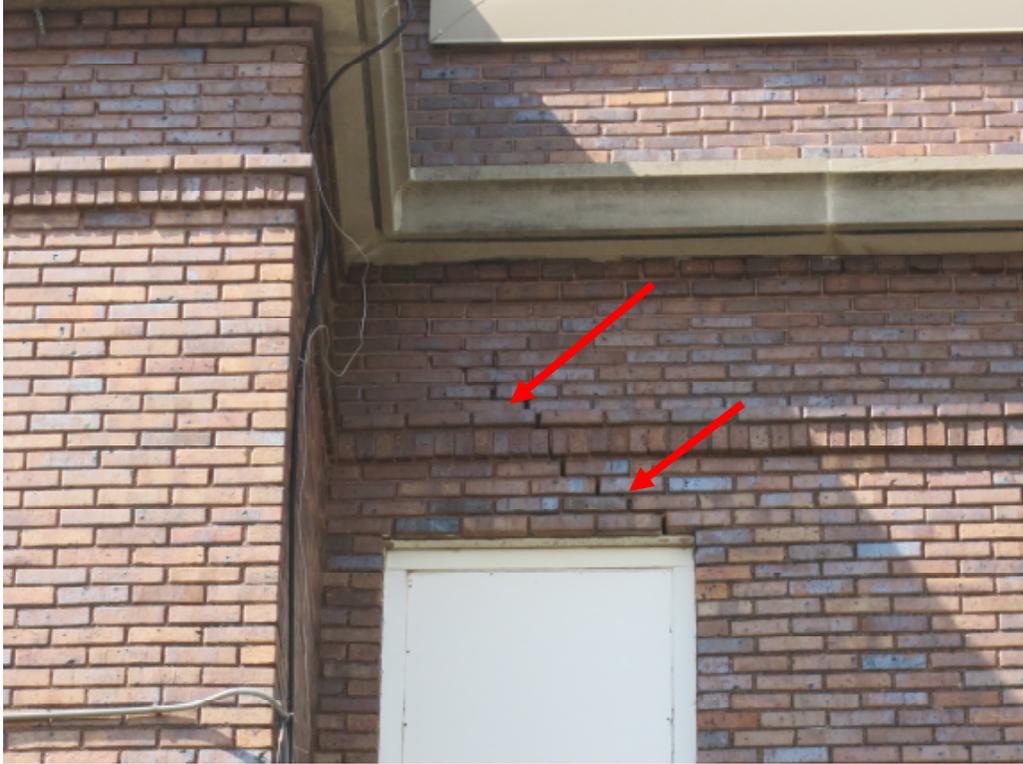
- g. Some cracking in individual bricks and some stone pieces was observed but with no evidence of moisture infiltration or freeze-thaw damage.
 - h. Some diagonal cracking observed on the west and east façades.

- iii. Might consider epoxy injection in cracked brick units but may not be required.
 - iv. Diagonal cracking may be due to long term sagging of window or opening lintels along with minor foundation settlements.

Photo 2 – View of east elevation with diagonal brick cracking

- 1. Provide masonry repointing of brick joints where needed.
 - a. Estimated area of repointing based on 20% of total area.
 - b. Provide temporary scaffolding for access to all exposed areas of brick
 - c. Estimated cost - \$30,000 to \$50,000
- 2. Provide stone and brick epoxy injection in cracks
 - a. Use same scaffolding from brick repointing efforts above
 - b. Use colorless epoxy to minimize visible crack repair work.
 - c. Estimated cost - \$10,000

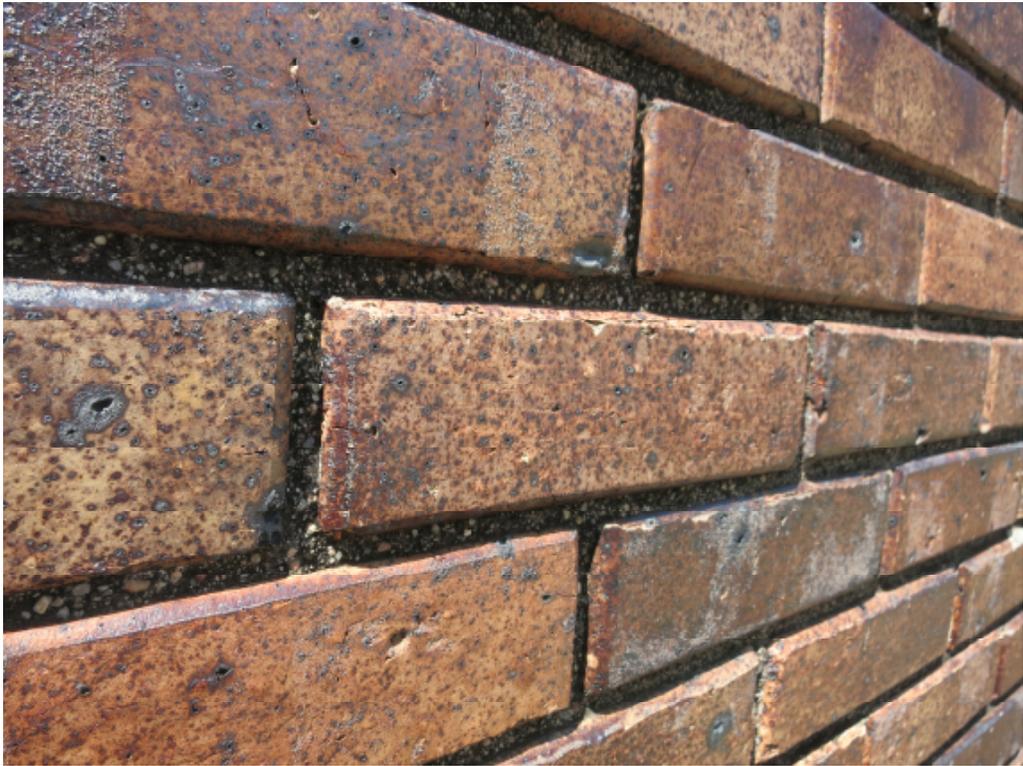
- i. Some areas of deep rakes in mortar joints but no associated evidence of freeze-thaw damage.
 - j. Base concrete foundation wall had numerous vertical cracks with weathering. No open cracks or evidence of significant foundation movements.

Photo 3 – Typical brick condition with raked mortar joints

- i. Some areas of brick would require re-pointing efforts to ensure long term performance.
 - ii. Cracks in stone would require epoxy injection to seal cracks and ensure long term performance.

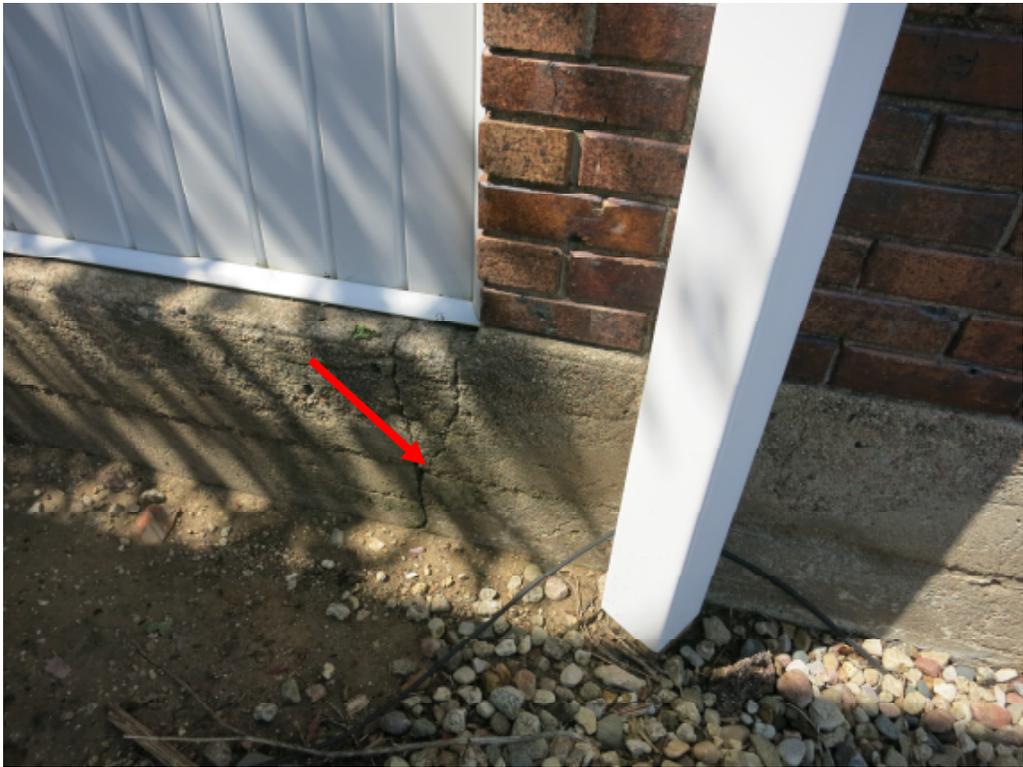
Photo 4 – Concrete foundation wall with vertical crack.

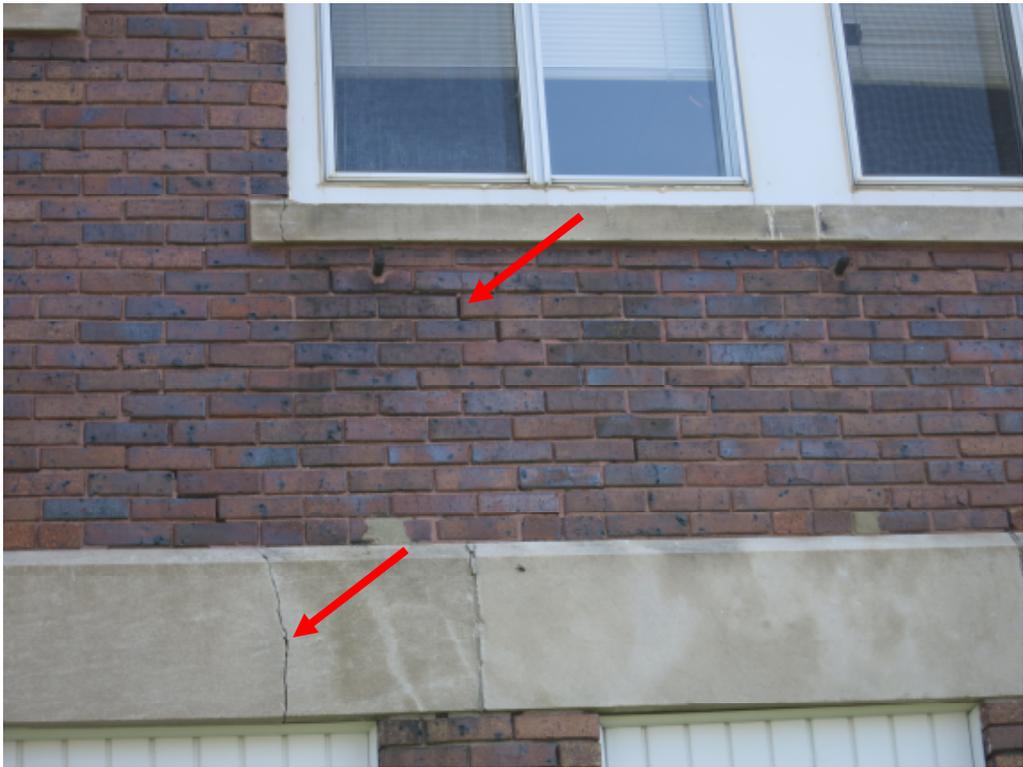
Photo 5 – Rear (west) elevation with brick cracking and stone cracking

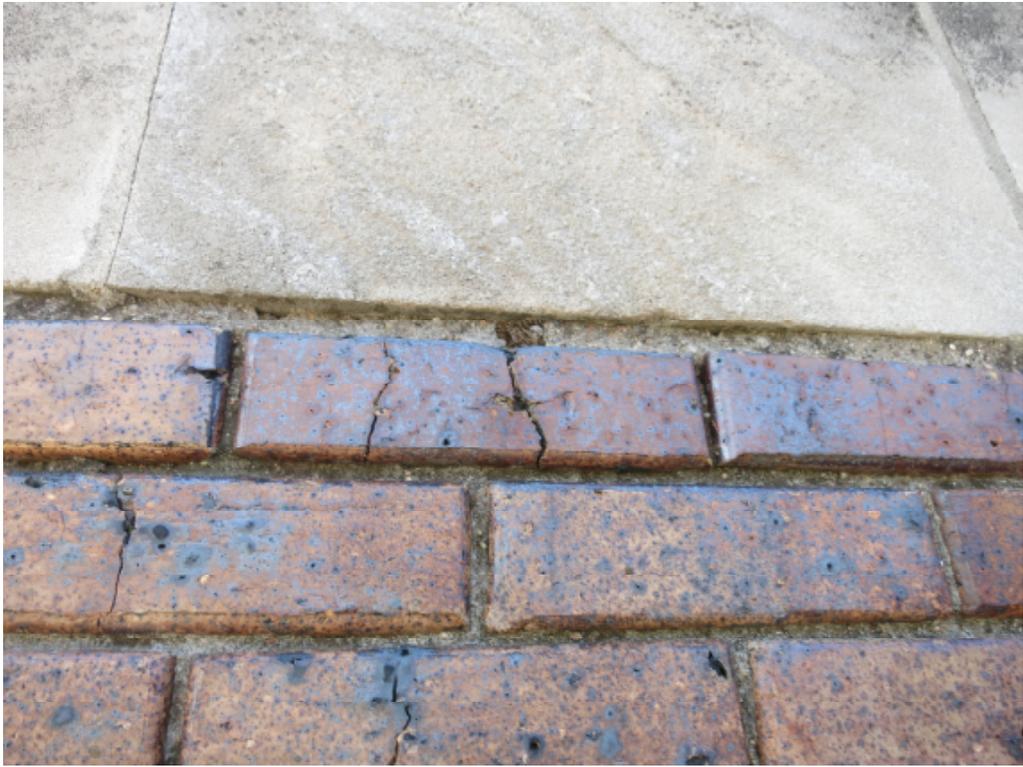
Photo 6 – Typical brick cracking

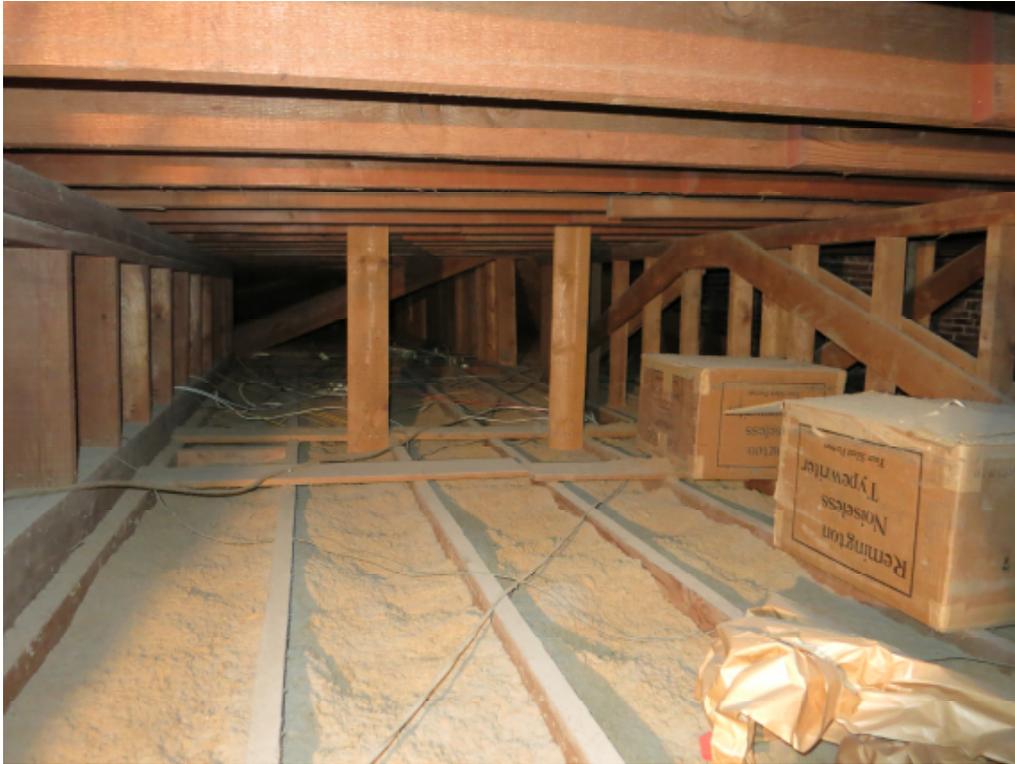
- e. Ceiling joists appeared to be in fair condition.
- f. Noted minimal ceiling insulation in the attic area.
- g. Appeared to be three or four vents in the roof.

Photo 7 – Typical attic view – note minimal insulation

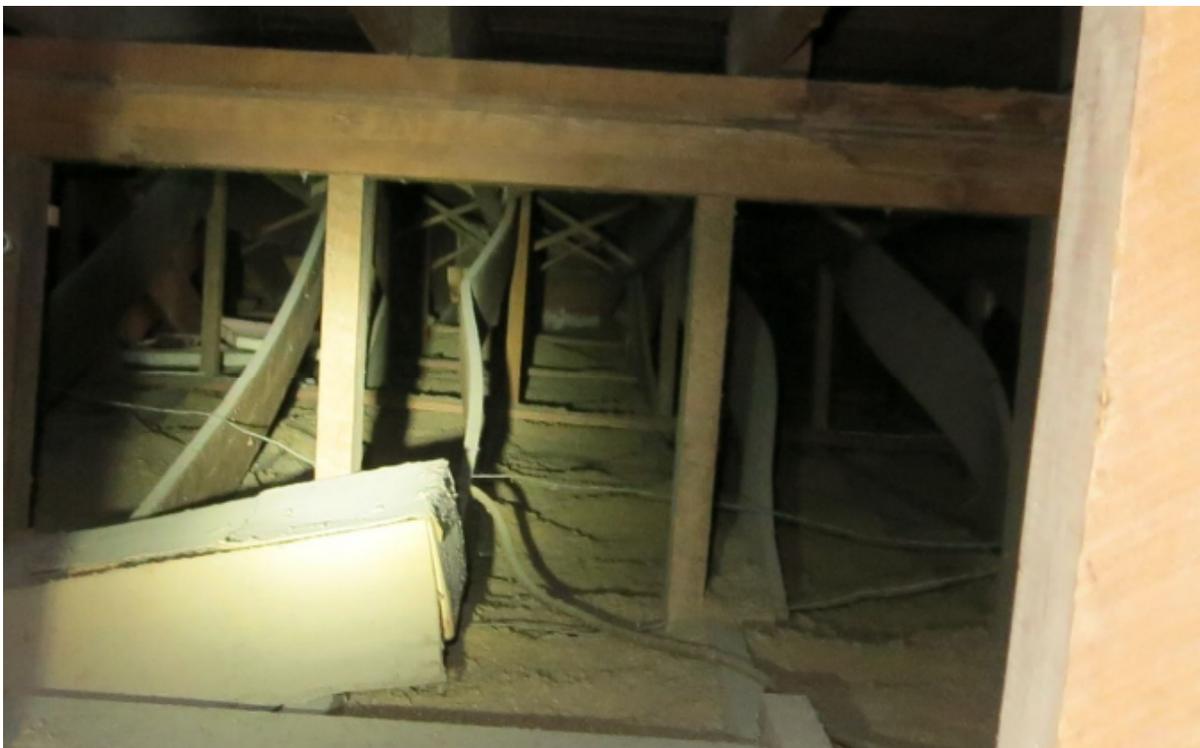
- d. A number of 1x diagonal braces were observed to be severely warped or buckled. These members appear to be used to laterally stabilize the roof framing and do not appear to affect the general load capacity of the roof.

Photo 8 – Attic view with warped/buckled diagonals

Repair Warped 1x Bracing in Attic

1. Leave existing in place
2. Supplement with new 2x6 braces
3. Nail or screw into place.
4. Replace access hatch with new
5. Estimated cost - \$3,600

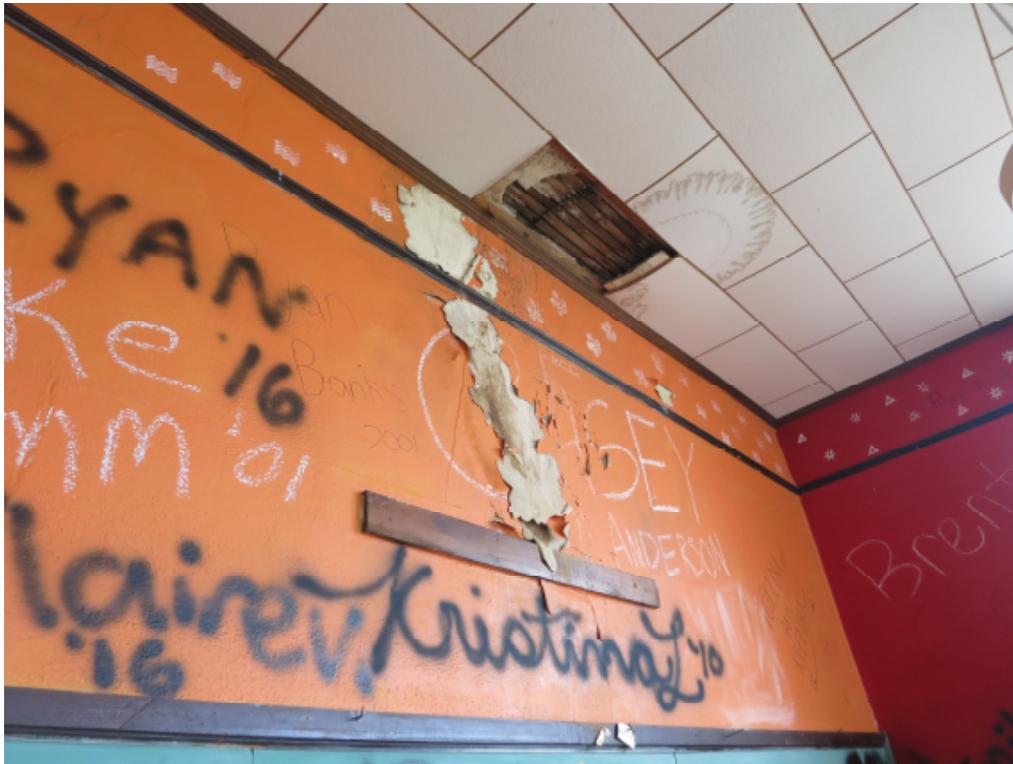
- b. Minor cracking was observed in numerous areas throughout walls and ceilings.
 - c. Some moisture infiltration/stains noted on the third floor level.

Photo 9 – Third floor with previous moisture infiltration

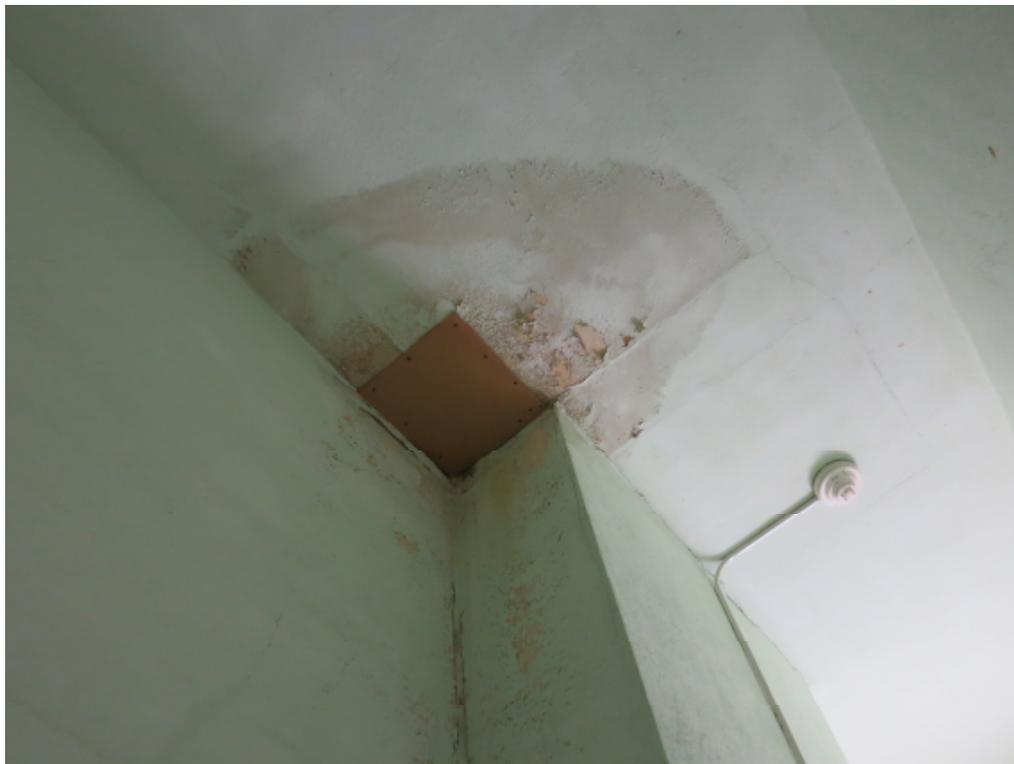
Photo 10 - Third floor with previous moisture infiltration

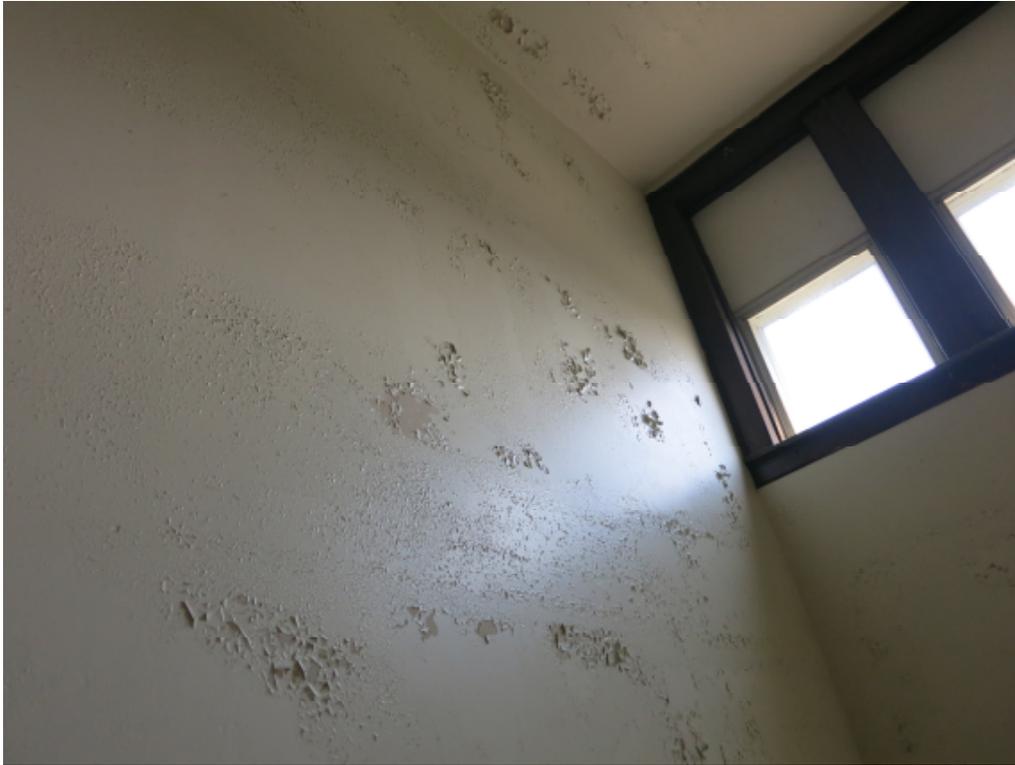
- d. Significant racking of door frames was observed, especially in the four doors off the central common area on the second floor.
 - e. Possible lead-based paint peeling in the central stairway area.

Photo 11 – Top of main stairway with peeling paint (lead based?)

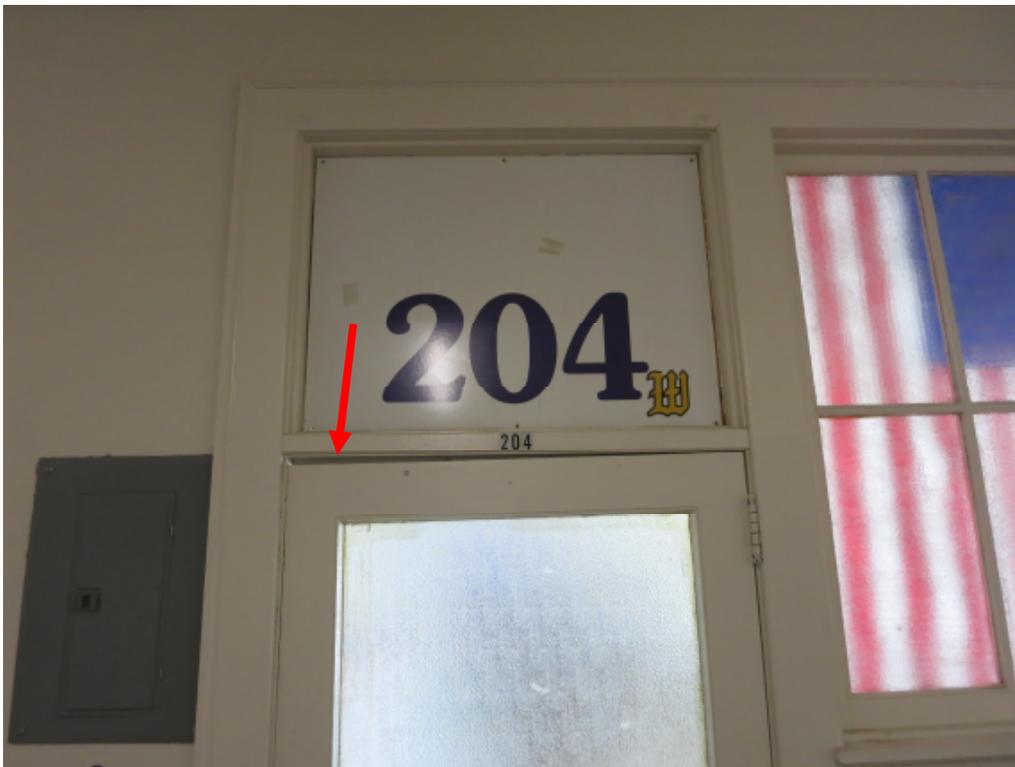
- f. No unstable or dangerous conditions were observed related to interior walls.
 - g. Conclusions
 - i. Racking of door frames could create an unsafe condition where a door may not operate properly and interfere with occupant egress out of the room and floor during an emergency.

Photo 12 – Second floor with racked door

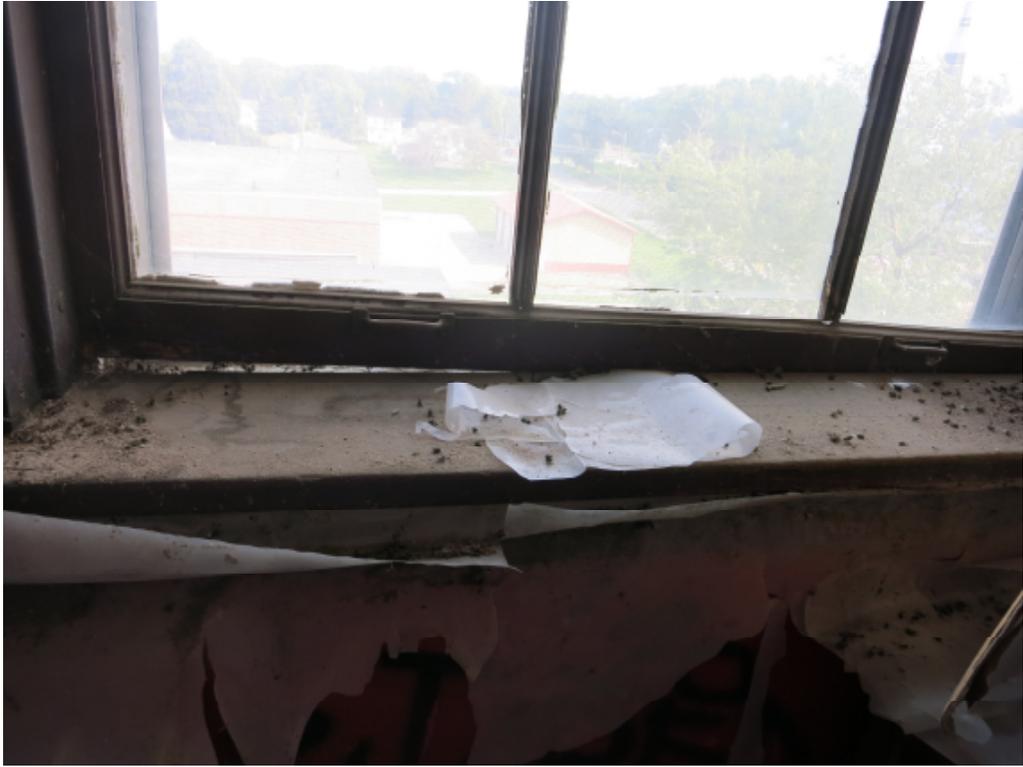
- v. No significant foundation movements observed.
- 5. Other observed items.
 - a. Some windows were observed to be in poor conditions. Some were racked on the inside relative to interior wall framing and some did not close completely.

Photo 13 – Third floor window with damaged and racked frame.

Replace Windows

See architectural recommendations

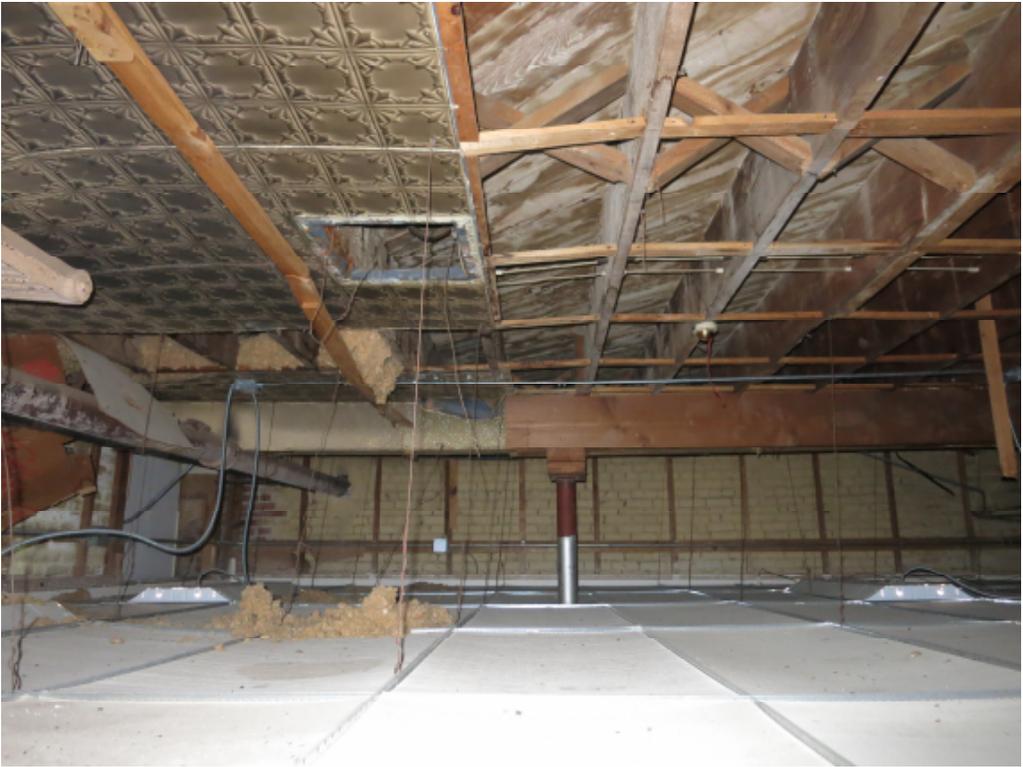
- iii. The beam to the north has the two columns supporting it at 1/3 points. This beam is not visible and is covered by some type of material.
 - iv. The columns extend down to the floor and there is about a 30” square cut out area where the hardwood floor was removed and replaced – apparently to allow construction of a small footing below the columns.

- vi. The condition currently appears competent and safe.
 - c. The interface between the adjacent buildings on the south, east and north sides appears to be in good condition with no signs of differential movements between the buildings and no moisture infiltration.

Photo 14 – View above art room ceiling with shored floor beam and steel pipe column
