City of Crete East Crete Area

JEO Consulting Group, Inc.

Crete Blight Study Area

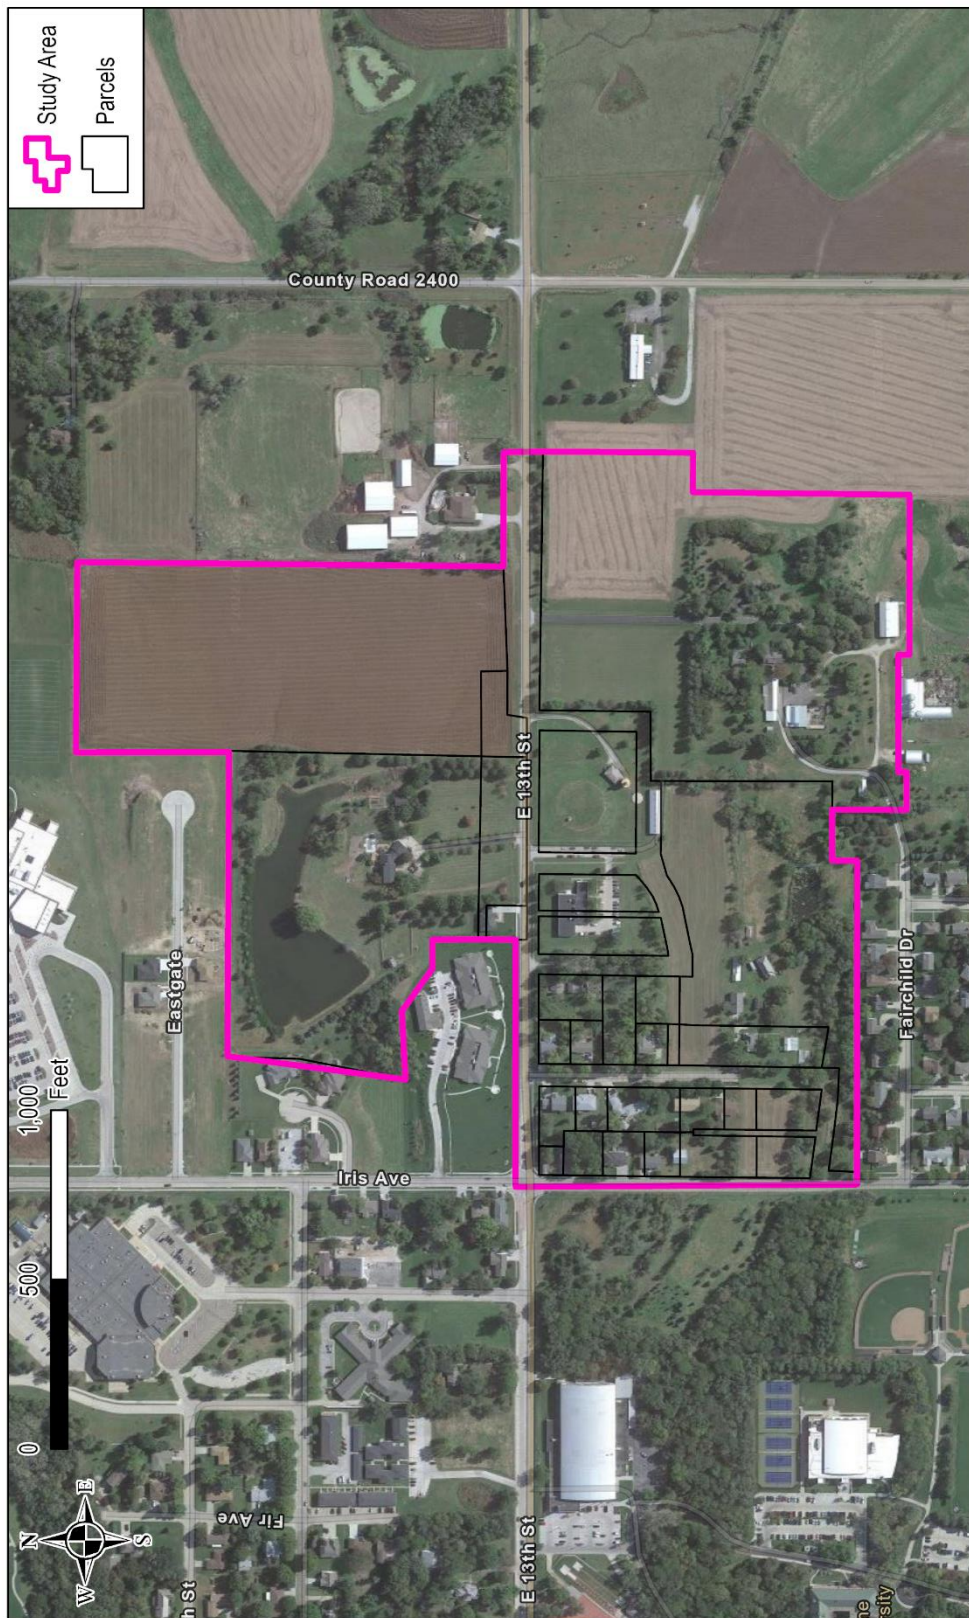
Figure 1: Designated Study Area

The study area as identified can be found in Figure 1. For this study, the study area will be known as the “Designated Study Area” which was reviewed for substandard and blight characteristics.

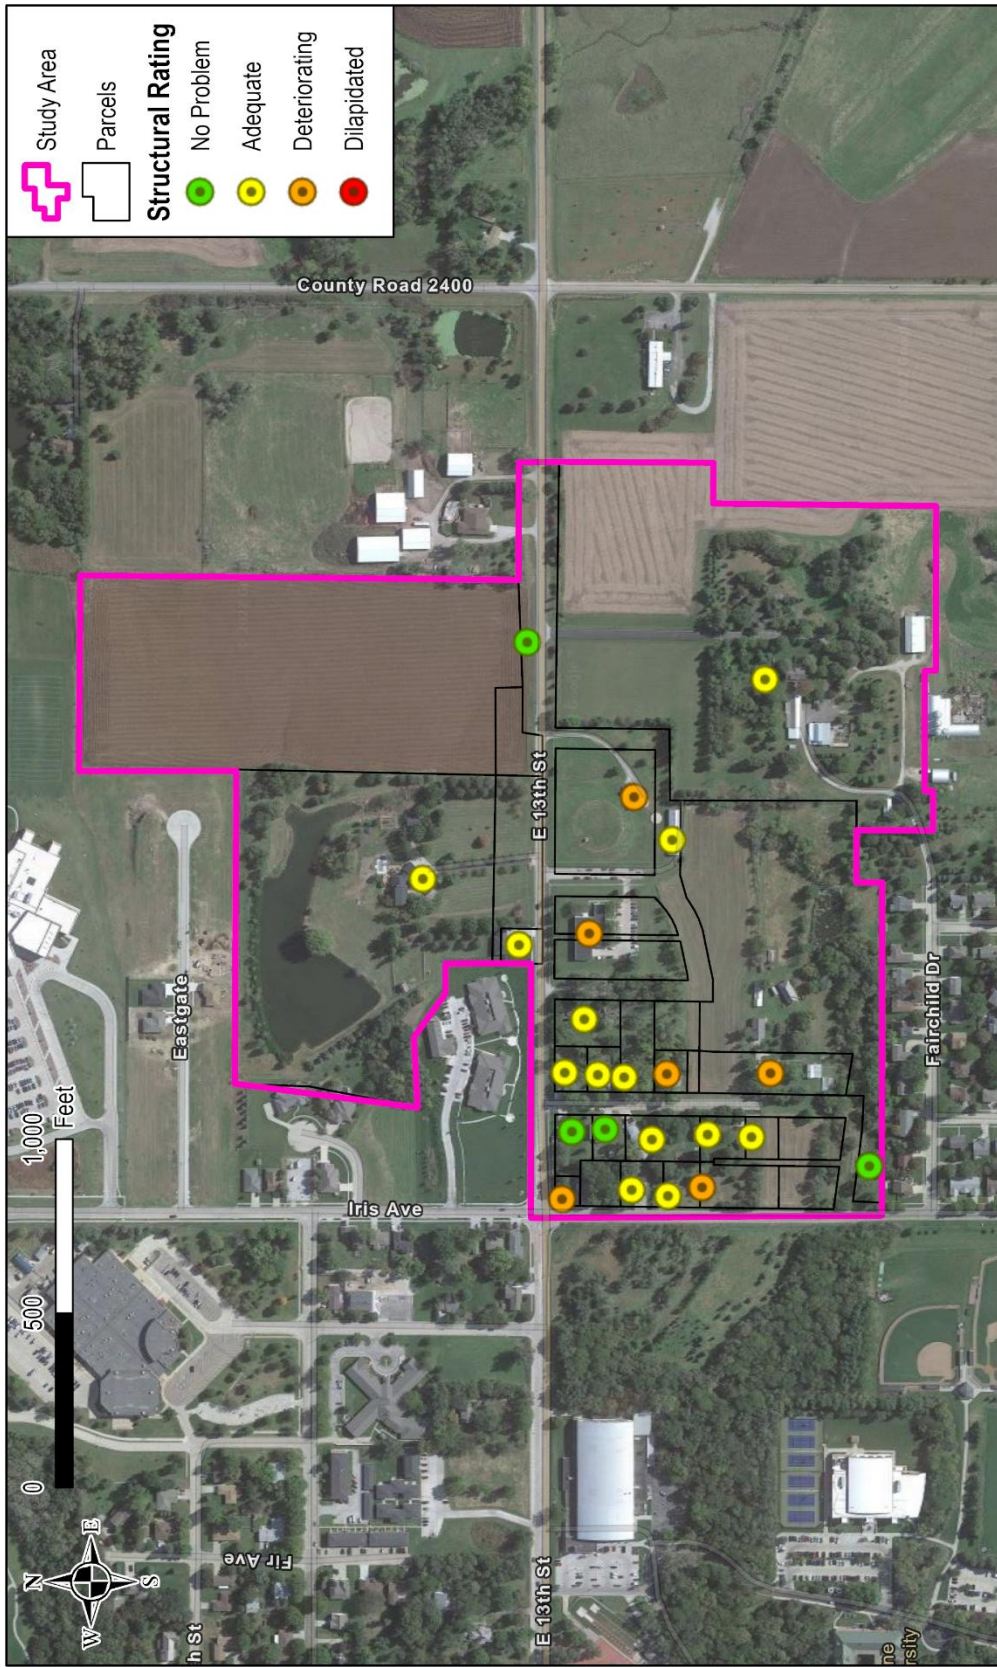
Figure 2: Structural Conditions

Each parcel within the East Crete Study Area Blight Study Area was examined for the structural conditions. A total of 23 structures were evaluated and 6 or 26% of the structures within the designated study area were graded as deteriorating or dilapidated. The structure condition ratings are illustrated in Figure 2. This is considered a contributing factor.

Crete Blight Study: Structural Rating

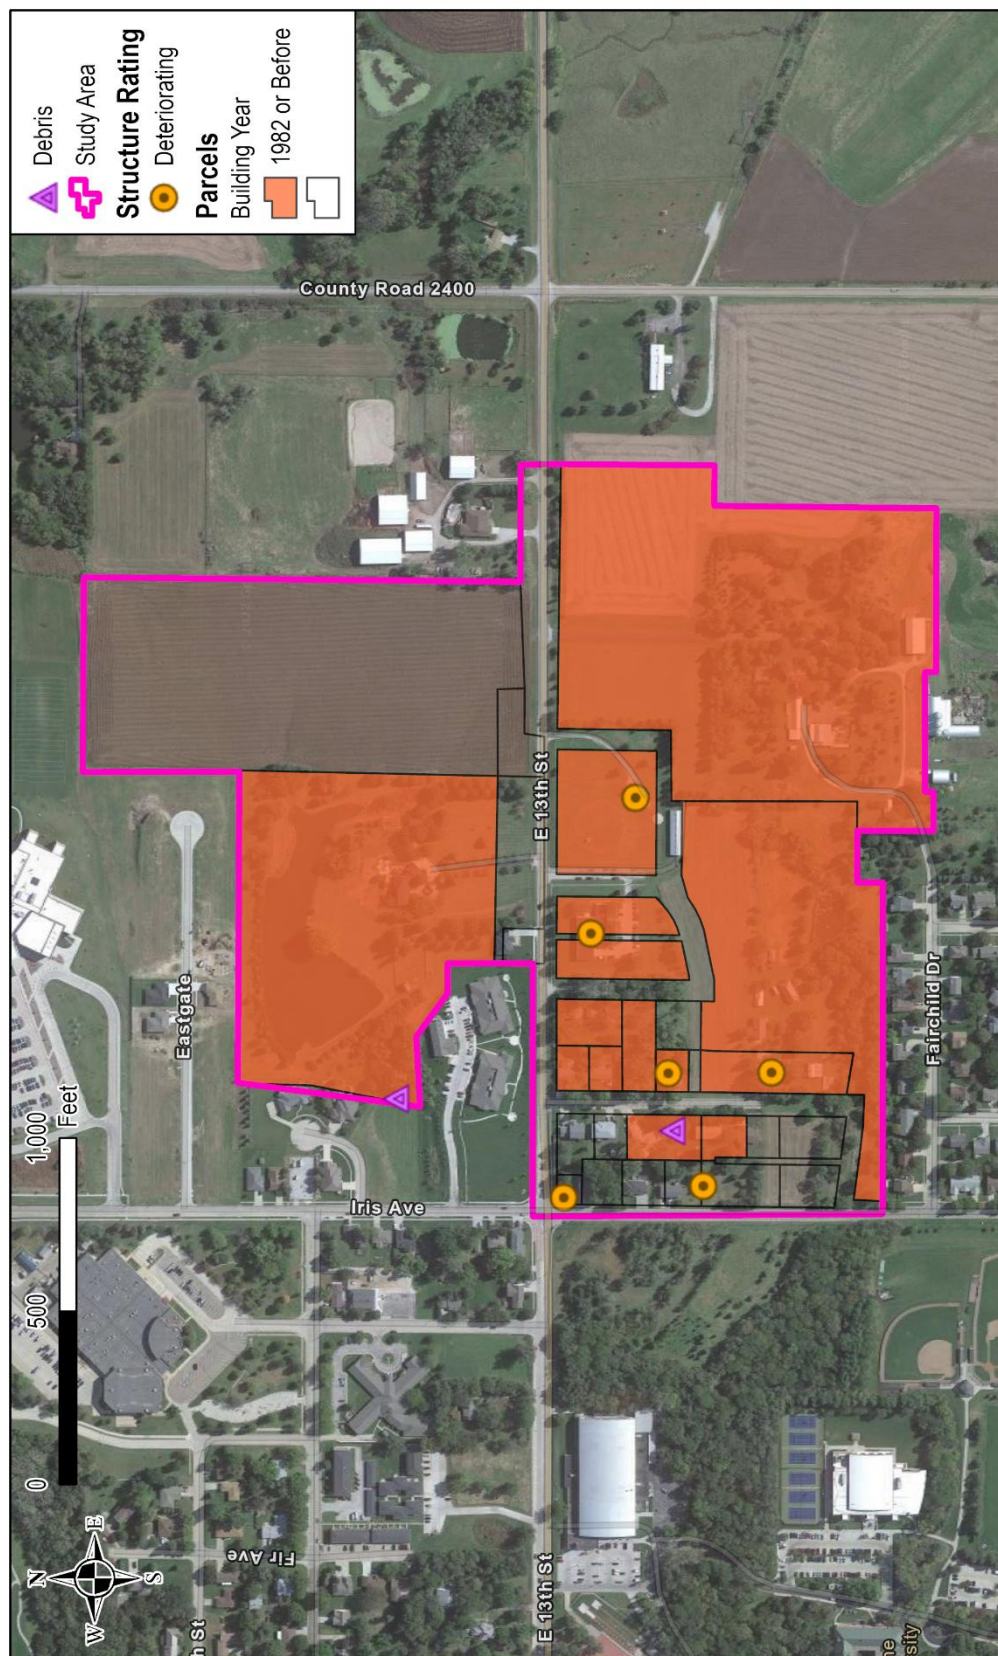
Crete Blight Study: Potential Hazards

Debris piles were noted in the field analysis in three locations. This can contribute to harboring rodents and vermin as well as pose a potential mosquito breeding area to spread disease.

The area along the southern perimeter of the study area is an open channel for storm drainage. During storm events, the unprotected area could pose a safety hazard to people and or structures in the vicinity.

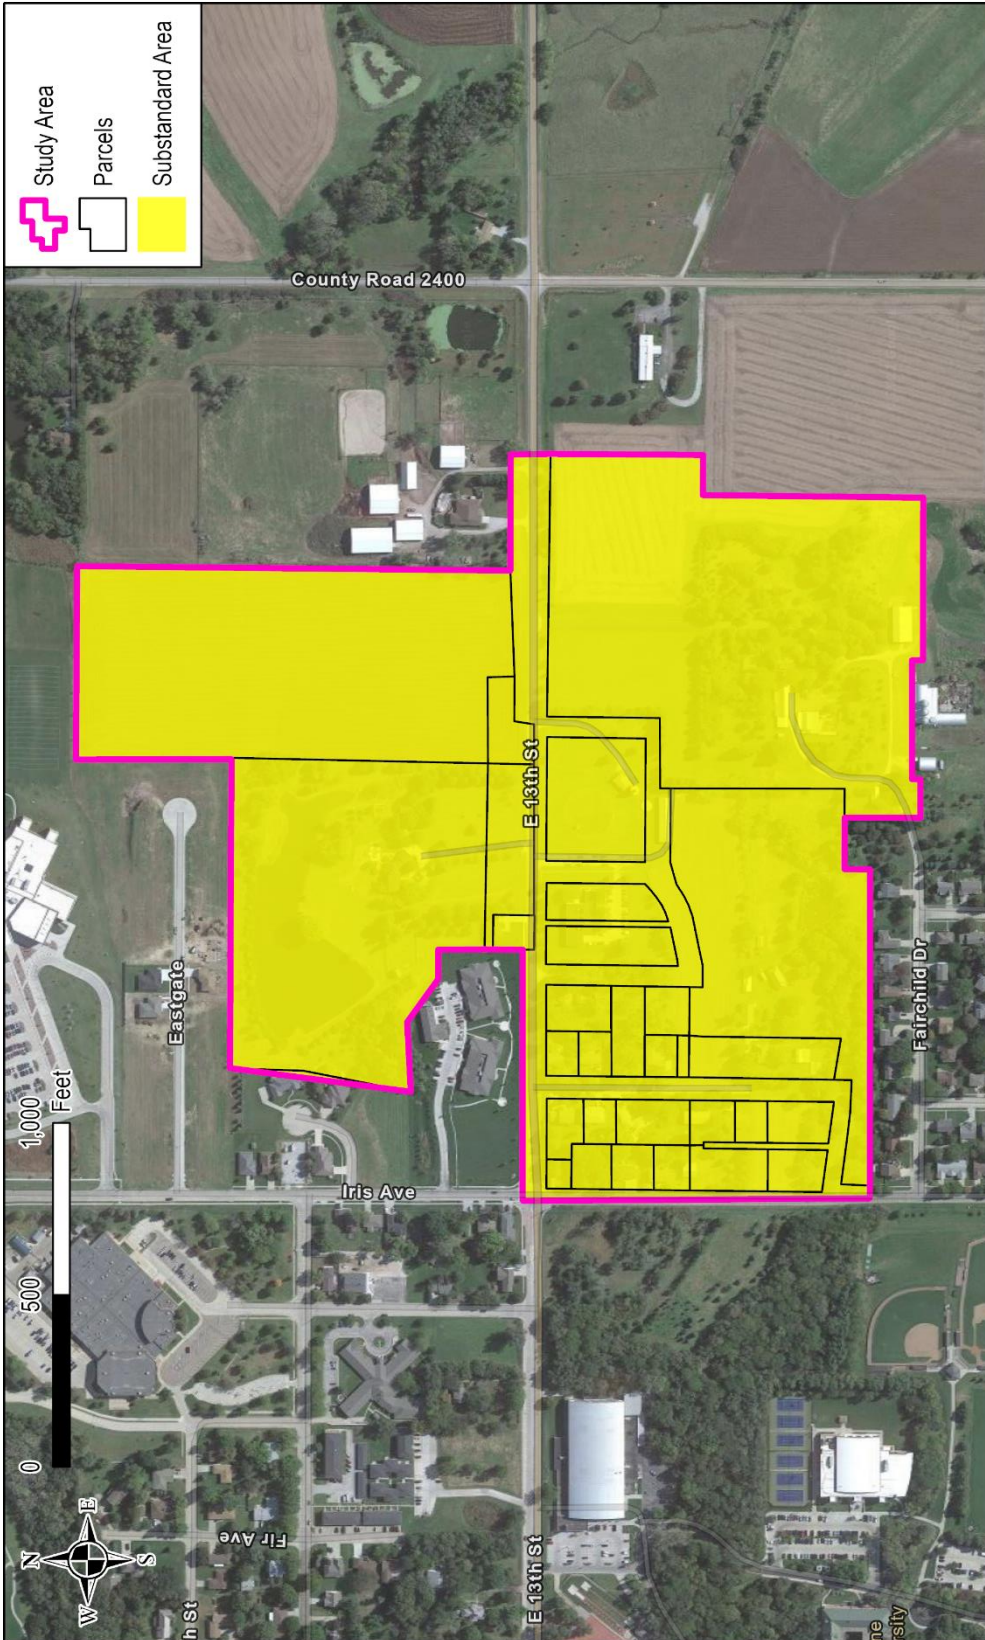
Figure 6 Recommended Blight and Substandard Designation

Based upon the review of the designated study area, and its context with the community, JEO Consulting Group recommends the designated study area be recommended as a Blight and Substandard Area. This area consists of approximately 84.0 acres. The following legal description delineates the Recommended Area
