# City of Crete Blight and Substandard Study Redevelopment Area #3 (East Crete)

JEO Consulting Group, Inc.

Appendix A Photo Exhibit

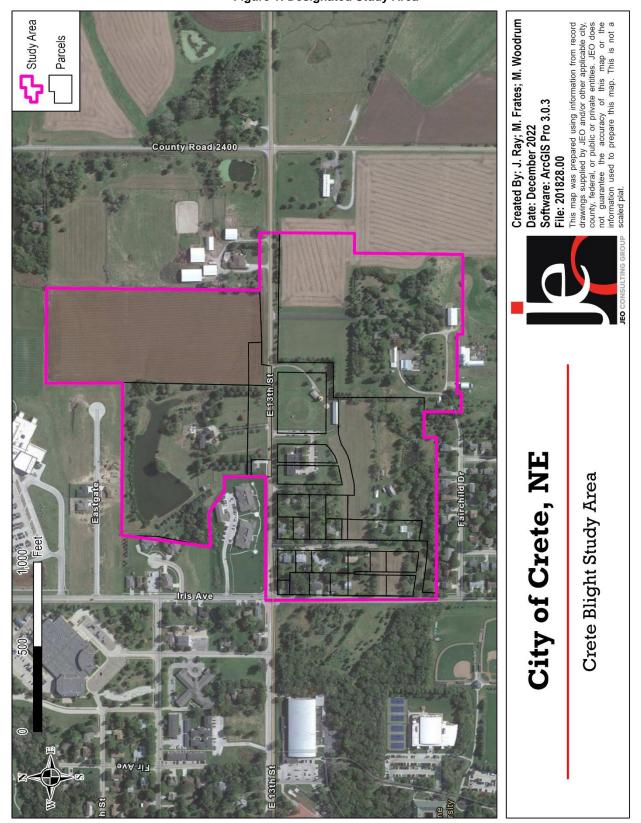
Figure 1: Designated Study Area

The study area as identified can be found in Figure 1. For this study, the study area will be known as the "Designated Study Area" which was reviewed for substandard and blight characteristics.

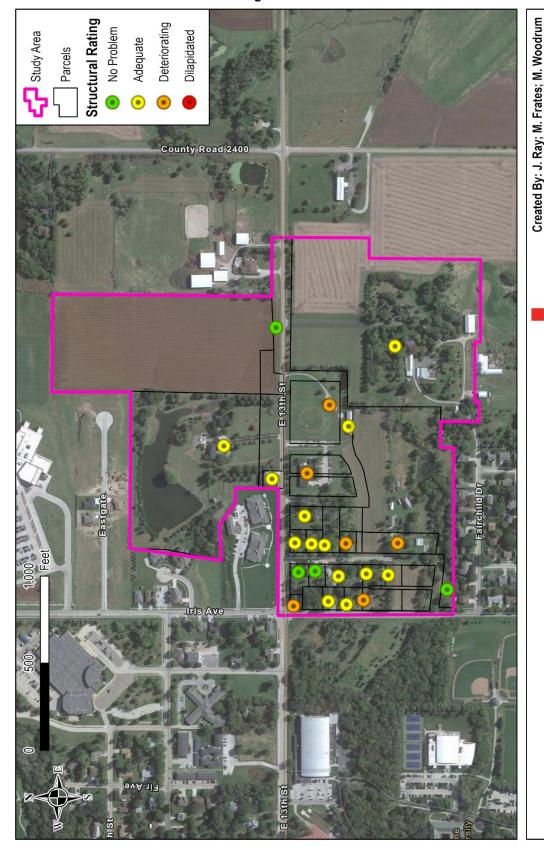
**Figure 2: Structural Conditions**

Each parcel within the East Crete Study Area Blight Study Area was examined for the structural conditions. A total of 23 structures were evaluated and 6 or 26% of the structures within the designated study area were graded as deteriorating or dilapidated. The structure condition ratings are illustrated in Figure 2. This is considered a contributing factor.

A total of 6 or 26% of the structures within the designated study area were graded as deteriorating. within the study area. This is considered a contributing factor but not at a predominate level.

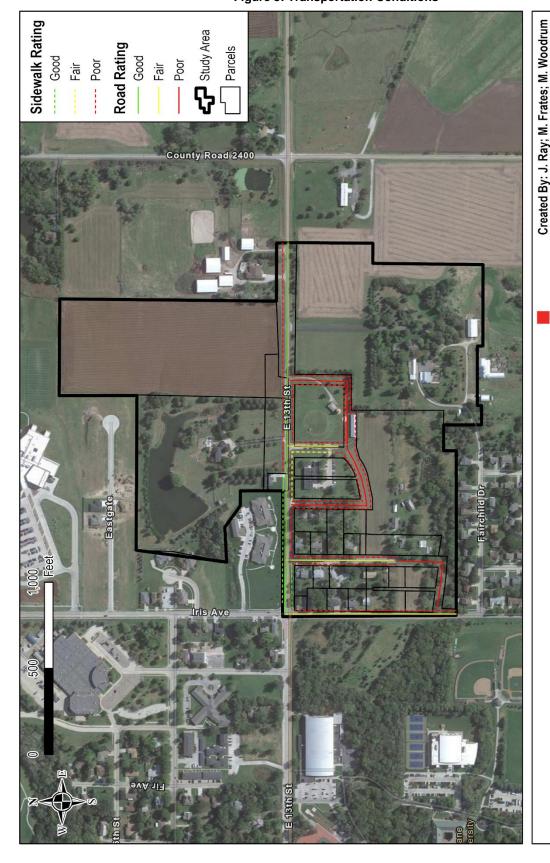
**Figure 3: Transportation Conditions**

Street conditions and accessibility within the East Crete Study Area Blight Study Area were evaluated in relation to the provision of safe and efficient public circulation and access, and with regard to ease of travel and appearance. The noted deficiencies are: missing portions or incomplete streets; limited urban grid pattern or connectivity, unpaved and undeveloped roads, and the lack of sidewalks in the area. The transportation infrastructure conditions are illustrated in Figure 3.

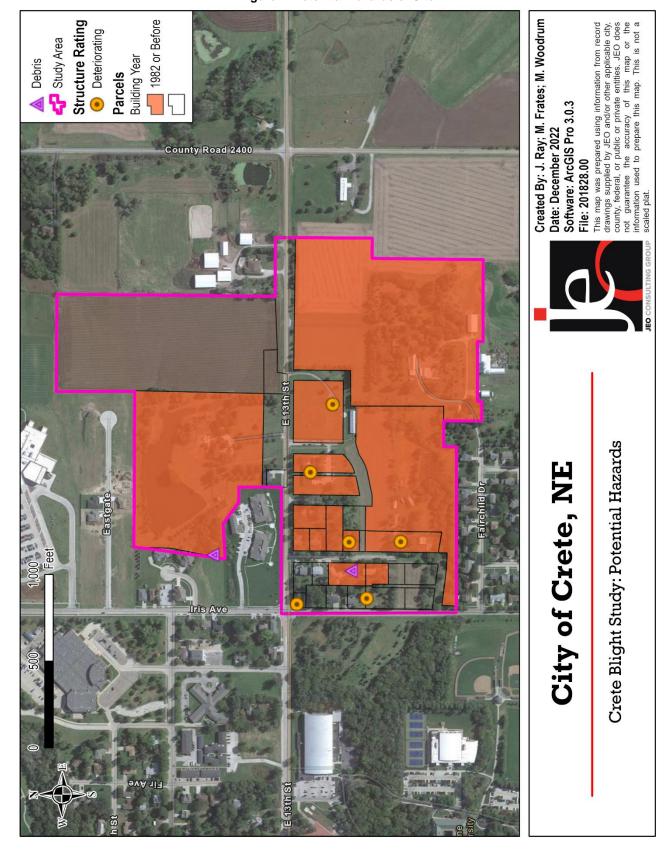
Figure 4: Potential Hazards of Site

Debris piles were noted in the field analysis in three locations. This can contribute to harboring rodents and vermin as well as pose a potential mosquito breeding area to spread disease.

The area along the southern perimeter of the study area is an open channel for storm drainage. During storm events, the unprotected area could pose a safety hazard to people and or structures in the vicinity.

Debris piles were noted in the field analysis in 3 locations. This along with heavily wooded areas can contribute to fire hazards or harboring rodents and vermin as well as pose a potential mosquito breeding area to spread disease.

The area on the southern perimeter has a large open channel for storm drainage. During storm events, the unprotected area could pose a safety hazard to people and structures in the vicinity.

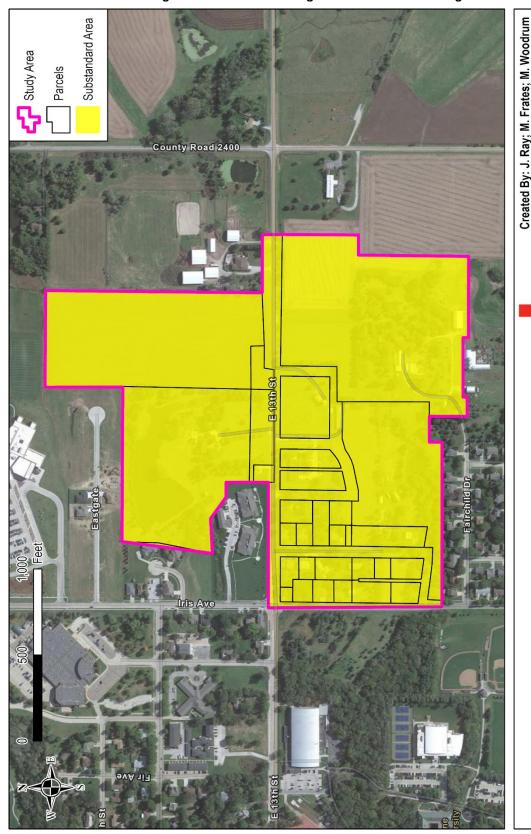
Figure 6 Recommended Blight and Substandard Designation

Based upon the review of the designated study area, and its context with the community, JEO Consulting Group recommends the designated study area be recommended as a Blight and Substandard Area. This area consists of approximately 84.0 acres. The following legal description delineates the Recommended Area
